STM investigation of structural properties of Si layers deposited on Si(001) vicinal surfaces

Abstract. This report covers investigation of the structural properties of surfaces of Si epitaxial layers deposited on Si(001) vicinal substrates with different miscuts. We have shown processes of generation and growth of surface defects to depend on tilt direction of a Si(001) wafer and epilayer growth mode. We suppose these effects to be connected with interaction of monoatomic steps.

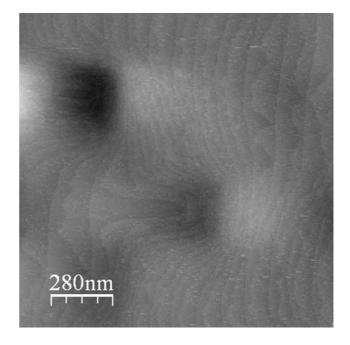
Fig. 1. STM image of the surface of the 50-nm Si epilayer deposited at 650°C on the Si(001) vicinal wafer tilted ~ 0.2 ° towards [110], the deposition rate was $\sim 0.3 \,\text{Å/c}$.

At first, we consider STM data for Si/Si(001) surfaces tilted towards the [110] direction. The surface is composed by S_A and S_B monoatomic steps [3]; S_B steps are wider than S_A ones. We have observed formation of such defects as faceted pits on these surfaces. In Fig. 1, an initial stage of the defect formation is shown. There observed the local stoppage of growth of an S_B step and appearance of two S_A steps instead. In other words, we have observed a gap of the S_B step. The S_A steps repulse each other and the defect cannot be overgrown quickly. The bottom of the deep pit has a rectangular shape and a long side of it formed by the S_A step.

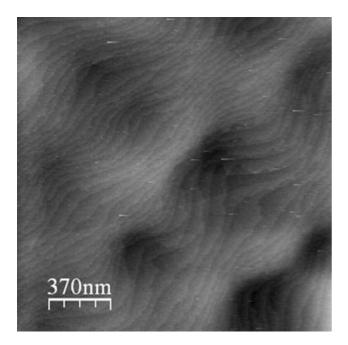
Fig. 2. STM image of the surface of the 50-nm Si epilayer deposited at 650°C on the Si(001) vicinal wafer tilted ~ 0.2 ° towards [100], the deposition rate was $\sim 0.3 \,\text{Å/c}$.

STM data for the Si/Si(001) surface tilted towards the [100] direction are presented in Fig. 2. The surface is composed by bent monoatomic steps. In this case every monoatomic step consists of short parts of SA and SB steps and runs along the [100] direction. There are local disarrangements of the structure. We suppose this kind of defects to be connected with a process of transition from the mixed $S_A + S_B$ monoatomic step to two single S_A and S_B steps instead of formation of the D_B step.

We have investigated the structural properties of the Si film surface depending on the rate of Si deposition. We have found that reduction of the Si deposition rate from 0.3 Å/c (Fig. 2) to 0.1 Å/c (Fig. 3) results in appearance of the structure formed by monoatomic steps running along the [110] direction and formation of shapeless pits on the surface instead of the structure formed by the bent monoatomic steps which run along the [100] direction.

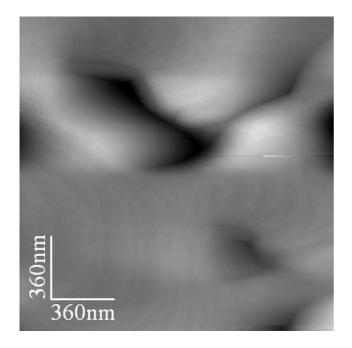
Fig. 3. STM image of the surface of the 50-nm Si epilayer deposited at 650°C on the Si(001) vicinal wafer tilted ~ 0.2 ° towards [100], the deposition rate was $\sim 0.1 \, \text{Å/c}$.
