WIRELESS SENSOR NETWORK TECHNOLOGY FOR MONITORING MOISTURE CONTENT OF WOOD

Ivan Araquistain, Jose Miguel Abascal, Oriol Munne

Tecnalia Research and Innovation

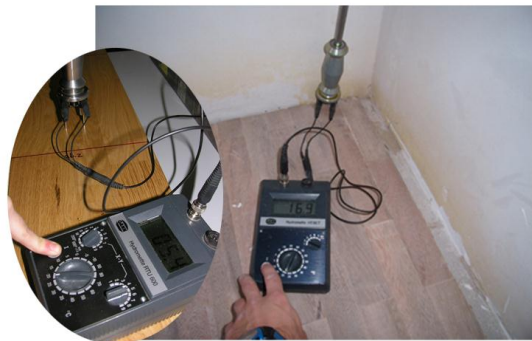
Figure 1: Wood moisture measurement

-Wood hydrometer: This equipment is intended to determine on-site, quickly and easily, the wood moisture content. Most frequently, it is based on the electrical conductivity of wood depending on moisture content. See equation (1), where R is the electrical resistance in Ohms and M the moisture content in %.

However, Non-contact wood hygrometers based on capacitive moisture sensing are now gaining market as they are easier to use.

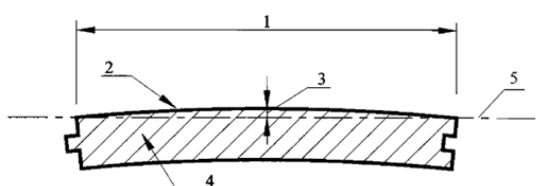
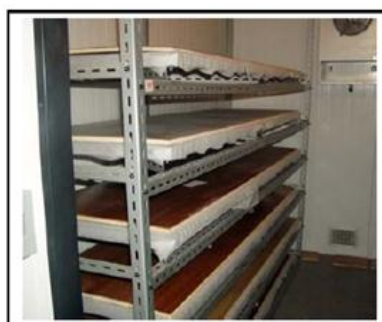
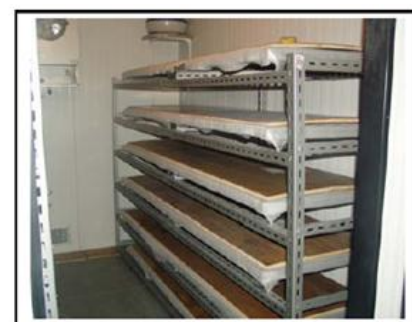
Figure 2: Wood parquet samples in the climatic chamber

Then, 12 specimens were introduced in the climatic chamber under conditions of 85% humidity and 23 ° C temperature. 10 of these specimens were used for measurements of curl and curvature of the face, while the other two were used to obtain samples that permitted the exact measurement of moisture content by oven-drying method. 5 of the specimens were placed directly on the shelves of the climatic chamber, while the other 5 were placed on battens.

Successive measurements were made to determine the curvature of the face and the curling of the specimens as long as they gained moisture content. All of the 10 samples exceeded the specifications of face curling after the exposure at the climatic chamber.

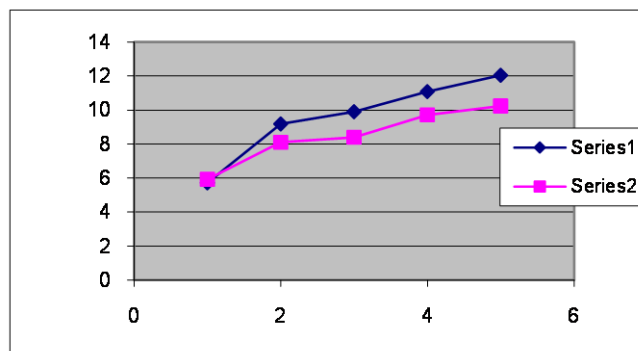
Graph 1: Moisture content of parquet samples

x-axis: Successive measurements
y-axis: Moisture content in %
Series 1 corresponds to: Specimens on battens
Series 2 corresponds to: Specimens directly on shelves

It is noted in Graph 1 that the moisture increasing of parquet placed on battens is faster than that of the ones placed directly on the shelves. Logical outcome, as in the case of the specimens on battens, moist air is in contact with both sides of the specimen.

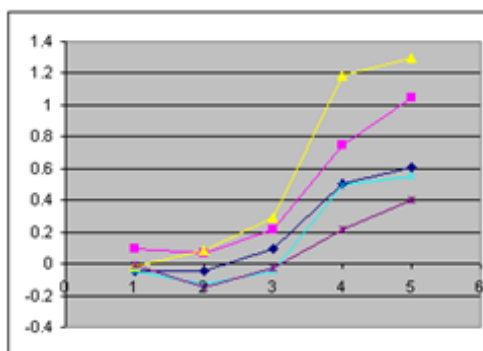
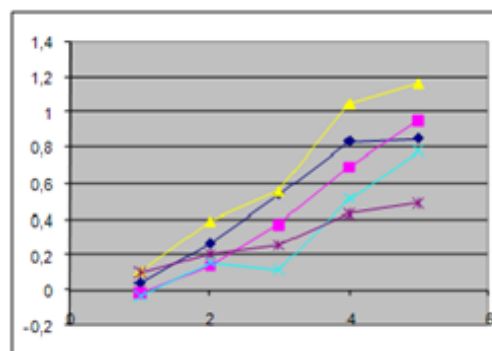
Graph 3: Curl of parquet specimens on batten (left) and on shelves (right)
x-axis: Successive measurements
y-axis: Curl in mm

* Note: The maximum allowed curl according to the standard (UNE EN 13489:2002) is 0.2% of the width. In this case corresponds to 0.42 mm. There is no specification for the curvature of face.

As Graph 3 shows, all specimens exceeded curl specifications which could constitute a basis to reject the material. This defect was evident when moisture content reached from initial 6% to 10-11% of moisture content.

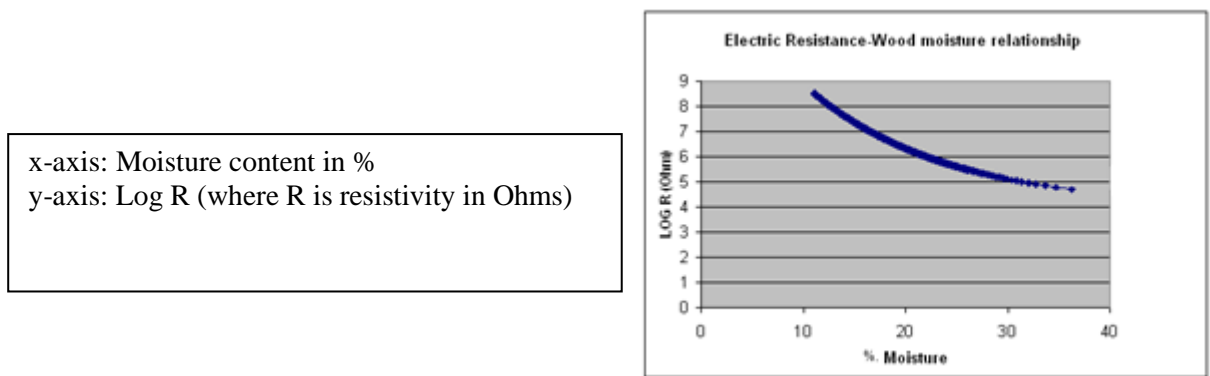
Graph 4: Electric resistance vs. wood moisture

Moisture measuring technology used in the wireless sensor was based on the electrical resistance of wood, as it varies with the moisture content of it and to a lower extent with the temperature. In addition to this it depends on the wood species.

In dry condition, wood is a very good isolator for electricity, with an approximate resistance of (1.000 MΩ). However, with a 30% of moisture content, the electrical resistance of wood only reaches about (200mΩ). Therefore, it can be stated that the sensibility of the moisture measuring equipments is much higher when it comes to measuring low moisture rates than when it comes to measuring high ones. In spite of this fact, for detecting possible problems in wood structures, it is enough with measuring up to the 25% of moisture content with a correct accuracy (threshold for alarms is at 20%), even if for greater moisture contents, the accuracy level decreases.

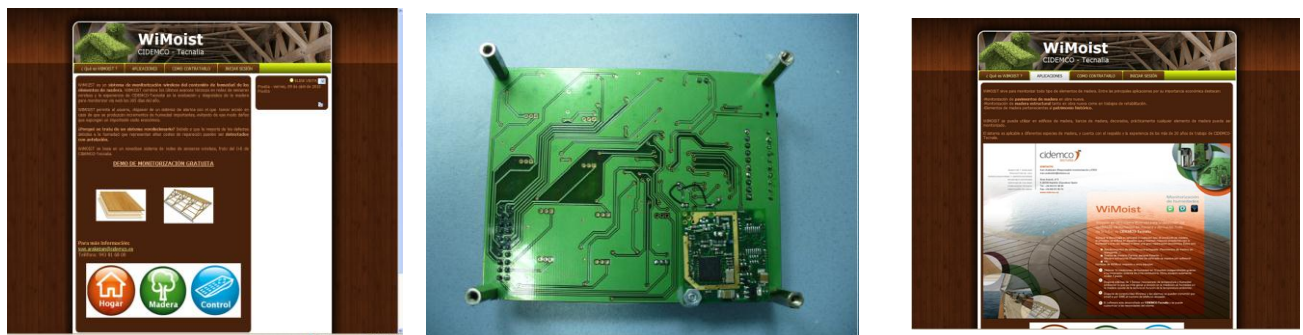
Figure 3: Electronic measuring circuit prototype and web application

Once the limits were established several electronic prototypes were developed in order to produce a wireless sensor capable of measuring moisture content out of 10 independent points, having a web application where the online monitoring results could be followed.

The web application enables the user to upload photographs from the areas where the sensors have been located. The application is organized by the number of floors of the building, which can be created and managed by the user.

The developed software has an implemented function to calculate moisture tendency, depending on current equilibrium moisture of wood and environmental moisture and temperature which will lead wood moisture to increase or decrease. This function is particularly useful for wooden floors, which are more likely to suffer from severe damages related to dimensional stability problems.
