# R&D Activities on RF Contacts for the ITER Ion Cyclotron Resonance Heating Launcher

Embedded RF contacts are integrated within the ITER ICRH launcher to allow assembling, sliding and to lower the thermo-mechanical stress. They have to withstand a peak RF current up to 2.5 kA at 55 MHz in steady-state conditions, in the vacuum environment of the machine. The contacts have to sustain a temperature up to 250°C during several days in baking operations and have to be reliable during the whole life of the launcher without degradation. The RF contacts are critical components for the launcher performance and intensive R&D is therefore required, since no RF contacts have so far been qualified at these specifications. In order to test and validate the anticipated RF contacts in operational conditions, CEA has prepared a test platform consisting of a steady-state vacuum pumped RF resonator. In collaboration with ITER Organization and the CYCLE consortium (CYclotron CLuster for Europe), an R&D program has been conducted to develop RF contacts that meet the ITER ICRH launcher specifications. A design proposed by CYCLE consortium, using brazed lamellas supported by a spring to improve thermal

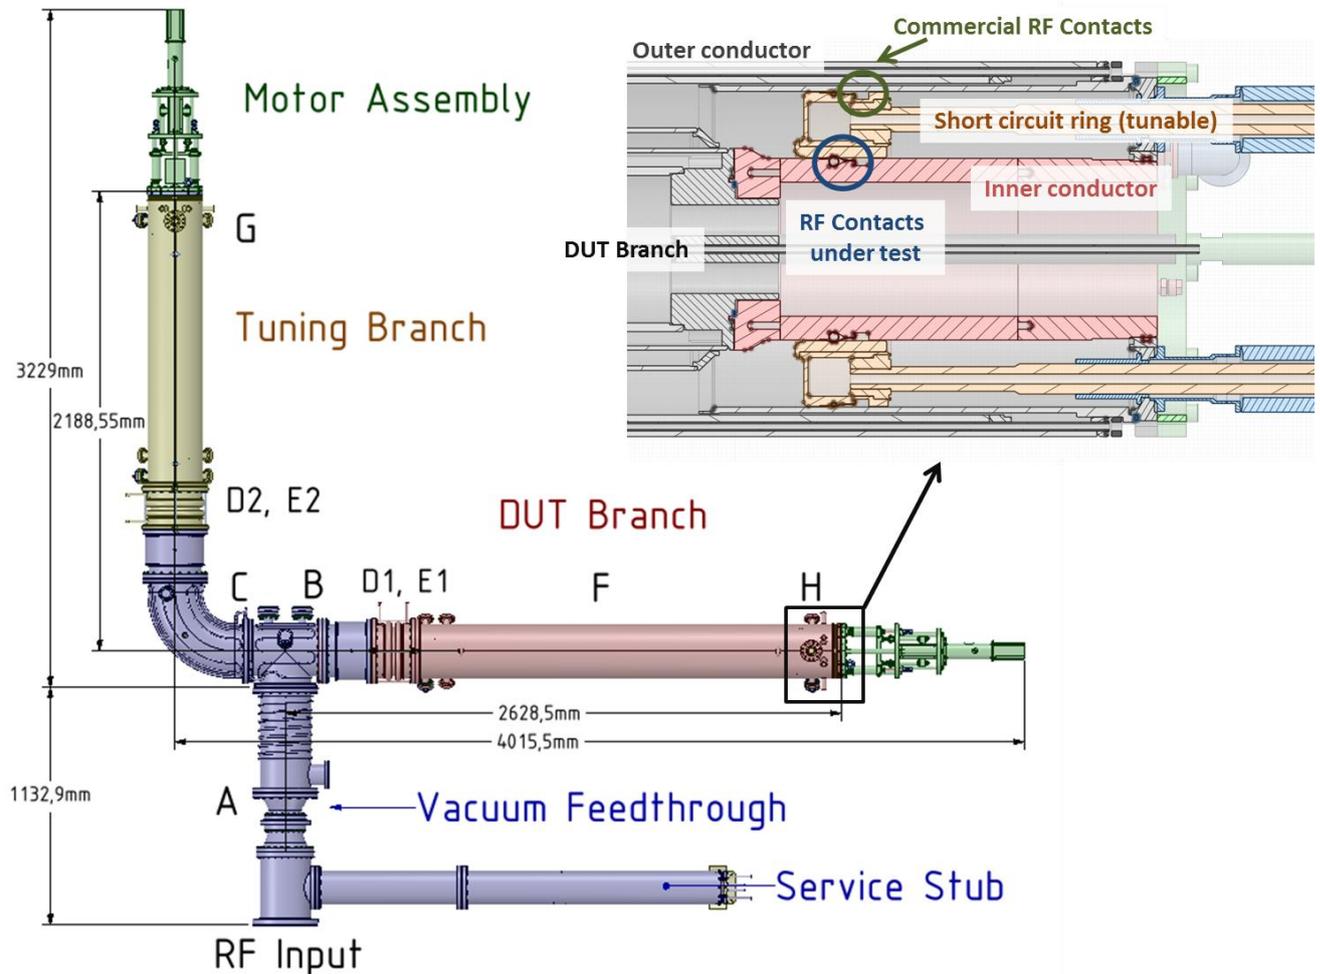
Fig. 1. T-Resonator description and overall dimensions. Letters indicate the locations of thermocouples.

Fig. 1 shows the T-resonator geometry. The RF contacts under test are located in the Device Under Test (DUT) branch, which has been designed in order to maximize the current level at the short-circuit side, in contrast to the tuning branch. The resonator is connected to the RF generator which can deliver a few hundred kilowatts to achieve up to 2.5 kA in the DUT branch and 45 kV in the tuning branch [7]. One of the main challenges of the RF contacts development is their qualification in steady-state conditions. The inner and the outer conductor of the resonator are thus actively cooled with water. The RF contact to be tested is assembled on a sliding trolley, actively cooled by the

TITAN hot water loop to mimic the  $\sim 90^{\circ}\text{C}$  operating temperature in ITER conditions. In order to test the contacts with a 20% safety margin, the required current on the contacts under test is 2.25 kA (with the worst current density case), pressure below  $10^{-3}\text{Pa}$ , at 62 MHz in order to maximize the current losses and thermal dissipation and during quasi steady-state pulses (20 to 30 minutes). The tuning branch, in which current is 60%

less than DUT branch current, is also ended with a sliding trolley, equipped with commercial Multi-Contact™ contacts. Motor assemblies on both sides of the resonator are used to remotely tune both short-circuit positions from the control room and to make short displacements mimicking the relative thermal displacements within the antenna during RF pulses.

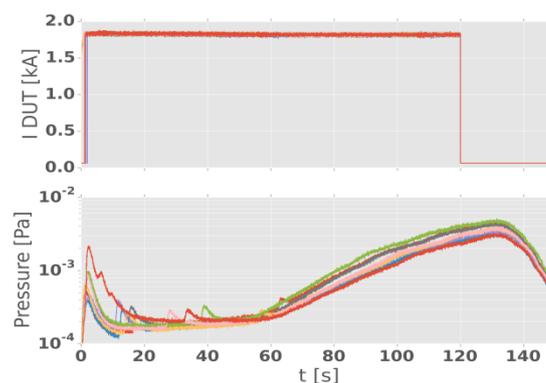
Fig.2. Illustration of the 8 consecutive trials of 1.8kA/120s pulses (traces superposed). For all pulses, the pressure is increasing after 50-60s of RF power, indicating an out-gassing component.

reflected power). Start of power RF pulses. (6) Decrease/Increase of hot water temperature for tests purposes. (7) The best RF pulses achieved (from the test stand point of view) were 2480 A/50 ms (corresponding to 2250 A + 10% margin) and 1470 A/1000 s. Out-gassing is very low during discharge (see close up illustrations below). (8) Best RF pulse achieved: 1700 A/1200 s. Following these pulses, large out-gassings have been monitored for higher currents, up to the interlock limit of  $10^{-2}$  Pa. Additional attempts have been performed at 1800 A/120 s, with reproducible out-gassings observed after 60 s of RF pulse, as illustrated in Fig.2. Ultimately after additional few attempts, RF power could not be sent in the resonator anymore. Finally RF shots have been performed with the resonator filled with nitrogen, and acoustic evidences of arcs have been heard.

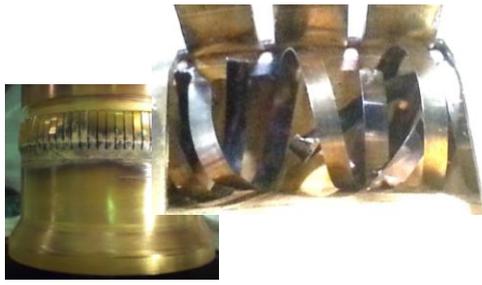
Fig.3. Close-up on the RF contact lamellas (left) and spring behind three lamellas (right). The diameter of the contacts band is 125 mm. The lamella width is 4 mm. The spring has melted in different locations (right).

Once disassembled, burn traces have been observed close to the lamellas of the DUT contacts (Fig.3), no other evidence of arcs were observed elsewhere on the RF structure. To investigate the defect, ultrasonic flaw detector was used on the contacts brazing and showed that the thickness under the brazed strip was not uniform, both in the axial direction (from the strip end to the lamellas) and in the angular direction (0-360°). Moreover, the burn traces are correlated to a local decrease of the thickness under the lamella. Since the detector couldn't be calibrated, no numerical value could be given. Post-mortem precise measurements of the brazing thickness are expected in a future work. This change of thickness could be interpreted as a flaw of brazing alloy under the material (probably due to small gaps). This hypothesis has been corroborated by a dye penetrant inspection, showing that local surface flaws were corresponding to local increase of the thickness measured with the ultrasonic flaw detector.

It is inferred that a degradation of the thermal contact between the lamellas and the core conductor, due to a deteriorated brazing layer or substances resulting from plating, could have locally increased the temperature, thus leading to out-gassing, to local arcing and a higher temperature increase up to the brazing material melting. It has to be noted that the spring has melted in various regions, indicating that its temperature abnormally increased locally. The cause of this melting is not known, but can be due to a fraction of the RF current flowing across the spring. Moreover, the region under the lamellas is badly pumped, and it is possible that out-gassing in this region had led to micro-plasma formation. Following this test, a novel design has been proposed that replaces the spring by folded stainless-steel lamellas. This configuration should improve the pumping behind the lamellas and its reliability.

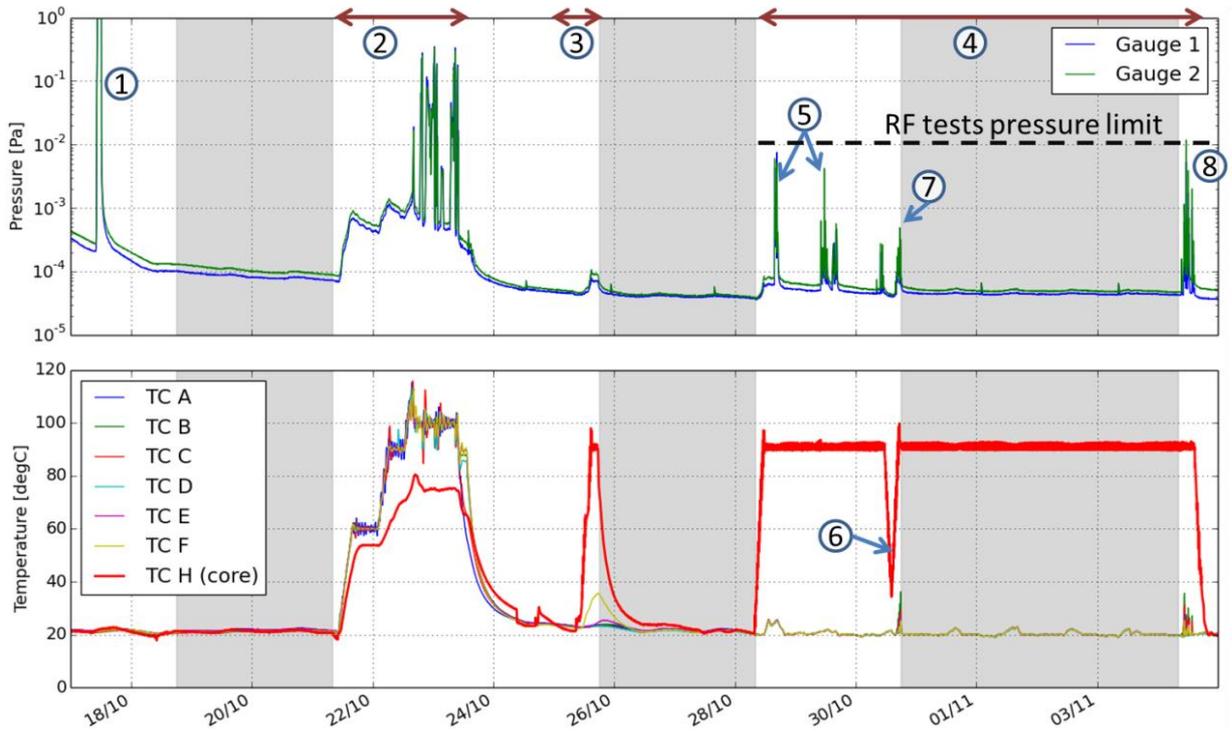
Fig.4. Timeline of the CCFE contacts RF test from 17/10 to 05/11/2013 from continuous data acquisition system. Thermocouple (TC) locations are illustrated by the letters in the Fig.1. TC H is located in the contacts core under test (inner conductor temperature).

The RF contacts described in the above section have been tested under RF in the CEA T-resonator test-bed. The test timeline is illustrated in Fig.4 and detailed below.

(1) Vacuum pump down. (2) Electrical baking up to 110°C, where abrupt rises of the pressure occurred when temperature reached 110°C. These sharp rises are assumed to be due to thermal dilatations which induce leakage on the assembly. (3) Test of the 90°C hot water loop connected to the contacts. (4) The 90°C Hot water loop is on. (5) The pressure is below  $10^{-4}$  Pa ( $8 \cdot 10^{-5}$  Pa) and RF conditioning begins (series of short RF pulses on un-matched resonator). First successful RF conditioning on matched configuration obtained (no
