An induced annealing technique for SiPMs neutron radiation damage

ABSTRACT: The use of Silicon Photo-Multipliers (SiPMs) has become popular in the design of High Energy Physics experimental apparatus with a growing interest for their application in detector area where a significant amount of non-ionising dose is delivered. For these devices, the main effect caused by the neutron fluence is a linear increase of the leakage current.

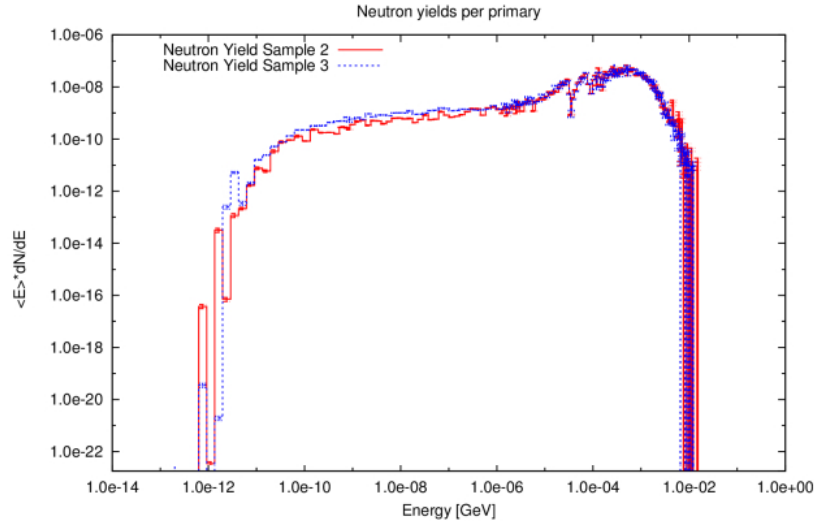
Figure 1. Fluka simulation of the neutrons energy spectrum at the SiPMs position.

The measurements described in this paper were performed at the Silicon Detector Facility of the Fermi National accelerator Laboratory ¹. Two different sets of SiPM arrays were studied: Hamamatsu [1] and SensL [2]. A sample from each vendor has been exposed to neutrons generated by the Elbe Positron Source facility (Dresden), up to a total fluence of $8 \times 10^{11} \text{ n}_{1\text{MeV-eq}}/\text{cm}^2$ [3]. The average energy of neutrons produced has been estimated by a full FLUKA simulation; the spectrum, Figure 1, is well centred around 1 MeV.

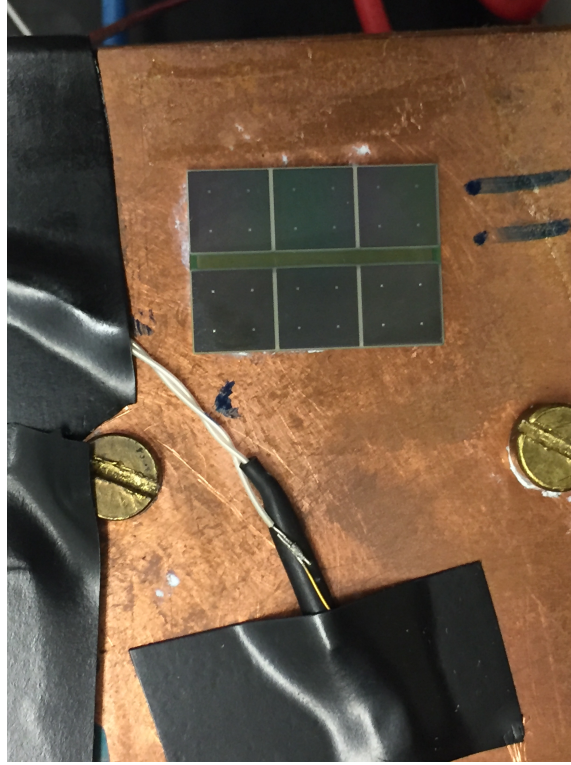
Figure 2 shows a picture of the Cu support with the PT1000, used to measure the temperature of the support, and one SiPM array plugged in. All the tests were performed inside a thermal chamber at a temperature of 20 °C. This setup allowed us to monitor the temperature of the SiPM active region

Figure 2. Cu support with one PT1000 and one SiPM array plugged in.

and of the Cu support during all the measurements and bias the SiPM with a current limitation of few hundreds mA. A second PT1000 sensor was placed on the top of the silicon resin of the SiPMs; the third PT1000 sensor was used to check that the temperature drop on the pin-side of the SiPM was within 2 °C with respect to the one measured on the active region.

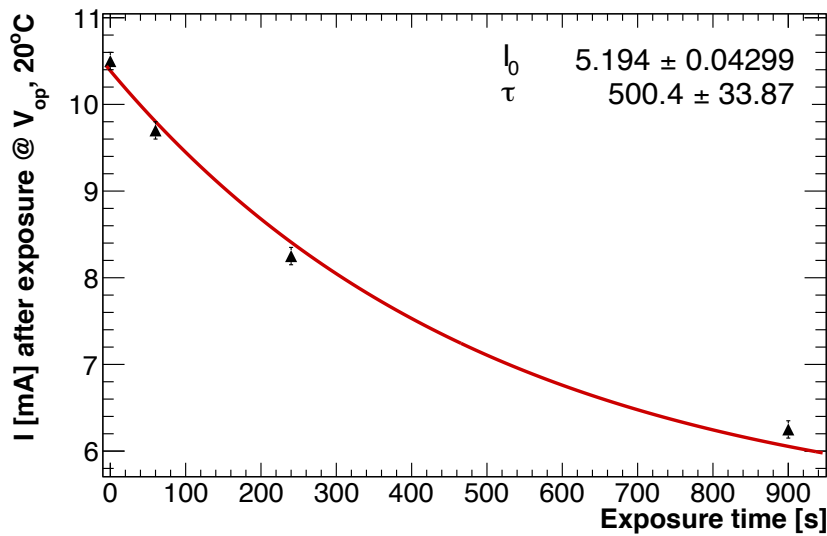
Figure 3 shows the results obtained with one cell of a Hamamatsu SiPM array polarized in direct configuration at $V_{\text{DIR}} = 10 \text{ V}$. The I_{dark} shows an exponential trend with a decay time of $\tau = 500 \text{ s}$ and a constant current term $I_{0\text{dark}} = 5.2 \text{ mA}$ ³. A reduction of $\sim 40\%$ in I_{dark} after $\sim 5 \text{ min}$ of direct polarization was achieved. In this configuration the SiPM was generating a I_{TEST} of $\sim 530 \text{ mA}$,

Figure 3. I_{dark} as a function of the exposure time for a direct polarisation. Points were fit with an exponential curve.

corresponding to a power of $\sim 5 \text{ W}$, that is the power needed to recover the damage of a factor of about 2.

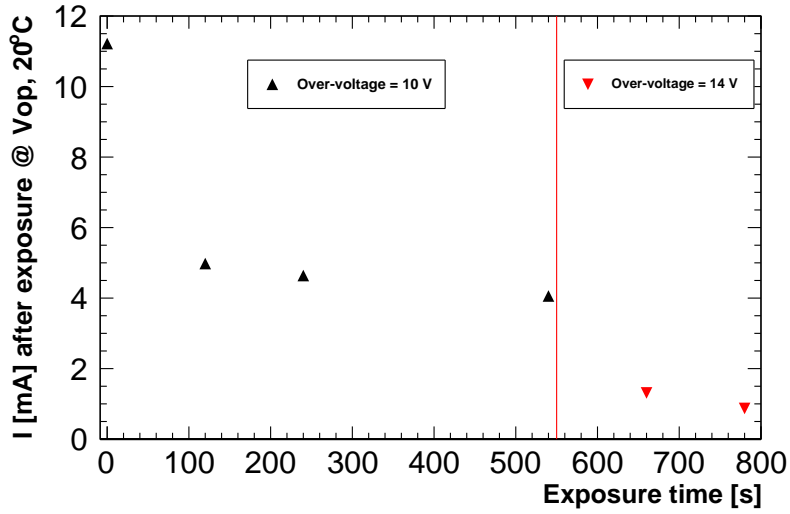
To quote the performance of the recovery method in inverse polarization two different settings of over voltage were tested. Both Hamamatsu and SensL SiPMs have been checked in this configuration. Figure 4 shows the I_{dark} variation as a function of the exposure time for a Hamamatsu SiPM. The first four measurements were taken at $\Delta V_{\text{IND}} = 10 \text{ V}$, then we improved the recovery by increasing the over voltage up to $\Delta V_{\text{IND}} = 14 \text{ V}$. After about 13 min at the described conditions, the SiPM I_{dark} reached about 1 mA that corresponds to a reduction of a factor of 10 when compared to the starting value. Finally, we tried to increase the over-voltage up to $\Delta V_{\text{IND}} = 17 \text{ V}$, but at this value the SiPM got broken. The I_{TEST} measured during this operation was $130 (186) \text{ mA}$ for a ΔV_{IND} of

Figure 4. I_{dark} as a function of the exposure time for a Hamamatsu SiPM cell for an inverse polarization. The two different settings for the over-voltage used during the test are separated by the vertical red line and indicated in the legends.

10 (14) V, corresponding to a dissipated power of about 8 (12) W. The temperature measured on the SiPM active region with the PT1000 was ~ 150 °C.

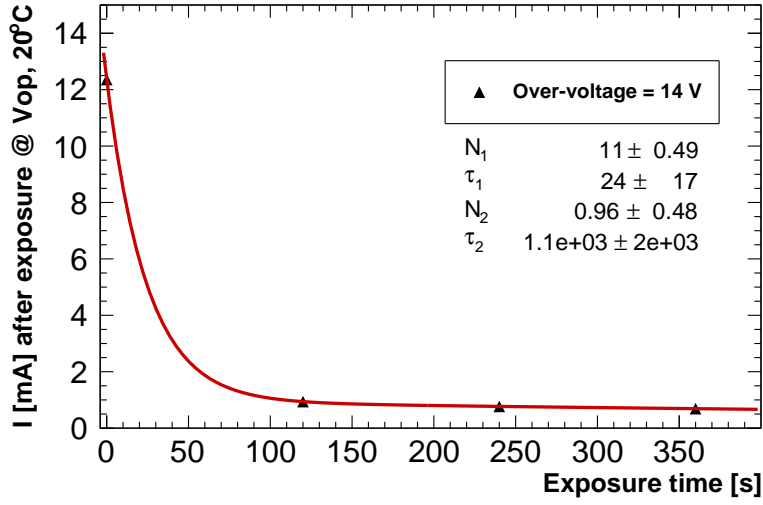
After the learning phase, we tested another Hamamatsu SiPM cell of the same device setting ΔV_{IND} at 14 V. Figure 5 shows the results of the I_{dark} measurement operated every 2 min; from the fit⁴ we observe that a rapid reduction of the leakage current occurs with a τ of the order of 25 seconds. After about 6 min of electrical annealing, a total reduction of a factor 15 on the leakage current was observed, thus indicating a good agreement with the previous test done on the same SiPM model.

Figure 5. I_{dark} as a function of the exposure time for a Hamamatsu SiPM cell applying an over-voltage of 14 V during the recovery.

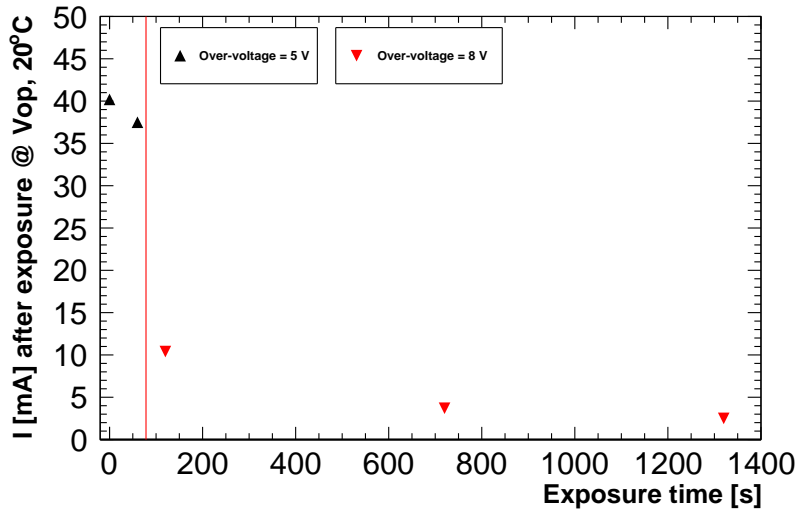
A similar test has been carried out also for the SensL device [2]. Figure 6 shows the measured I_{dark} for two different settings of ΔV_{IND} ⁵: 5 and 8 V. After 22 min we measured an overall reduction factor ~ 16 on I_{dark} (from 40.2 to 2.5 mA). Unfortunately after 22 min the SiPM got unplugged from the Cu plate, reached a temperature larger than 200 °C and got broken. Figure 7 shows the localization of the heating induced by the over voltage condition on the single cell under bias. During the annealing treatment, we have measured a I_{TEST} current of 200 (400) mA for ΔV_{IND} of 5 (8) V, corresponding to a dissipated power of about 6 (13) W. The temperature measured on the SiPM active region was ~ 150 °C.

Figure 6. I_{dark} as a function of the exposure time for a SensL SiPM cell. The two different settings for the over-voltage used during the test are separated by the vertical red line and indicated in the legends

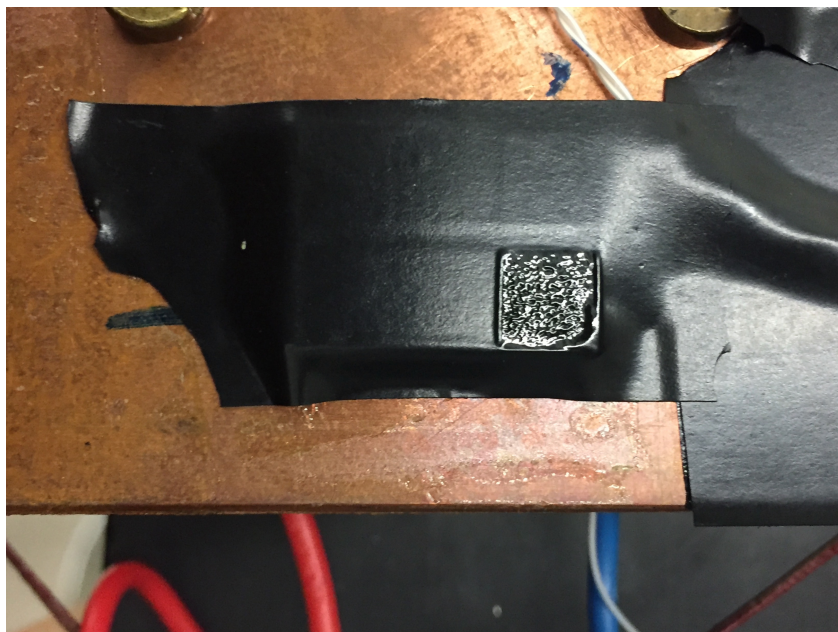
Figure 7. SiPM array on the Cu support at the end of the tests.

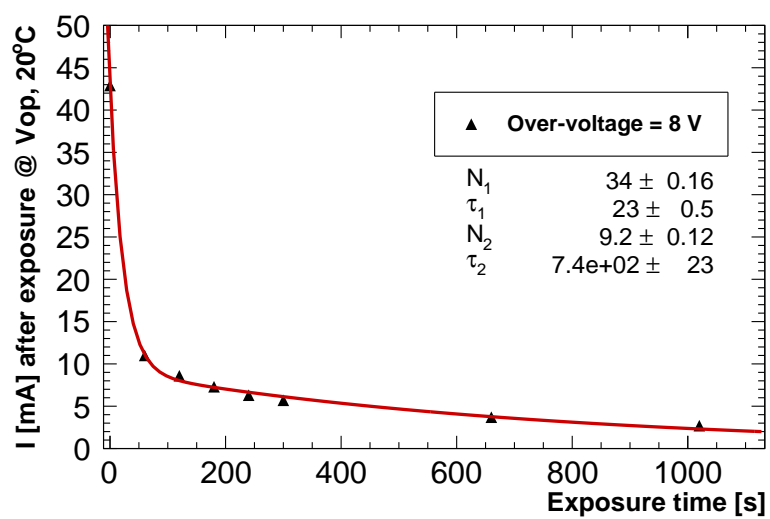
We repeated the measurement on another cell of the same device at $\Delta V_{\text{IND}} = 8$ V. Figure 8 shows the I_{dark} variation as a function of the exposure time; also in this case, we observe that a rapid reduction of the leakage current occurs with a τ of the order of 25 seconds, consistent with the value observed in Figure 5. After ~ 17 min the I_{dark} was reduced from 42.9 to 2.7 mA that is compatible with the reduction observed in the previous test.

Figure 8. I_{dark} as a function of the exposure time for a SensL SiPM cell applying an over-voltage of 8 V during the recovery.
