Large-area, high-resolution characterisation and classification of damage mechanisms in dual-phase steel using deep learning

Carl Kusche^{1,+}, Tom Reclik^{1,+}, Martina Freund¹, Talal Al-Samman¹, Ulrich Kerzel¹, Sandra Korte-Kerzel^{1,*}

¹ Institute of Physical Metallurgy and Metal Physics, RWTH Aachen University, Aachen, Germany

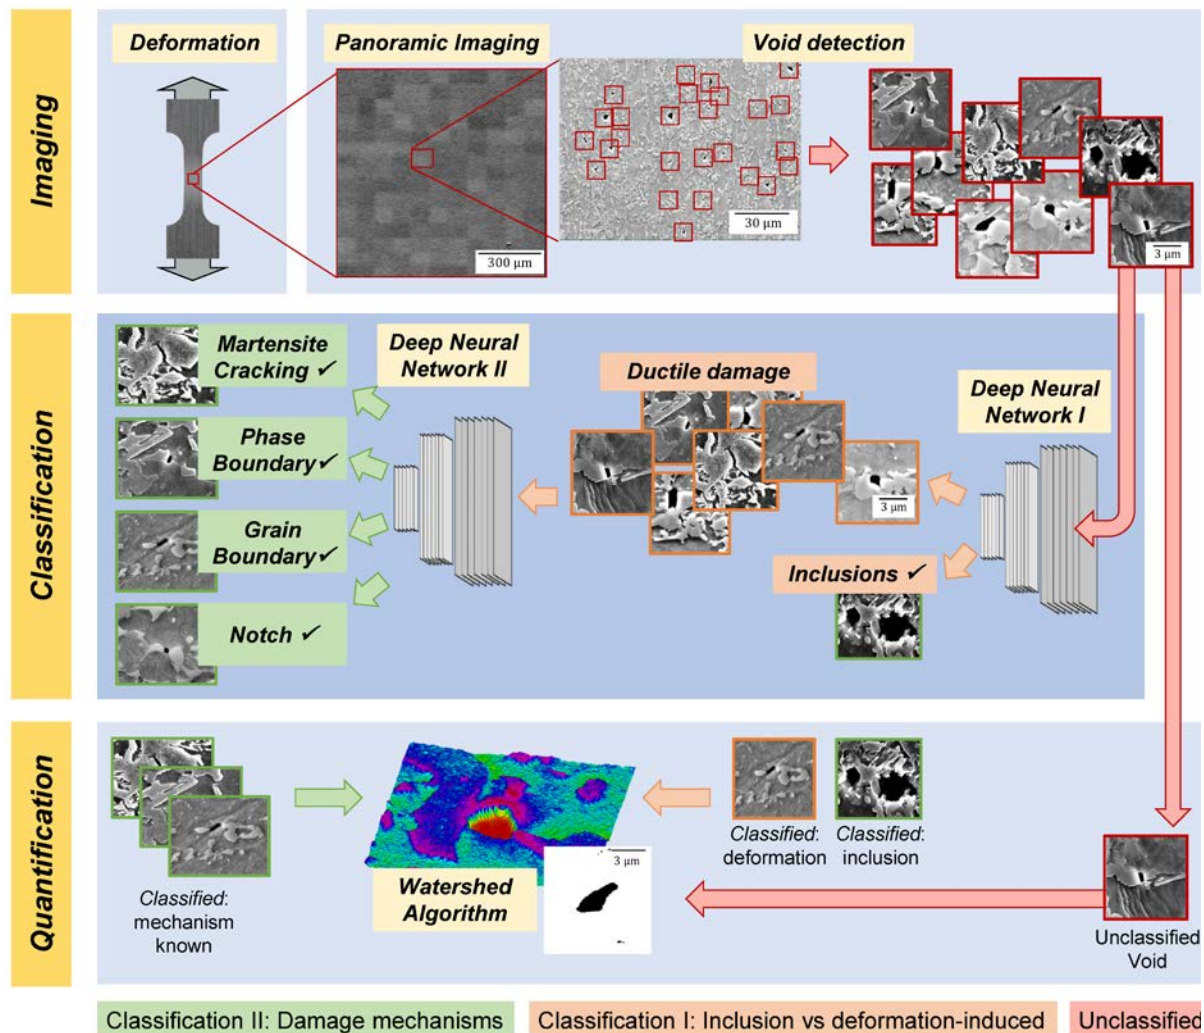
Fig 1. New approach for high resolution statistical damage classification by artificial intelligence. Based on panoramic imaging inside the SEM, the observed damage is identified, quantified and classified by artificial intelligence into four pre-selected categories (shown schematically).

Here, we propose a promising new framework (Fig 1) to achieve just this, the analysis of large micrographs of the order of a mm² at high resolution, and therefore without the usual sacrifice of statistical relevance in the study of deformation-induced damage in highly heterogeneous microstructures. We employ panoramic imaging by scanning electron microscopy (SEM) at high resolution, both after deformation (ex-situ) and during straining (in-situ) inside the SEM. For this, we use a DP 800 dual phase steel as an example material that combines a high commercial popularity as a sheet metal in the automotive industry with great challenges in its characterisation and knowledge-driven improvement due to its intrinsic and scale-bridging heterogeneity from the micron to the millimetre scale. To enable automated detection and efficient quantitative and qualitative analysis of damage within the images recorded before, after and also during deformation, we use trained convolutional neural networks, known to be particularly apt at image recognition and analysis [19]. For almost a decade, the “ImageNet Challenge” [20] has been focussing on the optimisation of algorithms and techniques for image recognition and object detection and identification. In recent years, powerful architectures based on deep convolutional networks have started to dominate the field. The success of deep convolutional networks in image analysis has already found numerous applications, from the identification of cancerous anomalies in medicine [21, 22] to the detection of cracks in concrete [23].

The analysis setup is illustrated in Fig 1. As a first step, the grayscale high-resolution electron microscope panoramic image is analysed with respect to the grayscale values. As all damage sites considered in this analysis are characterised by a dark area in the micrograph, a suitable

cut-off is chosen to identify the potential damage sites. Then a clustering algorithm (DBSCAN [25, 26], implemented in scikit-learn) is used to distinguish actual voids from artefacts like singular pixels below the cut-off value. The DBSCAN (Density-Based Spatial Clustering of Applications with Noise) algorithm takes a set of points as input, in our case the micrograph images. Fundamentally, algorithm group points that are close to each other (typically estimated by the Euclidean distance) are integrated into clusters. The algorithm is controlled by two parameters, the distance ϵ , which effectively describes how far the algorithm should consider points to be part of the current cluster, and the minimum number of points within a distance ϵ that are needed to form a cluster. Points, which are not associated to clusters are considered as noise. A sample image of 250-by-250 pixels is then taken at each potential damage site from the panoramic micrograph. These candidate pictures are presented to a first deep convolutional neural network, which aims to identify whether the damage site in question is due to an inclusion. If the probability calculated by the neural network exceeds a pre-defined threshold ($p_1 > 0.7$), this damage site is classified as inclusion, otherwise, the image is cropped to 100-by-100 pixels and presented to a second deep convolutional neural network which is specifically trained to classify a damage site into martensite cracking (MC), notch (N), grain boundary decohesion (B) or phase boundary decohesion (PB). Again, if the calculated probability exceeds a given threshold ($p_2 > 0.7$), the damage site is classified accordingly, otherwise the picture is flagged for later manual analysis. Finally, the original panoramic microscope image is amended such that all identified damage sites are highlighted and labelled.

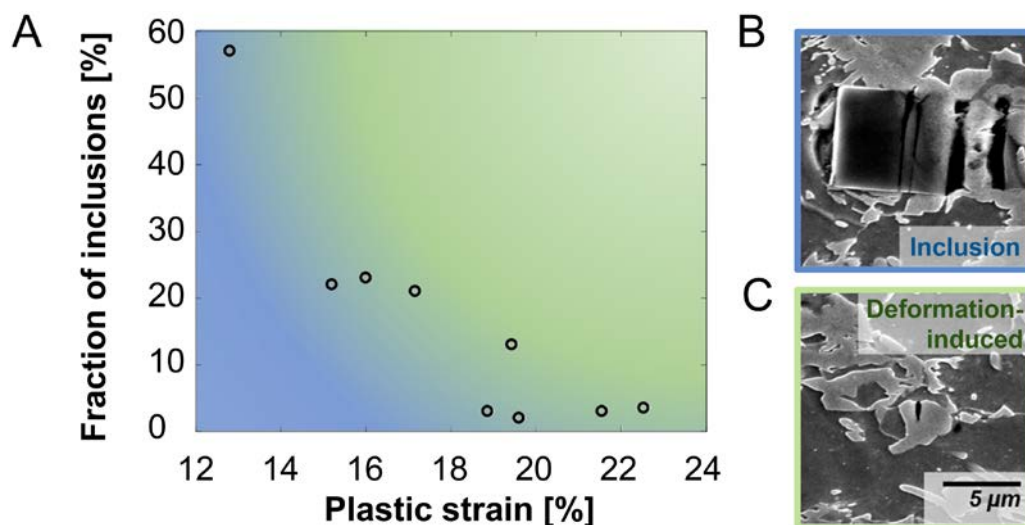
Fig 3. Separation of inclusions and deformation-induced damage. (a) Contribution of voids from inclusions to the total number of voids as a function of plastic strain in a tensile test (over an area of 0.63 mm^2). Particularly at low strain levels the separation of inclusions and deformation-induced damage is essential. Micrographs illustrate the difference in size between (b) a typical inclusion and (c) a typical martensite crack induced as a result of deformation.

The relevance of this approach is illustrated in Fig 3, where the number fraction of inclusion-induced voids is presented for a series of tensile samples deformed in small strain increments from a pre-strain of 12 % to a total strain of 24%. Particularly in the first one percent strain increment, the contribution of inclusions to the measured damage from a simple thresholding approach is considerable with over half of the measured damage sites pertaining to inclusion

damage. With respect to area fraction, there is an even greater contribution of inclusion-related voids due to their average size of $\sim 0.93 \mu\text{m}^2$ compared with an average size of deformation-induced damage sites of $\sim 0.43 \mu\text{m}^2$. We believe that the ability to quickly and automatically remove inclusions from any further analysis of damage quantity or damage mechanisms is therefore of great value not only to achieve more accurate data but also to avoid superfluous experiments or valuable characterization time spent to quantify the density of inclusions before investigation of any new batch of material. This boosts not only the accuracy of studies regarding microscale damage mechanisms but is also important for quantifications of void area fractions in deformed samples without a focus on the underlying mechanisms, such as in the analysis of damage parameters for mesoscopic process simulations.

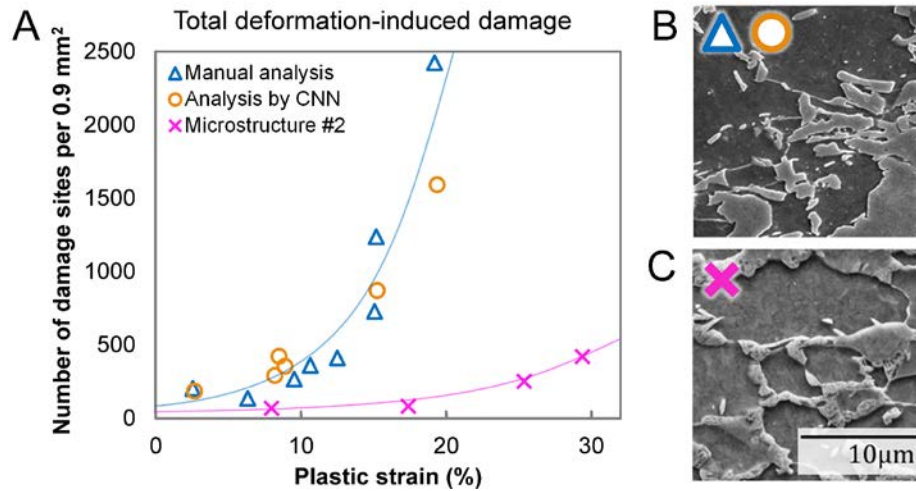
Fig 4. Evolution of total damage as a function of uniaxial strain. (a) Different panoramic micrographs were analysed manually (blue triangles) and by the CNNs (orange circles) both showing the same exponential increase in damage with strain. The drastic difference between microstructures of different DP800 grade steels is also shown for comparison (pink crosses). Micrographs of either microstructure are shown in (b) and (c).

The statistics reveal an exponential increase in the total number of damage sites with increasing tensile strain in the sample (Fig 4). This is commonly observed at larger strains but the expansion of this trend is confirmed here for smaller strains, which are at or below the detection level in studies with larger strain increments and reduced image size or resolution. The evolution of the total number of deformation-induced damage sites, i.e. excluding inclusions, as determined by human investigator and the neural networks is virtually the same within the scatter that remains even for the large areas analysed here (Fig 4).

At this point, it is important to distinguish between the classification by a human investigator and the neural networks. As outlined above, the neural networks were trained using the categories inclusion, martensite cracking, phase boundary decohesion and notch. Strongly evolved damage sites, e.g. martensite cracks, which have already induced flow in the surrounding ferrite, were excluded in order to remove the bias of the training data, where different human investigators might not be confident that they can identify the underlying nucleation mechanism. As this distinction results in a training dataset with clearer dominance of each mechanism but cannot be based on distinct thresholds, the category of evolved damage cannot be implemented in a straightforward manner into an automated analysis by artificial intelligence. The classifications by a human investigator and the analytical algorithm consequently differ in some respects: first of all, not all sites are attributed to a mechanism by the human investigator, as a significant percentage is labelled as evolved damage sites. Most of these sites are, however, classified by the neural network as phase boundary decohesion sites due to their curved outline resulting from ductile flow, rather than brittle fracture across a straight path. While this might be a wrong classification in respect to the nucleating mechanism, it is consistent with ductile processes dominating evolution of voids at intermediate strains (Fig 5b) regardless of nucleation mechanism, which is the original definition of those evolved damage sites. The classification accuracy of the brittle martensite cracks is higher with $85 \pm 6 \%$ compared with the accuracy of identifying all classes ($80 \pm 6 \%$). The division into voids that have an exclusively brittle origin and those that have nucleated or grown under the influence of ductile plastic flow in the nearest vicinity of the void is shown in Fig 4a.

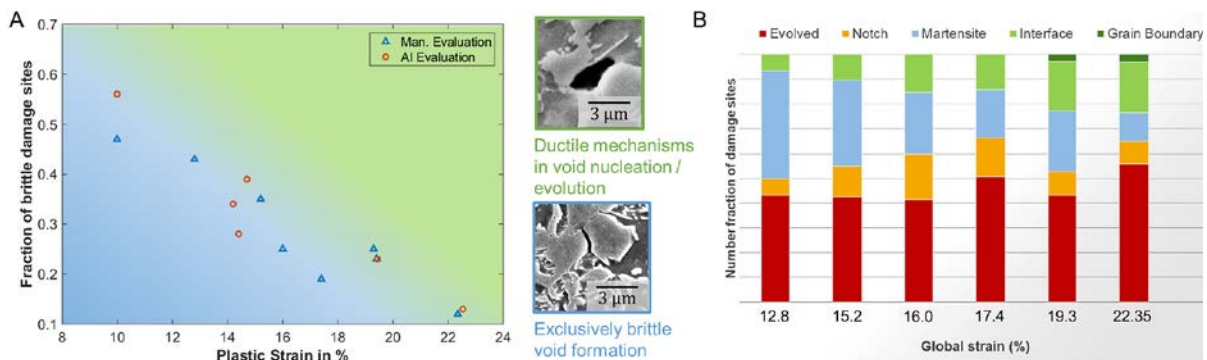
Fig 5: Change of dominant damage mechanisms with strain. The distinction between brittle and ductile damage (a) highlights the change in dominant mechanism with an only slowly increasing fraction of significantly evolved damage sites to the overall damage at increasing strains (b).

The damage mechanisms classified as outlined above paint an interesting picture. The relative contribution of each damage class to the overall damage (Fig 5) shows a clear trend: the fraction of undeformed, newly nucleated martensite cracks decreases significantly with the strain level. This can be rationalised on the basis that martensite cracking at lower strains occurs predominantly in distinct regions of the microstructure, namely prior austenite grain boundaries [39]. These weak and therefore brittle locations tend to fracture at relatively low stresses, which causes martensite cracks to emerge predominantly in the early stages of deformation and cease afterwards. At larger strains, the ductile mechanisms of void nucleation (phase boundary decohesion) and void plasticity (evolving voids) play an increasingly dominant role in both the nucleation and evolution of damage voids. As a result, it may be essential to guide microstructure design concepts towards damage tolerance and even distribution rather than minimisation of damage, as suggested also by Tasan et al. [1].

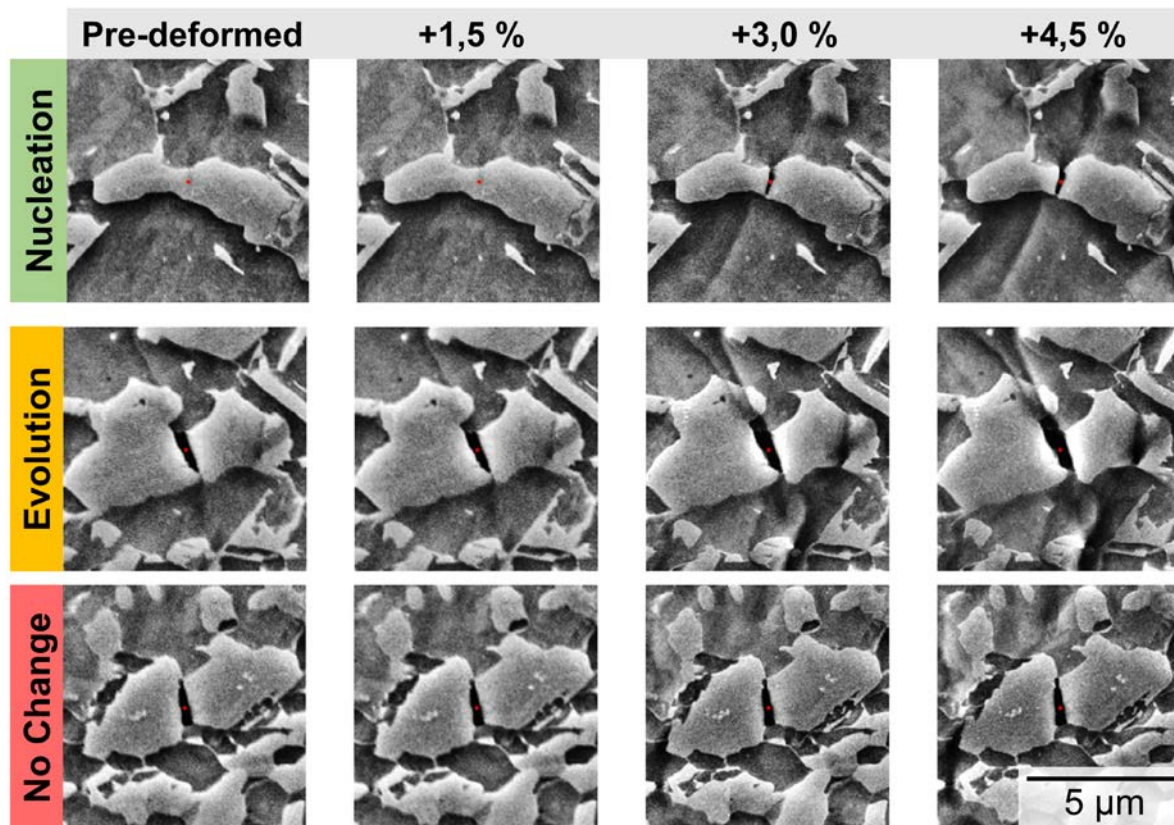
Fig 6. Automatically detected and classified martensite cracks. Crack development during in-situ experiments, showing (a) the nucleation stage and following crack propagation stage, (b) crack opening and evolution dominated by ductile behaviour in adjacent ferrite grains and (c) a similar martensite morphology as in (b) revealing no appreciable change over time at the same strain increments. The three-dimensional flow of the ferrite phase at the free surface in in-situ experiments leads to the formation of surface artefacts around the martensite islands in the form of trenches (indicated by white arrows in (b) and (c)), see also Fig 7.

While statistical evaluation of deformed samples provides the important quantification of the number or area of damage sites and the dominance of each mechanism for a given strain level, it cannot deliver local information about the specific evolution of individual damage sites. To achieve this, additional in-situ tensile tests within an SEM were performed, completing the picture of damage statistics with time-resolved information at high resolution. The experiments were performed in such a way that a pre-strain of 14% was imposed prior to surface preparation for the in-situ observation, providing a pre-damaged state at the start of the in-situ test. This was necessary because the overall strain increment is usually limited by the formation of artefacts due to surface roughening from plastic flow at the open surface. The induced damage sites were then identified from the previously acquired panoramic image and classified in this state, which is equivalent to the post-mortem analysis presented above. Each site of interest can then be automatically tracked over subsequent in-situ deformation steps and pre-processed to achieve efficient analysis and interpretation as shown in Fig 6.

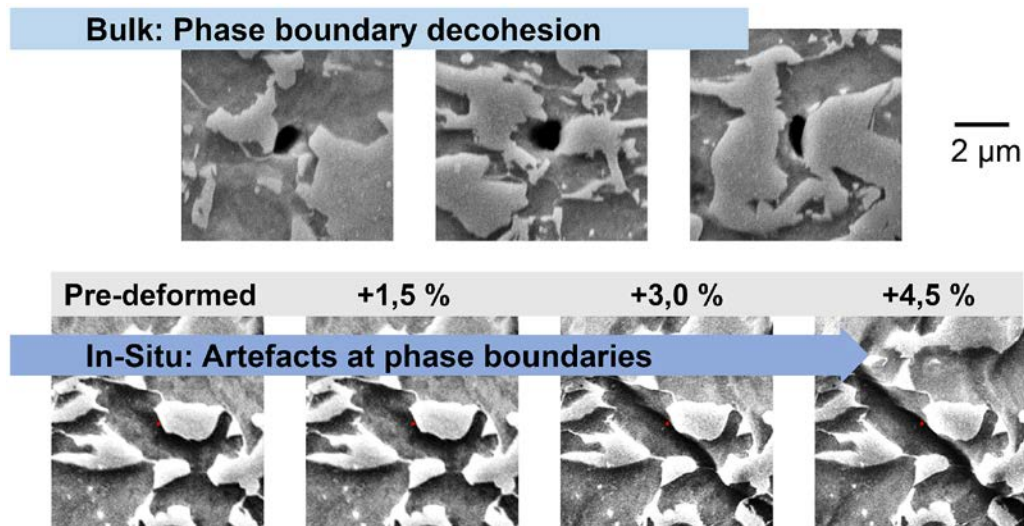
Fig 7. Differences between bulk and in-situ experiments. Plastic flow near phase boundaries between ferrite and martensite manifests very differently during deformation in the bulk and at the free surface in in-situ tests. In the bulk, it is dominated by phase boundary decohesion, while the surface is governed by artefacts due to flow normal to the free surface.

Our in-situ tests show that the prevalence of nucleation of different types of damage sites is affected by the chosen method of investigation. For example, phase boundary decohesion, seen frequently in the post-mortem analysis of bulk samples, was barely encountered in the in-situ tests. Instead, plastic flow at the free surface caused “sink-in” of the ferrite matrix that led to the formation of deformation artefacts in the form of trenches (Fig 7). These artefacts, which are attributed to the altered stress state at the free surface of the deformed sample, were typically found to follow the martensite/ferrite interphase boundaries. The formation of surface artefacts during in-situ testing and damage analysis therefore poses a major difficulty in assessing the nucleation and evolution of phase boundary decohesion processes during plastic deformation as the dominant flow patterns in the bulk (see also Fig 7) and at the free surface clearly differ. Transfer of insights from in-situ experiments to bulk deformation, the dominant situation in metal forming due to the large volume to surface ratio, is therefore not possible with respect to ductile damage nucleation and evolution of brittle damage by flow. In this respect, in-situ experiments should be treated with great caution and used only to couple the plastic flow in the ductile phase observed in simulation and experiment where micromechanical crystal plasticity models are used to re-create the in-situ situation.

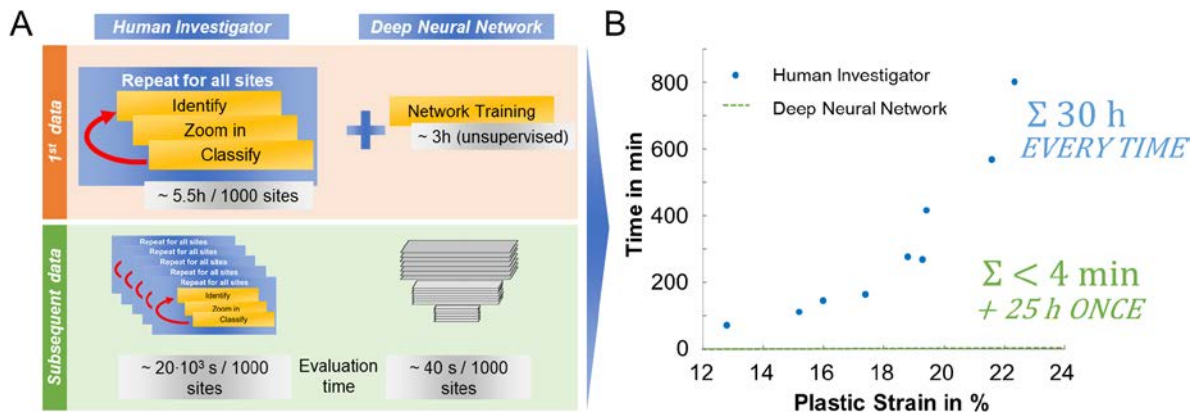
Fig 8. Time advantage of the proposed approach. (a) A direct comparison of the time invested (human investigator vs. artificial intelligence) in acquiring and processing initial and subsequent datasets of damage sites and (b) how the required time scales when evaluating strain dependent damage.

The neural networks developed in this study reduced the time required for micrograph analysis in terms of damage classification from days to minutes. While identifying and classifying a single damage site takes a human investigator about 20 s, leading to 5.5 hours per panoramic image with ~ 1000 damage sites, the use of trained artificial intelligence for this purpose reduces the time required to less than 1 minute (Fig 8). Depending on the required accuracy, the human investigator can instead focus on interpretation of the data and, where applicable, the few remaining unclassified cases, resulting in a total duration of a few minutes. In this context, we have also shown that a good performance can be attained based on a limited number of damage sites that can be acquired within a few hours. This was by no means pre-evident, as the underlying algorithms are commonly applied where millions of labelled, yet more variable and complex, images are available[44], e.g. from social media. Where mechanisms are of interest that occur rarely, i.e. a few times across an area of the order of 1 mm², but may be critical for material performance, the analysis by artificial intelligence is of particular help as it supports the researcher in the identification of atypical cases across large areas prohibitive to manual investigation. Such sites may then be represented in a new class of damage and fed back into the training dataset.
