Enhancing Bridge Deck Delamination Detection Based on Aerial Thermography Through Grayscale Morphologic Reconstruction: A Case Study

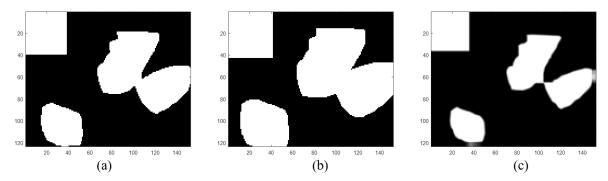
FIGURE 1 Example of Dilation (left) and Erosion(right) of a matrix.

Image is often presented in the form of a 2D matrix and Figure 1 illustrates the dilation and erosion processing on a matrix. The dilation process on a matrix transforms each entry to the maximum value based on its neighbor connectivity defined by the structure element and vice versa for the erosion process. Thus, the dilation of an image often returns an enlargement of object's bright shape and the erosion returns the shrinkage of the bright shape (see Figure 2, bright regions have the value of 1 and dark regions have the value of 0).

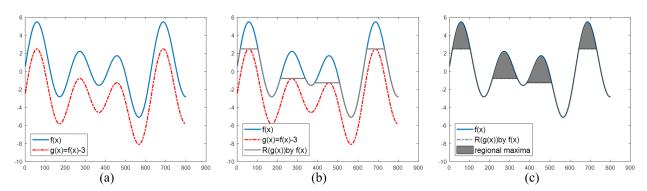
FIGURE 3 Illustration of grayscale morphologic reconstruction for 1D representation: (a) synthetic 1 D signal $f(x) = \sin(x) + 2*\cos(2*x + 5) + 3*\sin(3*x)$ and g(x) = f(x) - 3; (b) reconstruction of g(x) by f(x); (c) regional maxima by difference between f(x) and R(g(x))

Where Λ is the inclusion operation from Set theory and a "pointwise minimization" to ensure the $(G \oplus B)$ is "under" the mask F. Thus, the reconstruction by dilation $R_F^D(G)$ can be interpreted as the marker image G dilates with the structure element B under the mask image F until stability is reached $(D_F^k(G) = D_F^{k+1}(G))$. When the maker image G = F - h, a special case that marker image G is the shifted F by offsetting h, the reconstruction can be used for dome extraction. Figure 3 illustrated the 1D representation of this procedure. Based on the definition of reconstruction, the key to extract the regional maxima is depended on the selection of h value which defines the contrast between maxima and its surroundings. This property becomes useful for our case since the temperature contrast is the key to distinguish delamination from sound area.

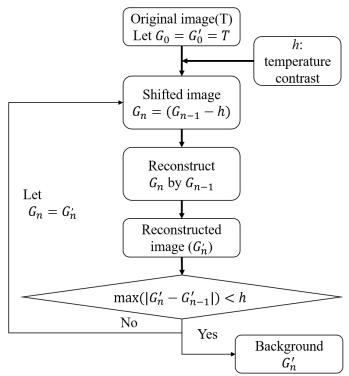
FIGURE 4 Thermal background estimation

The thermal background is estimated through an iterative the grayscale morphologic reconstruction using the temperature contrast as the h criterion. Figure 4 shows the procedure for thermal background estimation. The original thermal image (T) was shifted to a marker image (G) by subtracting a pre-defined temperature contrast ($h = 0.5^{\circ}$ C). Then the reconstructed image G' was calculated through grayscale morphologic reconstruction of G by T. The different was then calculated for the reconstructed image (G'_n) and the previous one (G'_{n-1}). If there would exist a maximum value in the difference smaller than h, it indicated the difference between two backgrounds was not identical under the criterion of h so that it could be used as the final background. Otherwise, it would be resent to the reconstruction process until satisfying the criterion. After the background was estimated, the residual was then calculated by original image subtracted from the background. The residual would contain the regional maxima derived from the background.

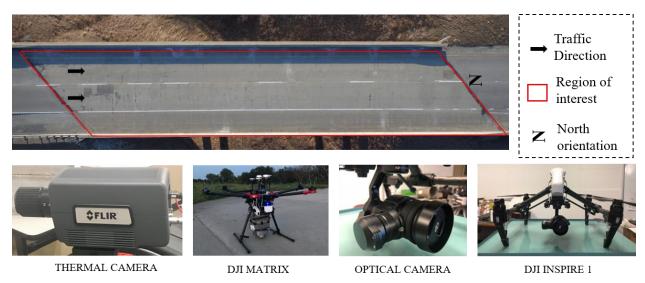
FIGURE 5 Field setup and data collection

A field study was conducted for delamination detection through aerial thermography. The survey was carried out for an in-service bridge at the northbound of US 77 close to Lincoln, Nebraska. The data was collected through UAV with carrying optical and infrared cameras in October 2017. Two configurations were implemented in Figure 5 based on different payload requirements. DJI matrix was used to carry the infrared camera integrated with an onboard computer for thermal imaging. DJI inspire one carried the High Definition visible camera for imaging the surface condition of the bridge. A pilot was responsible for controlling the UAV while the imaging system was set as automatic recording during flight. The path of UAV was designed to follow the center of the bridge at a fixed height and constant speed without traffic control. After the data was collected, the thermal image was then pre-processed through the customized MATLAB algorithms

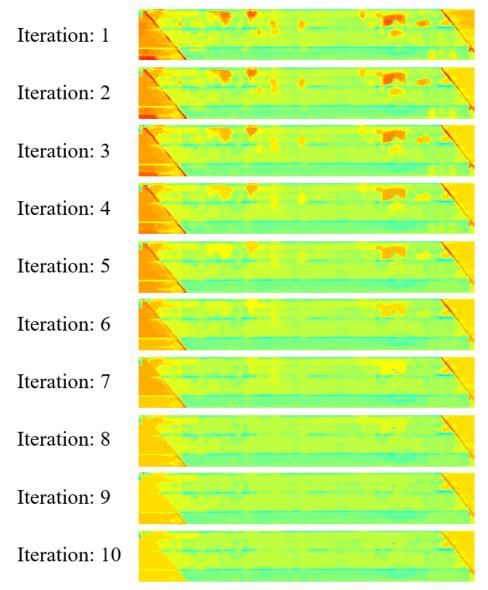
FIGURE 7 iteration of background estimation

Figure 7 shows the intermediate results of background estimation were obtained during the iteration, and the hammer sounding result (validated by coring) was used as the reference for ground truth (Figure 9). In Figure 7, the regional maxima in the processed image were gradually "faded away" until 10th iteration which the difference between iteration 9 and 10 was not significant. Thus, the result from iteration 9 was used as the background and residual image was then calculated (see Figure 8). In Figure 8, the regional maxima were derived from the background, and the information of variation for maxima was kept so that the post-processing such as segmentation could be used for discrimination of delamination. Figure 9 shows the hammer

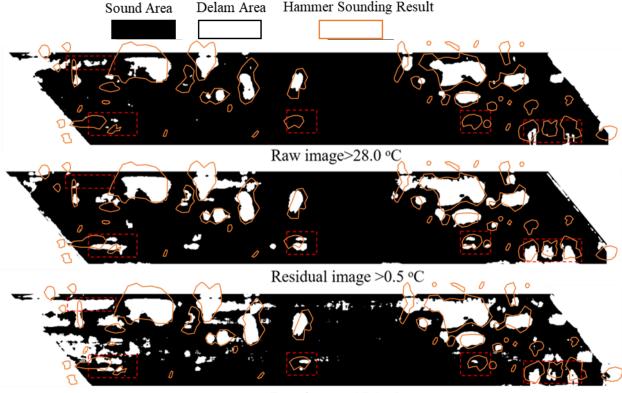
Raw image>27.3 °C

FIGURE 10 Delamination detection based on global threshold method

The processed results are compared between using raw image and using residual image. Two methods were tested: 1) global threshold; 2) K-means clustering. In Figure 10, a comparison was made to implement the threshold on the raw image and the residual image. Top image (Figure 10 top) shows an underestimation of delamination when the top-half image had a similar pattern to the hammer sounding result, the bottom-half suffered the insufficient estimation. Figure 10 bottom shows the overestimation when the bottom-half image had the sufficient indication of delamination, the top-half image shows overestimated. The residual image (Figure 10 middle) shows closer estimation in terms of the threshold-based method.

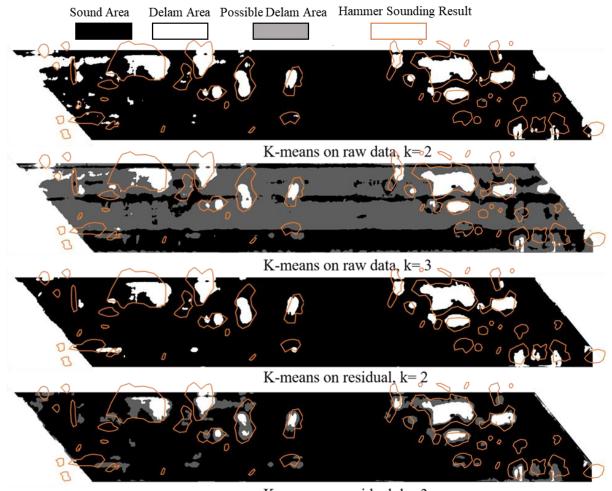
K-means on residual, k=3

FIGURE 11 Delamination detection based on clustering method

K-means clustering as a multiple level classification method was recently introduced by (11) for delamination indication. The selection of number K is often based on researcher's experience or follow the criterion proposed by (11). We compared the situation of k equals 2 and 3 on the raw and residual image. Three color codes (white, gray, and black) were used to indicate the conditions of delamination, possible delamination, and sound in Figure 11. When k equals 2, the k-means

method showed similar outcomes for both raw and residual data. However, when k equals 3, the outcome behaved very differently, and the residual data showed closer prediction comparing to the raw data. The reason could be the k-means method miss-classified the intermediate level of background on the top-half image with the delamination on the bottom-half image due to the close temperature value shared.
