# Uneven illumination surface defects inspection based on convolutional neural network

Hao Wu<sup>\*12</sup>, Xiangrong Xu<sup>1</sup>, Wenbin Gao<sup>1</sup>

**Abstract** : Surface defect inspection based on machine vision is often affected by uneven illumination. In order to improve the inspection rate of surface defects inspection under uneven illumination condition, this paper proposes a method for detecting surface image defects based on convolutional neural network, which is based on the adjustment of convolutional neural networks, training parameters, changing the structure of the network, to achieve the purpose of accurately identifying various defects. Experimental on defect inspection of copper strip and steel images shows that the convolutional neural network can automatically learn features without preprocessing the image, and correct identification of various types of image defects affected by uneven illumination, thus overcoming the drawbacks of traditional machine vision inspection methods under uneven illumination.

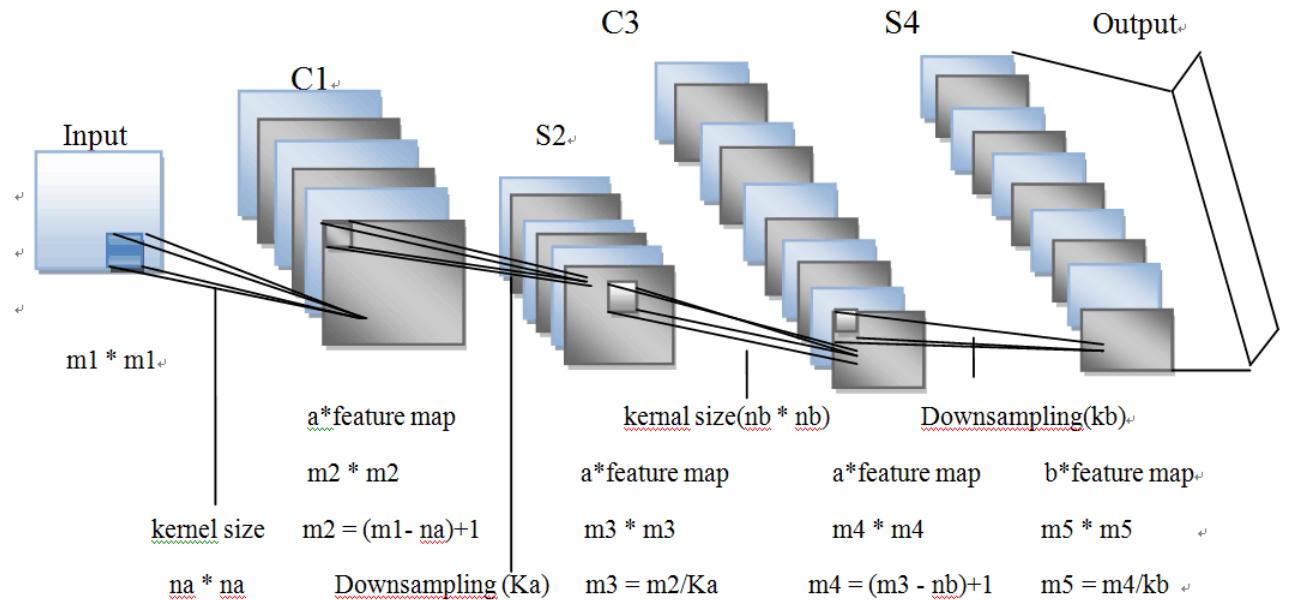
LeNet-5 is one of the earliest convolutional neural networks [18], and its structure is shown in Figure 1 : LeNet-5 structure were seven layer structure. First as the input layer of input, then C1 is the convolution layer, which contains a Four feature map, the convolution kernel size is  $na \times na$  , and the feature map size after the convolution operation is  $m2 \times m2$  . S2 Sampling is the next layer, comprising feature image with number of a , each feature in C1 neurons corresponding features of  $nb \times nb$  local neighborhood as input. C3 is also a convolution layer, a feature maps has the size of  $m4 \times m4$  . S4 is the downsampling layer, including b feature maps, each of the neurons in each feature map of S4 corresponds to C3 feature map. Subsequent to S4 is a fully connected layer containing neurons. The final output layer consists of radial basis functions used to identify defects.

Figure 1. Convolutional neural network structure

The experiment platform is run on MacBook air notebook with 8GB of memory computer, this paper build the convolutional neural network, which is similar to convolutional neural network LeNet-5 , this convolutional neural networks has two convolution layers and two pooled Layer. And it is trained in the number of different numbers. Then test it.

The input image height and width are `image_height=400` , `image_width=400` (ie, image pixel  $400 \times 400$  ), and the first layer of convolution kernel is  $3 \times 3$  , convolution layer `c1` , get 6 feature maps of size  $398 \times 398$  , the downsampling coefficient is 2 , the downsampling layer `S2` gets 6 sizes of  $199 \times 199$  Feature map of  $199$  , the second layer of convolution kernel size is  $3 \times 3$  , convolutional layer `C3` gets 12 sizes of  $100 \times 100$  feature map, the downsampling coefficient is 2 , the downsampling layer `S4` , get 12 sizes of  $50 \times 50$  feature map. The output layer is 2 due to classification and defect .

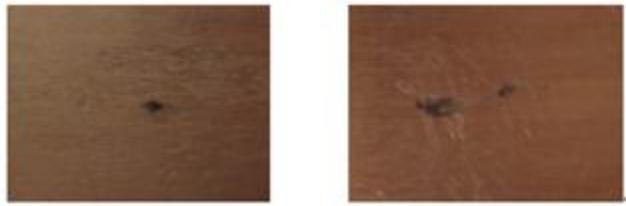
and others defective. For simple defects such as inclusions, pits, and flaking, the defect images are shown in Figure 2 : where these defects are obvious, the right part area is darker than the left area , that is, they are affected by uneven illumination .

Figure 2 Defect copper image samples

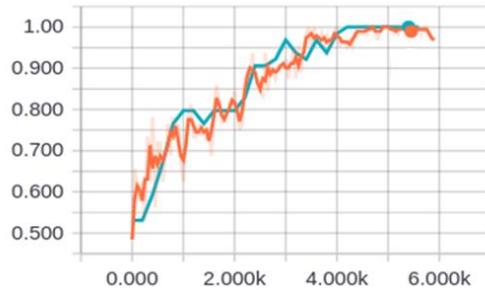
Since the two-layer convolution is relatively simple, we set the number of training steps to 5000 for the first time . Based on the computer configuration, and there is no GPU built , the training is cost for 2 hours, and the correct rate and loss during the training. The function changes are shown in Figure 3 and Figure 4 below. The orange and blue curves represent changes in the training set and the validation set, respectively.

Figure 3 correct rate change curve: training set ( orange ) and verification set ( blue )

It can be clearly seen from Fig. 3 and Fig. 4 that at the beginning of training, the loss function is about 0.6 and the correct rate is about 0.5 . As the number of training steps increases, the loss function gradually decreases, and the correct rate gradually increases. When it reaches 2000 , the loss function is about 0.5 , and the correct rate is about 0.8 . When the number of training steps reaches 5000 , the loss function has been reduced to about 0 , and the correct rate is close to 1 . Therefore, according to the displayed results, the model for

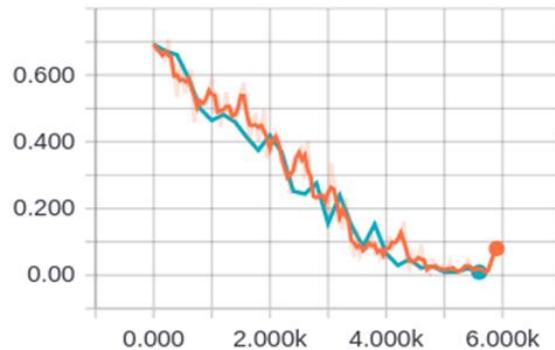
Figure 4 loss function curve: training set ( orange ) and verification set ( blue )

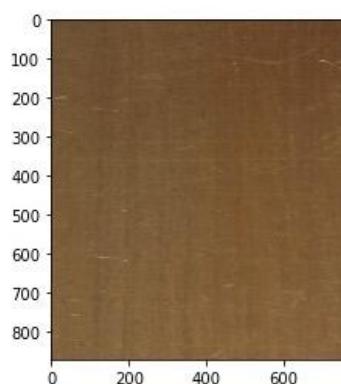
This is a OK with possibility 0.67436

Figure 5 Qualified sample test results

It can be seen from Figure 5 that there is no defect in the image of the copper strip image tested, it is a complete good copper strip image, and the result of the experimental model output "this is OK with possibility 0.67436", it is also a correct determined for the copper strip image. The probability of judgment is approximately 0.674. The judgment is correct.

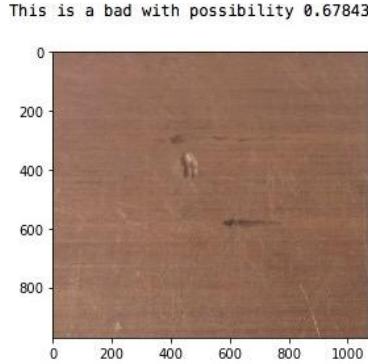
Figure 6 Defective sample test result

Furthermore, there are obvious defects in Figure 6. The test results show that the possibility of the copper strip image being defective is 0.678. Thus, the judgment result is correct. After several consecutive tests, the experimental results were the same as above, and no judgment errors occurred.

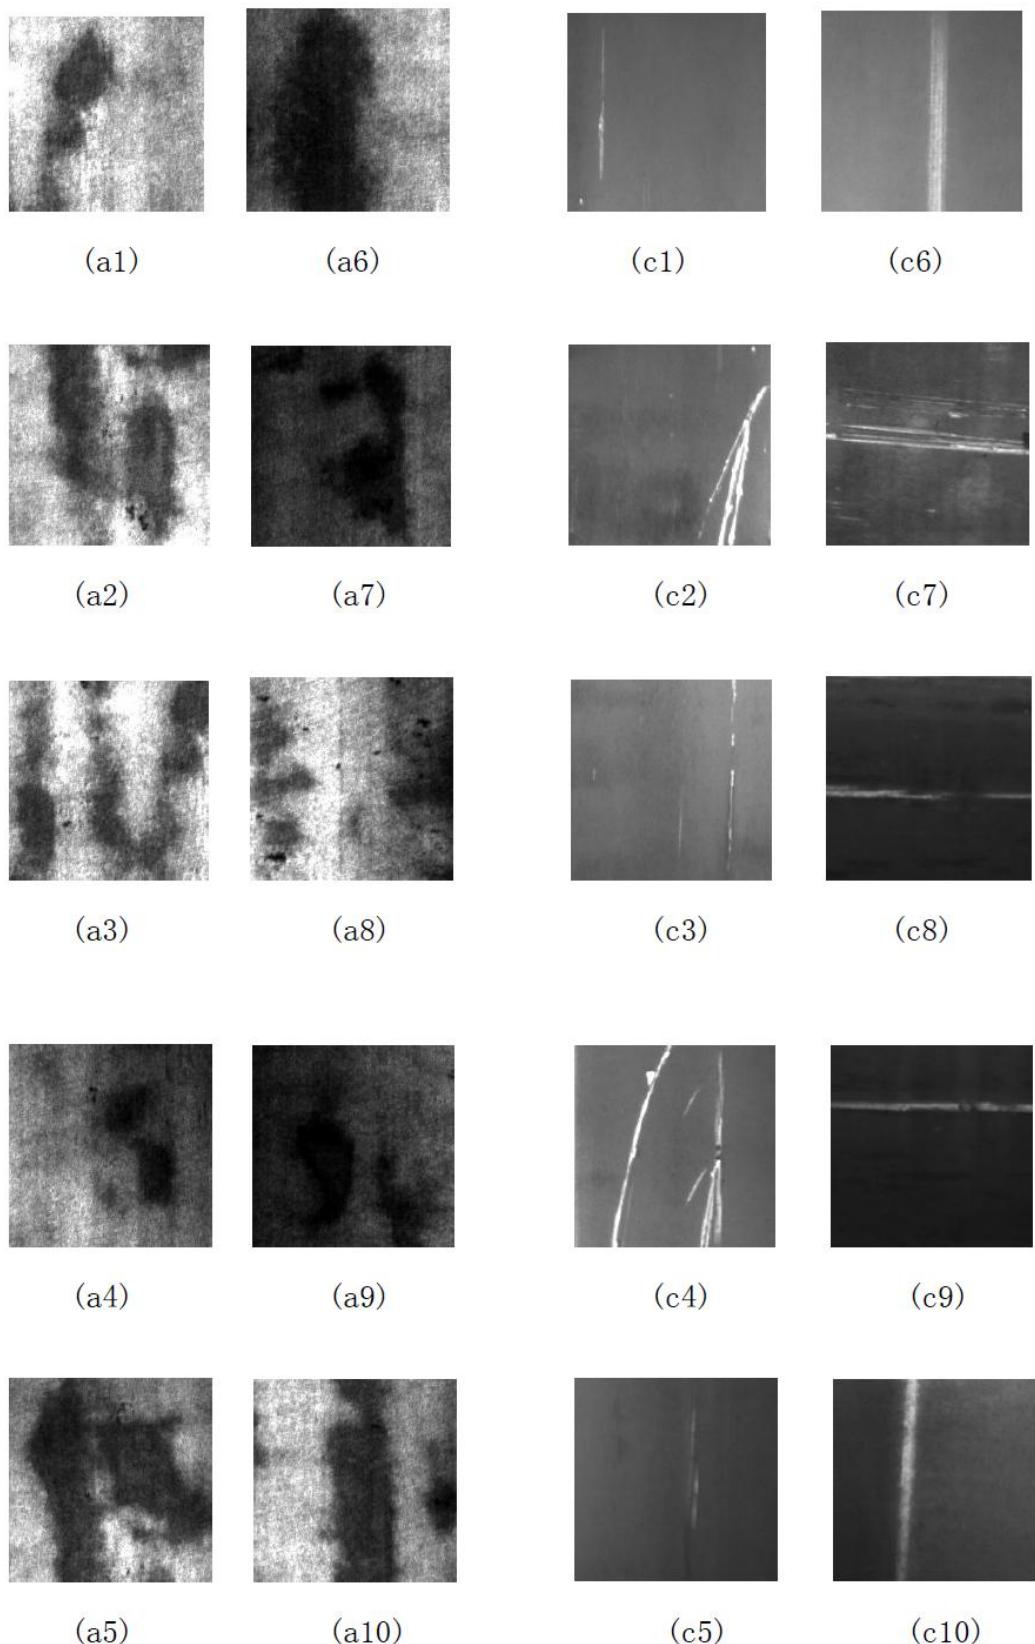
In order to further verify our proposed method, the NEU surface defect database[19] is used, this dataset contain several types of steel defect, here two typical surface defects of hot-rolled steel strips are used for our proposed method in this paper, i.e. patches (Pa), scratches (Sc). Some of these samples is shown in Figure 7. There are 300 samples for each type of defect, we use 250 samples for training(80%) and validation(randomly choose 20% of the whole 250 samples as validation data set), and 50 samples for testing, when the training epoch is 7, the training accuracy is over 90%, and the training accuracy arrived 100% when the training epoch is 13;when the training epoch is 44, the validation accuracy is 100%; when the training epoch is 146, the validation loss is 0.001,after 220 epoch of training, the validation loss is zero.

Figure ig.7. Defects of steel Surface [19]; (a1)-(a10) ten represent defective surface image of patches (Pa); (c1)-(c10) ten represent defective surface image of scratches (Sc);

For testing results, the inspection accuracy of patches is varied from 99.0539% to 99.9998%, the average accuracy for all the testing set of patches defect is about 99.8805%. The inspection accuracy of scratches is varied from 98.2197% to 99.99999%, the average accuracy for all the testing set of scratches is 99.7739%.
