# Two-Step Surface Damage Detection Scheme using Convolutional Neural Network and Artificial Neural Neural

**Abstract**—Surface damage on concrete is important as the damage can affect the structural integrity of the structure. This paper proposes a two-step surface damage detection scheme using Convolutional Neural Network (CNN) and Artificial Neural Network (ANN). The CNN classifies given input images into two categories: positive and negative. The positive category is where the surface damage is present within the image, otherwise the image is classified as negative. This is an image-based classification. The ANN accepts image inputs that have been classified as positive by the ANN. This reduces the number of images that are further processed by the ANN. The ANN performs feature-based classification, in which the features are extracted from the detected edges within the image. The edges are detected using Canny edge detection. A total of 19 features are extracted from the detected edges. These features are inputs into the ANN. The purpose of the ANN is to highlight only the positive damaged edges within the image. The CNN achieves an accuracy of 80.7% for image classification a

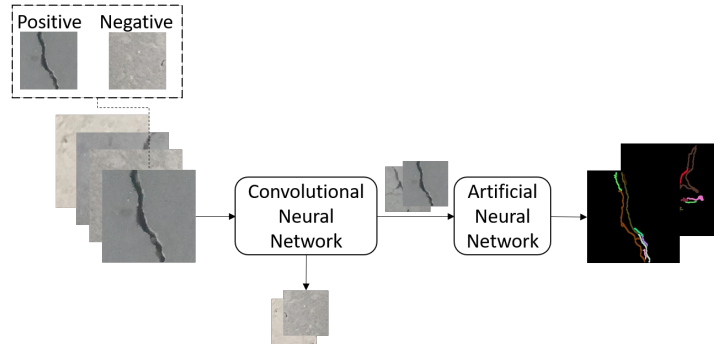
Fig. 1. Diagram illustrating the overview of the two-step scheme

classify positive from negative surface damage images, whilst the ANN highlights and locates the surface damage within the image. Both CNN and ANN require training, as they are supervised neural networks. An overview of the two-step scheme is shown in Figure 1. The CNN acts as a filter to only allow images with surface damage present to be further processed by the ANN. Figure 2 illustrates the training process for both neural networks. The CNN is trained with image-based data, whilst the ANN is trained with feature-based data. Figure 3 shows a more detailed process of the two-step scheme, in which the processes are further detailed in this paper.

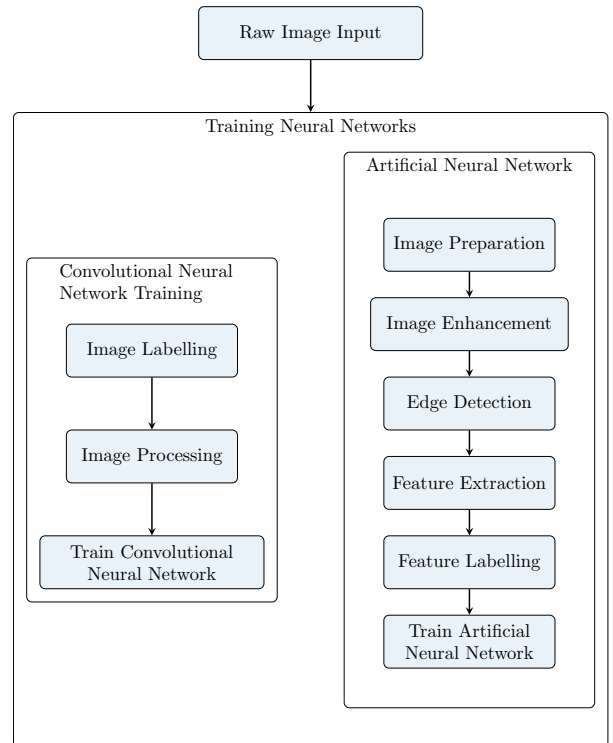
Fig. 2. Block diagram illustrating the overview system for training the both neural network components

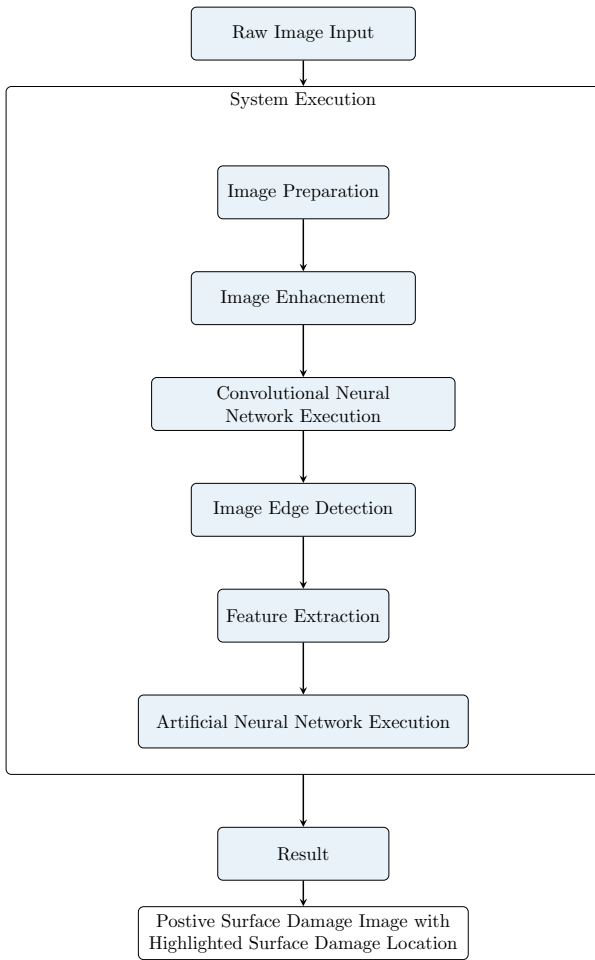
Fig. 3. Block diagram illustrating the overview system for executing both neural network components for surface damage detection

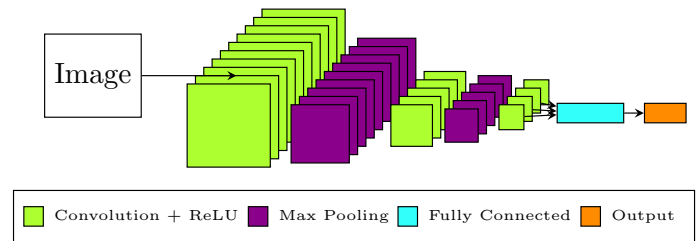
shown in Figure 4. There is a total of 8 layers in the CNN architecture. The CNN accepts colour image inputs in the shape of  $227 \times 227 \times 3$ . The kernel size for the first convolutional layer is  $(198 \times 198)$  to produce an output shape of  $30 \times 30 \times 227$ . The  $2 \times 2$  max pooling layer further condenses the input to produce a shape of  $15 \times 15 \times 227$ . The consecutive layers further reduce the input data to produce a summary vector which categorizes the image into two categories: positive and negative. The CNN is trained with a total of 1,260 images, composed of 630 positive and negative surface damage images. Additionally, the CNN is trained with 10 epochs, to ensure that the CNN obtains high accuracy without over-fitting the neural network to the training images.

Fig. 4. Diagram illustrating the architecture of the Convolutional Neural Network

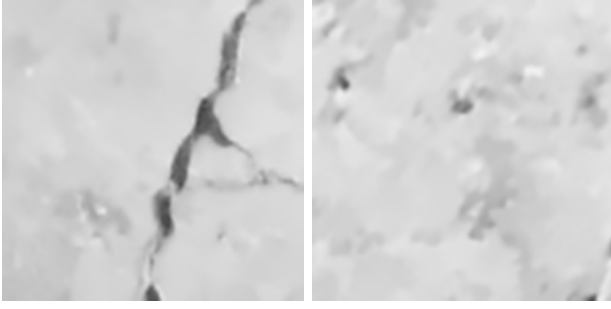
1) *Image Preparation Enhancement*: The images are prepared for edge detection and consequently, feature extraction. The image preparation process converts an image from Red, Green, Blue (RGB) to greyscale. The RGB pixels can be ignored as it does not hold the crucial information for the classification of positive and negative edges within the image. The RGB pixels are replaced with monochrome pixels with values ranging from 0 to 255. The image is further enhanced using tools from the OpenCV library. The raw image is enhanced by applying equalisation, gamma correction, de-noising, and unsharp masking. The enhanced techniques emphasises the image pixel intensity and contrast in preparation for the edge detection. The result of the enhancement is illustrated in Figure 5 for both positive and negative surface damage.

(a) Positive Damage Image (b) Negative Damage Image

Fig. 5. Edge Detected Images of Positive and Negative Surface Damage

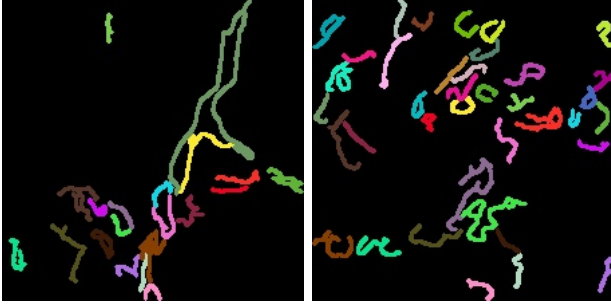
2) *Edge Detection*: *Canny Edge Detection* is applied to the enhanced image in which it generates a sequence of points that outlines the edges within the image. Figures 6(a) and 6(b) illustrates the detected edges for the positive and negative images for the Figures 5(a) and 5(b), respectively.

(a) Positive Damage Image (b) Negative Damage Image

Fig. 6. Edge Detected Images of Positive and Negative Surface Damage

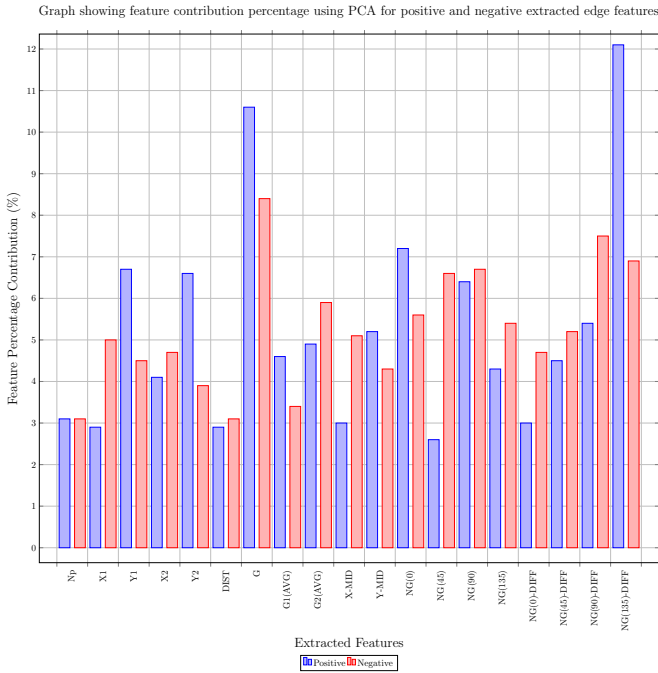
PCA is employed to evaluate the extracted features in order to determine the feature that holds the distinguishing information for the classification of positive and negative edge [10]. The results obtained through the use of PCA for positive and negative edge features are illustrated in Figure 7. The dominant features for a positive edge is *Number of 135 Difference Gradients and Gradient*.

Fig. 7. Graph illustrating the contribution for each extracted feature for a positive and negative edge.

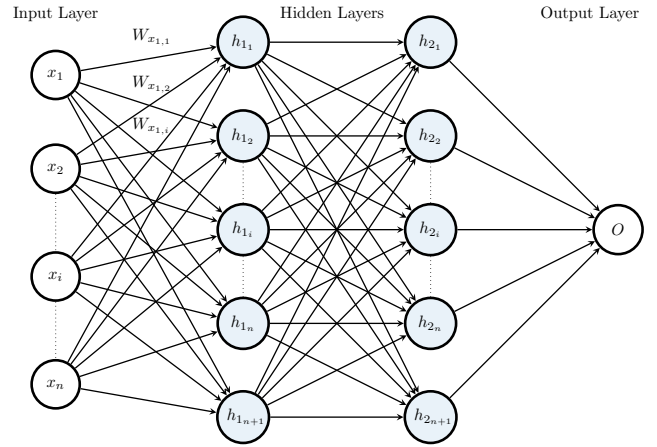
- 6) *Artificial Neural Network Training*: The features extracted from each edge are used as inputs into the ANN. The ANN consists of 3 distinct layers, namely, input, hidden, and output layer. The layers are connected through weighted connections between each node. The input layer consists of 19 nodes for the 19 extracted features. The hidden layer consists of 20 nodes, whilst there is one node in the output layer. The ANN performs a binary classification to determine whether the given edge is positive or negative surface damage. A graphical representation of the ANN architecture is shown in Figure 8. The ANN is trained with a total of 376 positive and negative edges from 57 images. The training of the ANN is less computationally intensive compared to the training of the CNN due to the reduced number of dimensionality, as the inputs to the ANN are the extracted features.

Fig. 8. Diagram showing a graphical set-up of the Artificial Neural Network

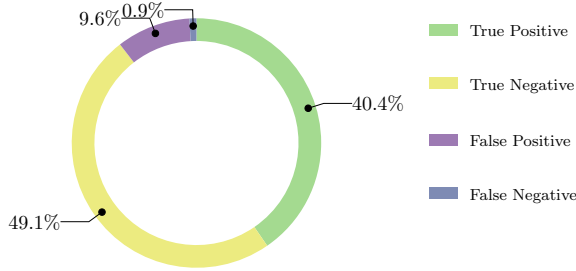
Fig. 9. Pie chart illustrating the detected True Positive, True Negative, False Positive, and False Negative for the individual CNN surface damage classification

Both CNN and ANN are evaluated individually to determine its individual performance. The detection accuracy for both CNN and ANN are illustrated in Figures 9 and 10, respectively. The results reflect the true positive,  $TP$ , true negative,  $TN$ , false positive,  $FP$ , and false negative,  $FN$  detections. The CNN is tested with a total of 540 images that is comprised of an equal number of positive and negative images. The ANN is tested with 500 edges, where 300 are positive and 200 are negative edges. The accuracy of the neural networks

are calculated using equation (7). The accuracy for CNN is 89.4%, whilst the ANN accuracy is 70.7%. The CNN has a higher accuracy compared to the ANN. The detection of the false negative is crucial as it is indicative of the incorrect detection where fault is present but classified as absent. The false negative detection for CNN is 0.9%, whilst for the ANN the false negative detection is 25.8%. The ANN has a far greater false negative detection, which contributes to lowering the detection accuracy of the overall ANN.

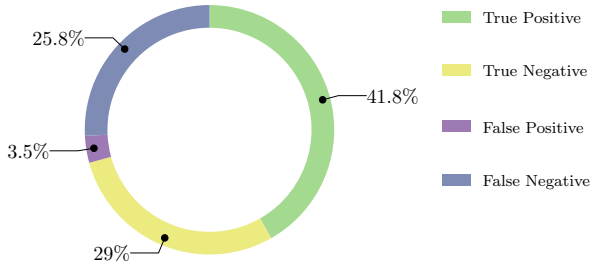
Fig. 10. Pie chart illustrating the detected True Positive, True Negative, False Positive, and False Negative individual ANN edge classification

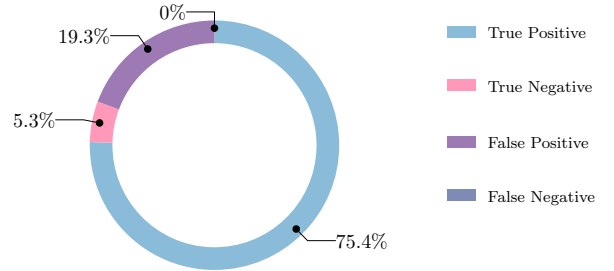
Fig. 11. Pie chart illustrating the detected True Positive, True Negative, False Positive, and False Negative for Two-Step CNN surface damage classification

In the two-step scheme, the CNN focuses on the image-based classification whilst the ANN focuses on feature-based classification and as a result highlights the damaged area within the image. The weakness of the CNN compared to the ANN is that the CNN is unable to highlight the damage in the image, whereas the weakness of the ANN is that it presents a higher false negative detection compared to the CNN. The combination of both neural networks compensates for one another's weaknesses by combining its individual strengths. This improves the detection of the surface damage. CNN is assigned to separate positive surface damage images from negative images. Only the positive images are further processed by the ANN. The ANN highlights the positive edges that are considered surface damage within the image. For the two-step scheme, the accuracy of the CNN is 80.7%, and the accuracy of the ANN is 98.1%. The detections for

both neural networks are illustrated in Figures 11 and 12. The accuracy of the CNN is 80.7%, which is less than the accuracy of the individual CNN evaluation. This is due to the false positive detection in the given testing sample. False positives are tolerated as it is an indication of a cautious system. The crucial detection is false negative detection, in which both CNN and ANN has 0% false negative detection for the two-step scheme.

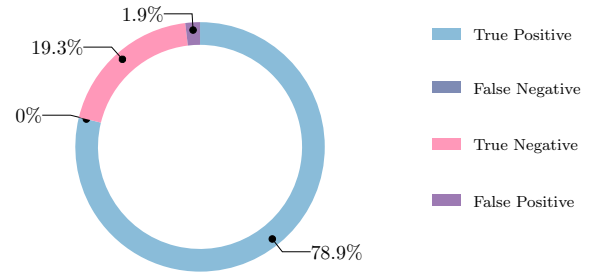
Fig. 12. Pie chart illustrating the detected True Positive, True Negative, False Positive, and False Negative for Two-Step ANN surface damage classification

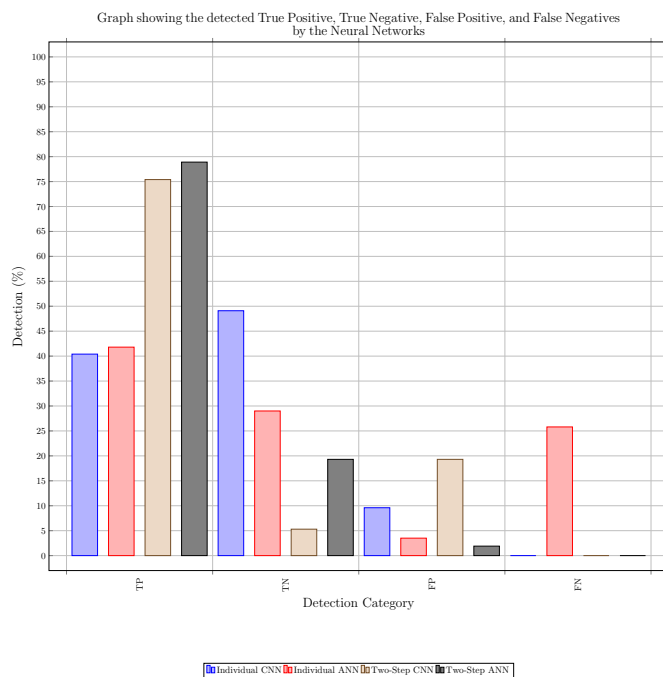
Figure 13 illustrates the comparison of the detection between the individual neural networks and the neural networks in the two-step scheme. The detection of the false positive and false negative detections are crucial as this is not reflected in the accuracy of the neural networks. The false negative detection is the most crucial, as false negatives classify positive edges as negative edges. Therefore the false negative indicates the percentage of positive edges that go undetected by the neural networks. The results obtained from the two-step ANN show that the false positive and false negative is decreased to 0%, compared to the false positive and false negative detections for the individual neural networks. This is an improvement from the individual ANN false negative detection of 25.8%.

Fig. 13. Graph illustrating the detected True Positive, True Negative, False Positive, and False Negative surface damage classification

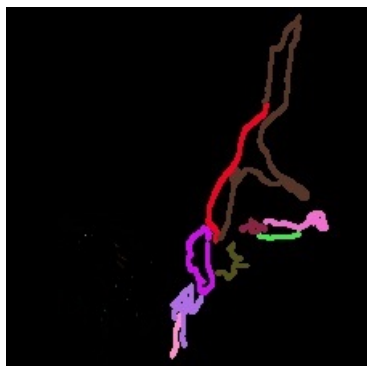
The result of the produced by the ANN is shown in Figure 14.

Fig. 14. Image illustrating the ANN detected positive edges for Figure 5(a)
