Differences in mechanical and microstructural parameters of fracture in a refractory masonry material under monotonic and cyclic loading

K. Andreev^{1,2}, Y. Yin², B. Luchini¹, I. Sabirov³

1 – Ceramics Research Centre, Tata Steel, 1951MD, Velsen Noord, The Netherlands

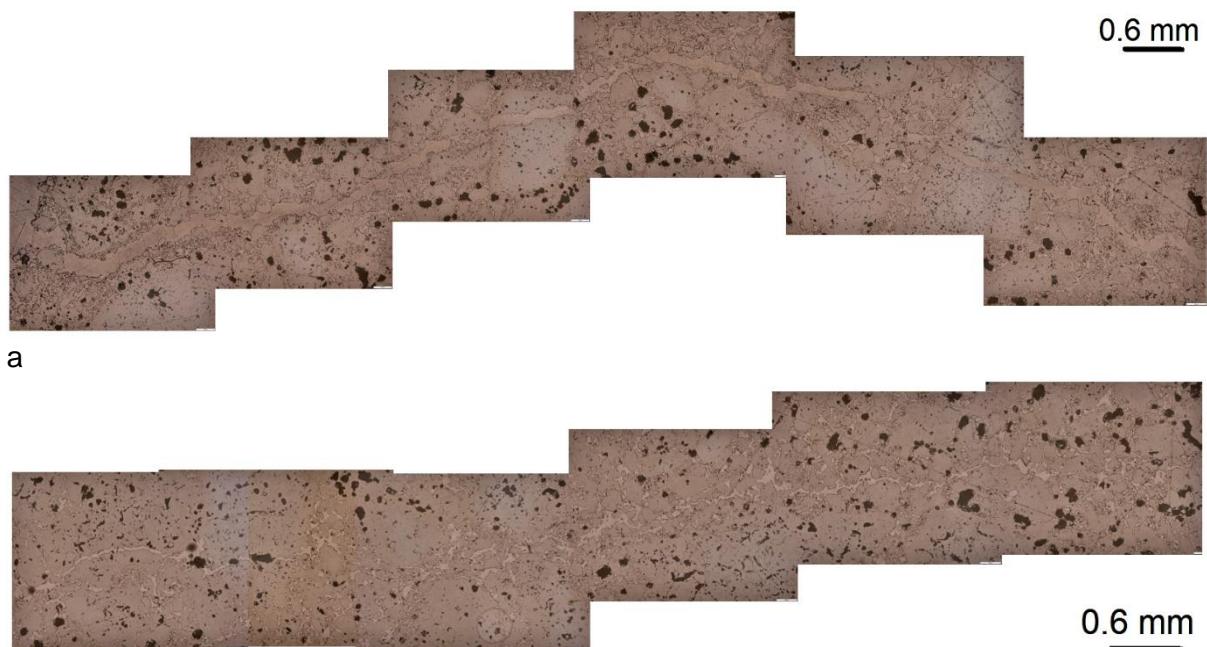
Fig. 4 Representative crack trajectory as seen for SC1, (a) the crack mouth (b) the tip of the crack.

The fracture in the samples 1, 2 and 3 in each group was studied by fractographic analysis (Fig. 4, 5). The crack profiles show single major crack with occasional occurrences of minor crack branching. In cases when an alternative crack is branched off at higher angle, it stops quickly (e.g. SM2, SM3, Fig. 5). If the angle between the branching cracks is small, the cracks propagate for some distance almost in parallel and then re-unite (e.g. SM3, SC2). For both
