# Early stages of dissolution corrosion in 316L and DIN 1.4970 austenitic stainless steels with and without anticorrosion coatings in static liquid lead-bismuth eutectic (LBE) at 500°C

**Keywords:** liquid metal corrosion; dissolution corrosion; lead-bismuth eutectic (LBE); austenitic stainless steels; anticorrosion coatings

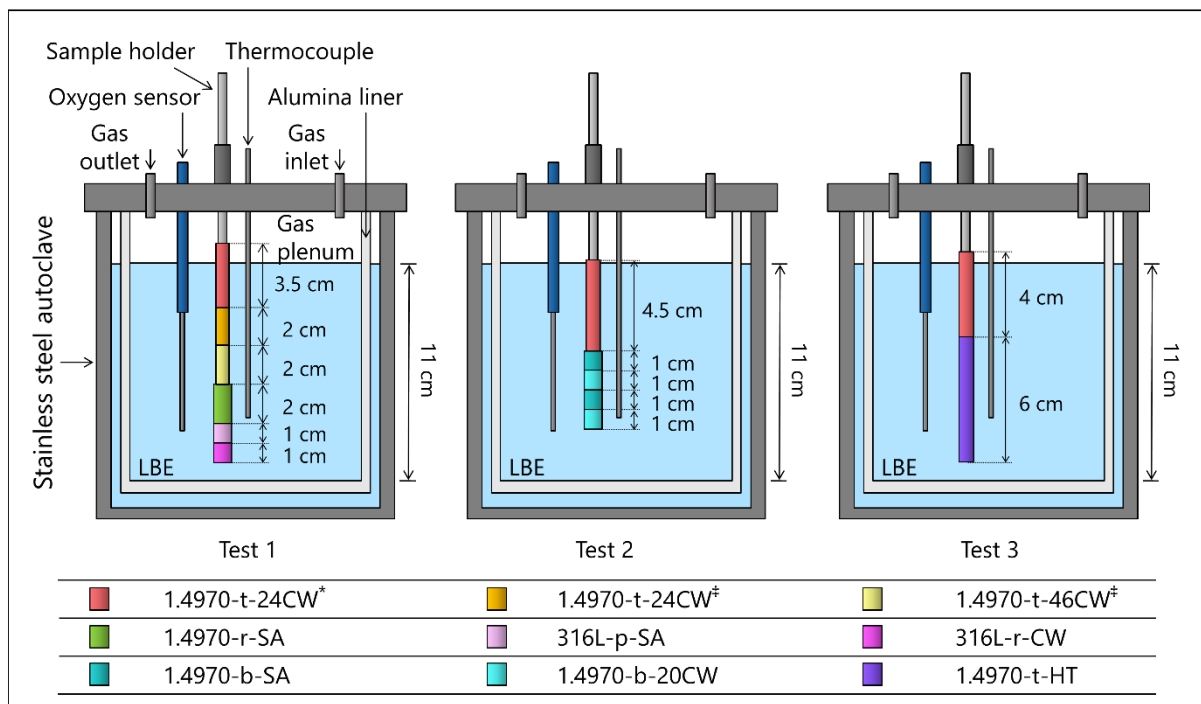
**Fig. 1.** Experimental setups used to expose uncoated 316L and DIN 1.4970 steels to oxygen-poor, static liquid LBE at 500°C for ~600 h. Openings in the lid of the steel autoclave allow the insertion of the sample holder, oxygen sensor, thermocouple, and gas inlet/outlet supply. An alumina liner prevents the contact of the LBE bath with the steel autoclave walls. The color-coded legend allows the distinction of the different steel specimens in each test setup. Symbol \* refers to a ‘brushed & polished’ cladding tube surface state; symbol ‡ refers to a ‘brushed’ cladding tube surface state.

Three exposures (tests 1, 2 and 3 in Fig. 1) were designed and performed to study the effect of the steel microstructure and thermomechanical state on the early stages (~600 h) of dissolution corrosion of *uncoated* specimens made of the MYRRHA candidate austenitic stainless steels 316L (structural steel) and DIN 1.4970 (fuel cladding steel) in contact with oxygen-poor ( $C_O \ll 10^{-8}$  mass%), static liquid LBE at the elevated temperature of 500°C. A schematic representation of the setups used to test uncoated 316L and DIN 1.4970 steels is shown in Fig. 1. Another exposure (test 4 in Fig. 3a) was performed to test the protectiveness of candidate ceramic coatings on the DIN 1.4970 MYRRHA fuel cladding steel under conditions promoting dissolution corrosion; in that test, both *uncoated and coated* DIN 1.4970 fuel cladding tube segments were exposed for 1000 h to oxygen-poor ( $C_O < 10^{-10}$  mass%), static liquid LBE at 500°C. A schematic representation of the setup used to expose uncoated and coated DIN 1.4970 cladding steels is shown in Fig. 3a.

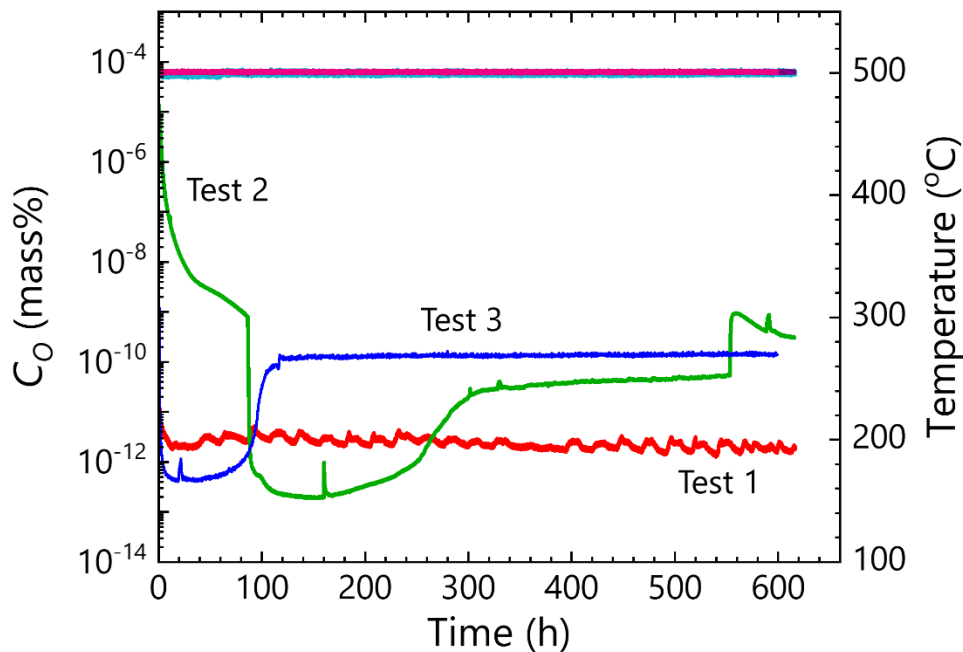
**Fig. 2.** Temperature and LBE oxygen concentration profiles during the exposures of uncoated 316L and DIN 1.4970 steels at  $500^\circ\text{C}$  for ~600 h (tests 1, 2, 3 in Fig. 1).

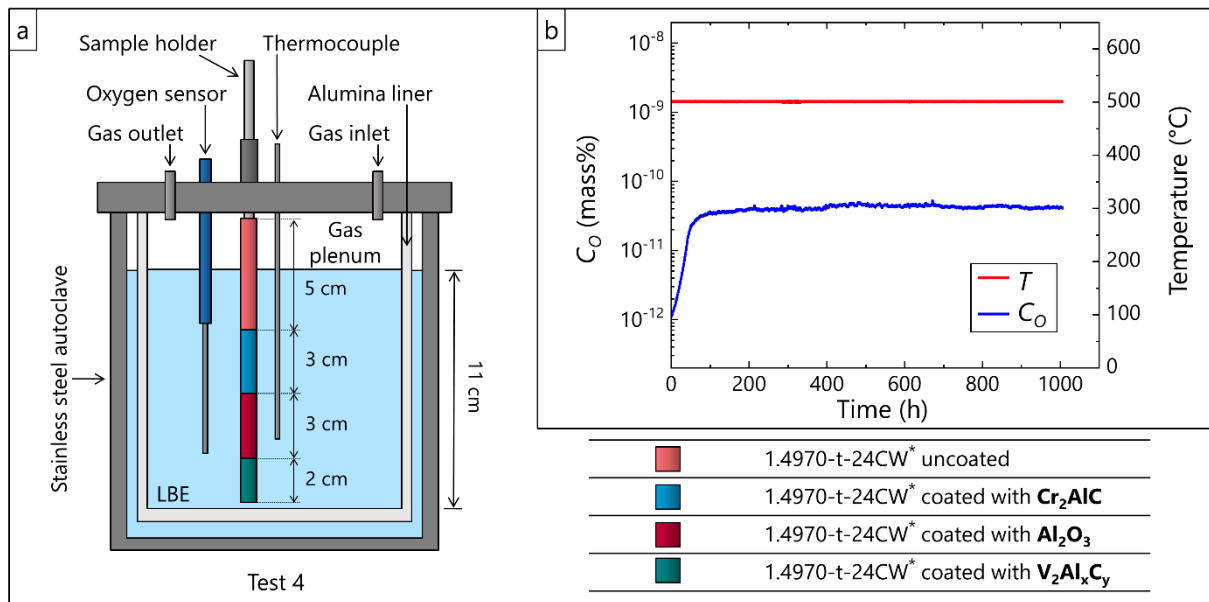
**Fig. 3.** (a) Experimental setup used to expose uncoated and coated DIN 1.4970 cladding tube segments to oxygen-poor, static liquid LBE at 500°C for 1000 h. (b) Temperature and LBE oxygen concentration profile during the exposure of uncoated and coated DIN 1.4970 fuel cladding tube segments. The color-coded legend describes the exposed DIN 1.4970 stainless steel specimens.

The test setups for all exposures were identical stainless steel autoclaves with inner alumina ( $\text{Al}_2\text{O}_3$ ) liners to prevent the direct contact of the liquid LBE bath (i.e., the LBE volume in contact with the steel specimens) with the autoclave walls. A detailed description of the prototype test setup (schematically depicted in Figs. 1 and 3a) may be found elsewhere [8]. The temperature and LBE oxygen concentration during the exposures were monitored by thermocouples type K and electrochemical oxygen sensors (i.e., Bi/ $\text{Bi}_2\text{O}_3$  reference electrode in test 1 [30]; air/lanthanum strontium manganese oxide (LSM) reference electrode in tests 2-4 [31], respectively). Each test used ~5 kg of ‘fresh’ liquid LBE, the exact composition and impurities of which are reported elsewhere [8]. In all tests, the exposure temperature was kept constant at  $\pm 2^\circ\text{C}$  from the targeted temperature of  $500^\circ\text{C}$ , while the concentration of dissolved oxygen in liquid LBE was maintained low ( $C_0 \ll 10^{-8}$  mass%) by the continuous purging with a reducing conditioning gas (HYTEC 5: Ar-5%  $\text{H}_2$ , Rapid Industrial Gases Ltd., UK). The LBE oxygen concentration and temperature profiles during the LBE exposures of uncoated 316L and DIN 14970 steels (tests 1-3 in Fig. 1) is shown in Fig. 2, while the same profiles during the LBE exposure of uncoated and coated DIN 1.4970 steels (test 4 in Fig. 3a) is shown in Fig. 3b.

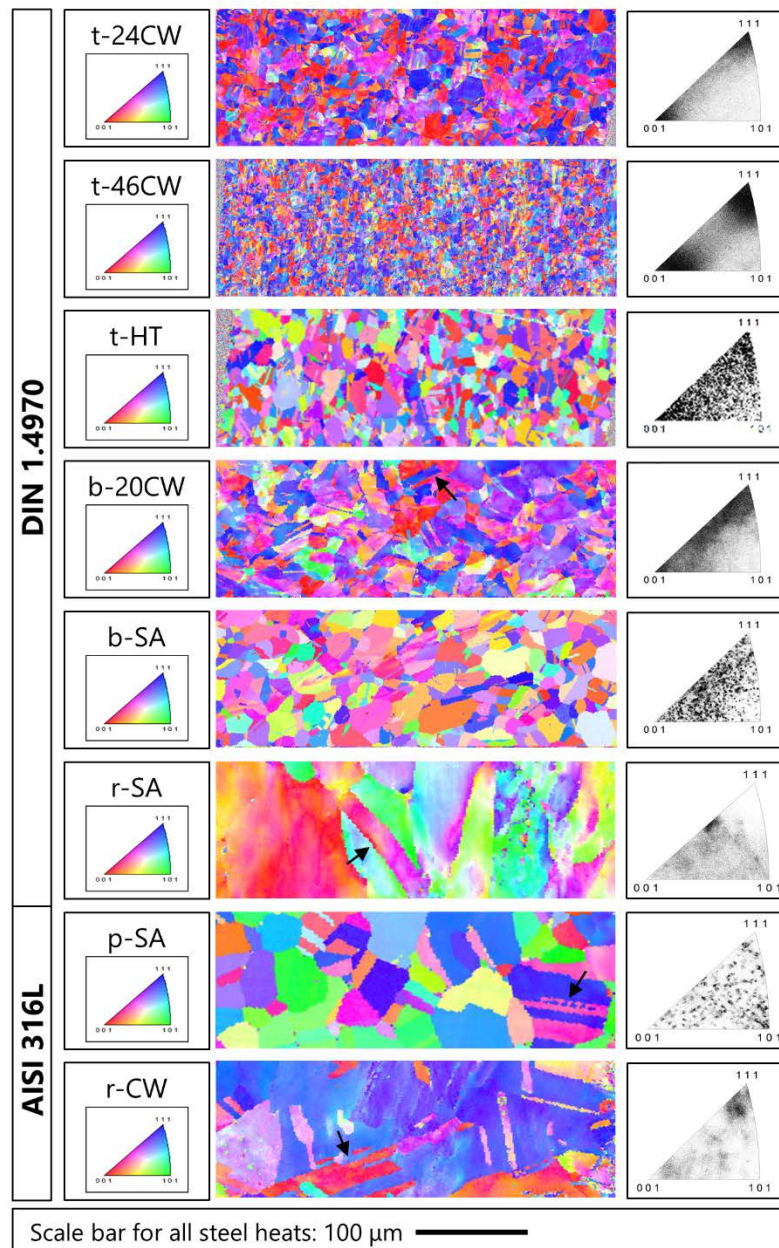
**Fig. 4.** EBSD orientation maps of the 316L and DIN 1.4970 stainless steels exposed to liquid LBE in this work, and corresponding inverse pole figures. The inverse pole figure colour maps correspond to the [001] zone axis. In all orientation maps, going from the left to the right indicates transition from the specimen bulk to its surface. Annealing twins are pin-pointed by arrows in the coarser-grained steels.

As indicated by the inverse pole figures in Fig. 4, the 316L and DIN 1.4970 steels used in this work are characterized by different crystallographic textures. All cold-worked steels (1.4970-t-24CW, 1.4970-t-46CW, 1.4970-b-20CW, and 316L-r-CW) showed a mixed  $\langle 111 \rangle$  and  $\langle 001 \rangle$  texture, typical for austenitic (*fcc*) stainless steels [9,47], such as the 316L and DIN 1.4970 steels used in this work. A less strong texture was observed in all solution-annealed steels (1.4970-t-HT, 1.4970-b-SA, 1.4970-r-SA, and 316L-p-SA), as expected. Even though its effect on the dissolution corrosion behavior of austenitic stainless steels has never been systematically studied, texture can affect locally the progress of LBE dissolution attack. The effect of crystallographic orientation on the (local) dissolution corrosion behavior 316L steels exposed to oxygen-poor, static liquid LBE has been touched upon in prior studies [9,13]. In fact, it has been shown that steel grains with the  $\langle 111 \rangle$  orientation close to the direction of steel tensile loading (e.g., load resulting in cold deformation) favor LBE dissolution attack, while grains with the  $\langle 001 \rangle$  orientation delay locally the attack [9]. The higher susceptibility of grains with the  $\langle 111 \rangle$  orientation to LBE dissolution attack may be attributed to their high density of deformation twins, as such twins are known to promote the LBE ingress into the steel bulk [8,9,13,47]. As was pointed out in earlier studies [48], twinning at low strain levels (in the present study, the degree of steel cold work varied between 20% and 46%) depends strongly on the crystallographic orientation and it is favored in grains with the  $\langle 111 \rangle$  orientation close to the direction of tensile loading. Table 4 summarizes the fractions of the scanned areas that were occupied by grains with diameters  $> 10\ \mu\text{m}$  and  $< 4\ \mu\text{m}$ , the weighted average grain diameters (in  $\mu\text{m}$ ), and the texture for all exposed steels.

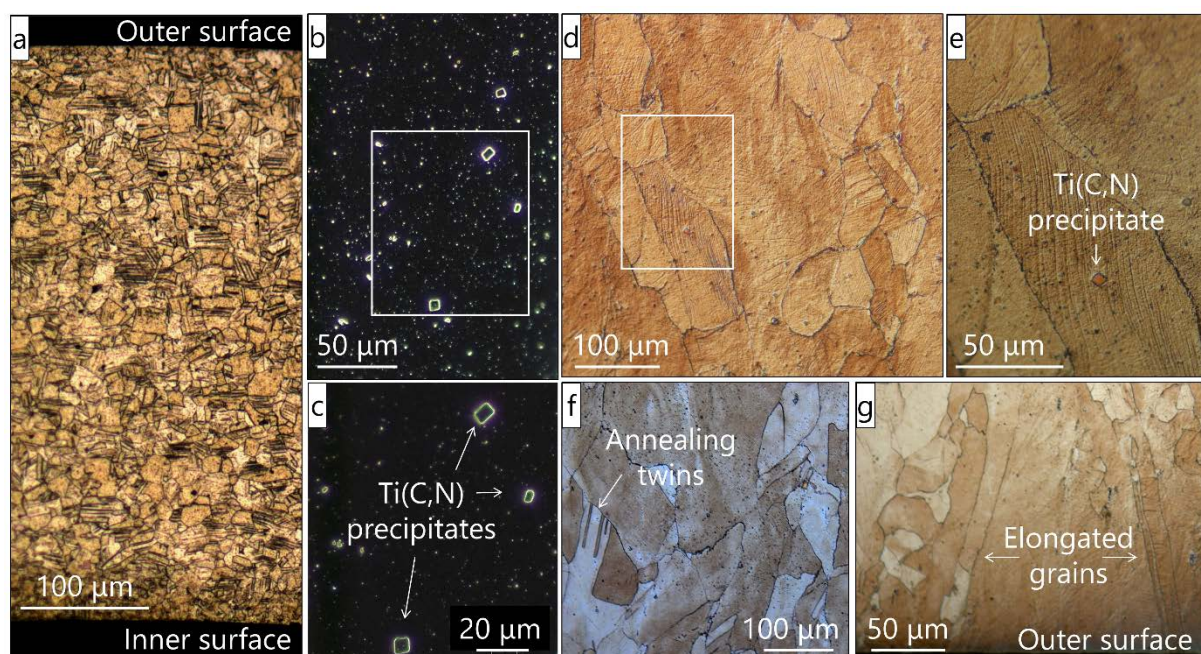
**Fig. 5.** LOM images of DIN 1.4970 steels: (a-c) 1.4970-t-24CW, and (d-g) 1.4970-r-SA. (a) Overview of chemically etched 1.4970-t-24CW. (b,c) LOM dark field images (overview & detail) of the distribution of Ti(C,N) precipitates in OPS-polished 1.4970-t-24CW. (d-f) Bimodal grain distribution in chemically-etched 1.4970-r-SA; microstructural features, such as Ti(C,N) precipitates, GBs, and annealing twins, are visible. (g) Large ( $>150 \mu\text{m}$ ) elongated grains at high angles ( $70-80^\circ$ ) with the outer surface of the 1.4970-r-SA specimen.

Dark field LOM images of OPS-polished 1.4970-t-24CW revealed a bimodal distribution of Ti(C,N) precipitates across the wall thickness (Figs. 5b-5c). With the exception of a few, very large (4.5-9  $\mu\text{m}$ ) Ti(C,N) precipitates, the rest of the precipitates appeared to be in the submicrometer range. Prior characterization of the MYRRHA reference 1.4970-t-24CW fuel cladding showed that the submicrometer Ti(C,N) precipitates could be divided into 'primary' (50-300 nm) and 'secondary' (1-20 nm) ones [44]. The ultra-fine 'secondary' precipitates are held accountable for the superior steel resistance to (thermal & radiation) creep and radiation swelling [44]. Knowing the distribution of foreign steel precipitates can provide additional insights into the dissolution corrosion behavior of a specific steel. For example, Lambrinou et al. [8] demonstrated that such precipitates (oxides, sulphides,  $\delta$ -ferrite) in 316L stainless steels promote the local advancement of the dissolution front by allowing the faster LBE penetration into the steel/precipitate interface.

The LOM images in Figs. 5d-5g reveal 1.4970-r-SA microstructural features that could affect the steel dissolution corrosion behavior: bimodal grain and Ti(C,N) precipitates size distributions, large annealing twins, and elongated (>150  $\mu\text{m}$ ) grains at high angles with the outer specimen surface. The latter is considered potentially problematic, as GBs are preferred paths of LBE ingress into the steel and having such paths that run deep (>150  $\mu\text{m}$ ) into the steel might result in the formation of dissolution 'pits'. Lambrinou et al. [8] has previously reported dissolution 'pitting' in 316L steels due to the unfavorable orientation and inward convergence of large annealing twin boundaries (another defect favoring LBE penetration) with access to the steel specimen surface.

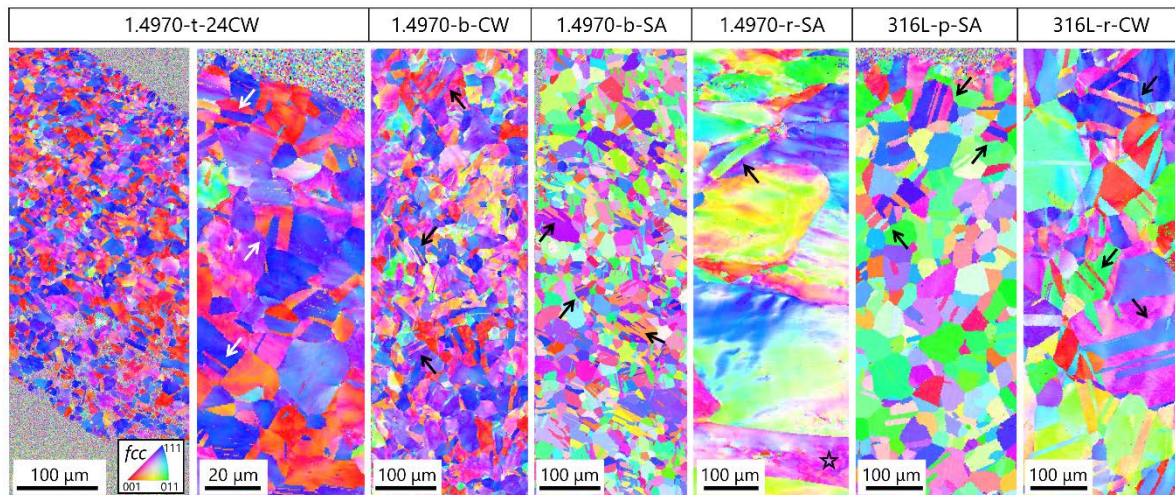
**Fig. 6.** EBSD orientation maps showing annealing twins (arrows) in the 1.4970-t-24CW, 1.4970-b-CW, 1.4970-b-SA, 1.4970-r-SA, 316L-p-SA, and 316L-r-CW steels. The twins are bigger in size in the coarser-grained steels 1.4970-r-SA, 316L-r-CW, and 316L-p-SA. A large elongated grain (star), similar to the ones shown in Fig. 5g, may be observed in 1.4970-r-SA. The inverse pole figure colour maps correspond to the [001] zone axis in all cases, except from those of 1.4970-r-SA and 316L-r-CW that correspond to the [100] and [010] zone axis, respectively.

As annealing twins are steel microstructural features that have previously shown that they are effective in aiding locally the progress of LBE dissolution attack and are even capable of forming dissolution 'pits' [8], it has been deemed necessary in this work to monitor systematically their distribution in the pristine steels by means of EBSD. A high density of annealing twins may be considered an inherent weakness of coarse-grained steels, since annealing twins traversing large grains offer paths of easy LBE penetration deep into the steel, depending on the actual grain size and the fraction of twinned grains. As far as dissolution 'pitting' is concerned, the orientation of large grains with annealing twins relative to the steel specimen surface is of primary importance, as shown by Lambrinou et al. [8]. The EBSD orientation maps of Fig. 6 show that all coarse-grained steels (1.4970-r-SA, 316L-p-SA, 316L-r-CW, 1.4970-b-SA, and 1.4970-b-20CW) are characterized by a non-negligible annealing twin density. As indicated by the systematic analysis of EBSD data, the fraction of annealing twins in these steels varied in the 13-60% range; the steels that showed the 'heaviest' combination of grain coarseness with a high fraction of annealing twins were the 1.4970-r-SA (grain diameter >270  $\mu\text{m}$ , 44% twins) and 316L-r-CW (grain diameter >188  $\mu\text{m}$ , 39% twins). The reference MYRRHA fuel cladding 1.4970-t-24CW shows a non-negligible amount of annealing twins (5%), which are smaller due to the fine steel grain size (11-12  $\mu\text{m}$ ). Despite their small size, the homogeneously distributed annealing twins in this steel are expected to contribute

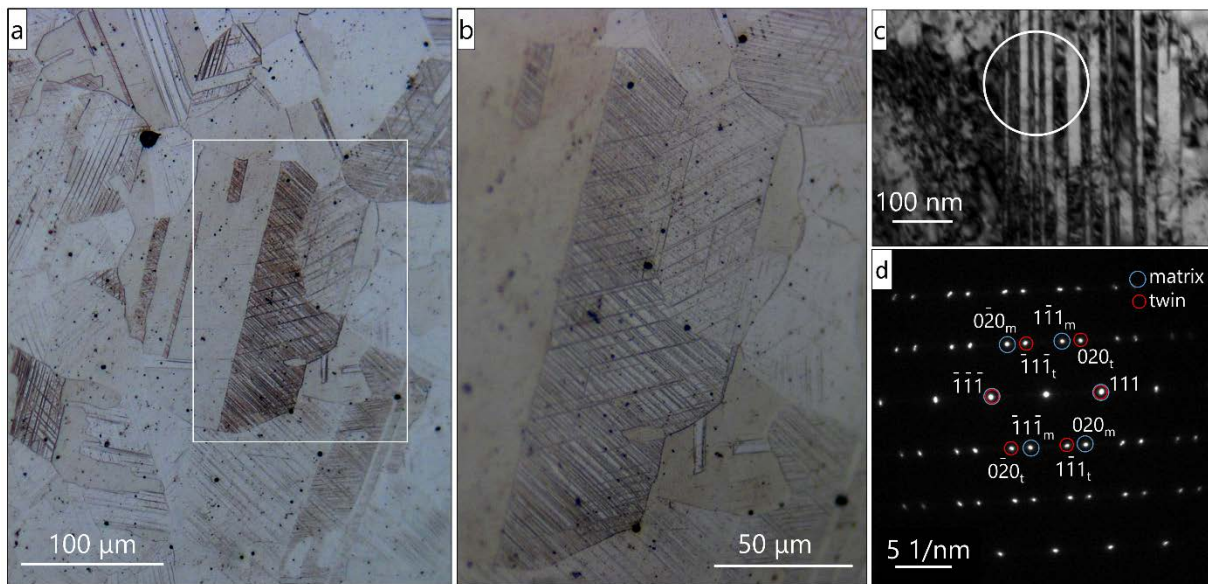
**Fig. 7.** (a,b) LOM images (overview & detail) of fine-scale deformation twins in chemically etched 316L-r-CW. (c) TEM BF image of deformation twin laths in 1.4970-t-46CW, and (d) SADP of the circled area in Fig. 7c.

Another steel microstructural feature that has been clearly shown in earlier studies [8,9,13,47] to promote the progress of LBE dissolution attack in 316L stainless steels are deformation twins. Their density clearly increases in cold worked steels, but due to their fineness it is difficult to monitor their distribution throughout the steel bulk. As the density of deformation twins is higher in cold worked steels, the susceptibility of cold worked steels to dissolution corrosion is expected to be higher, in agreement with previous studies [8,9,13,47]. TEM characterization of the deformation twins in the 316L-r-CW steel heat has been reported earlier by Lambrinou et al. [8]; in that earlier study, the 316L-r-CW steel heat was named 316LH2. LOM images of areas with high deformation twin density in chemically etched 316L-r-CW are shown in Figs. 7a-7b. TEM data, i.e., a bright field (BF) image and a selected area diffraction pattern (SADP), of deformation twins in the highly cold worked 1.4970-t-46CW fuel cladding steel are shown in Fig. 7c and Fig. 7d, respectively. The SADP (Fig. 7d), which was acquired from a set of twin laths (circled area in Fig. 7c) along the  $\langle \bar{1}01 \rangle$  orientation, verified that the diffraction spots of the steel matrix and twins are connected by a mirror reflection across the  $\{111\}$  twinning plane, as expected for an *fcc* lattice.

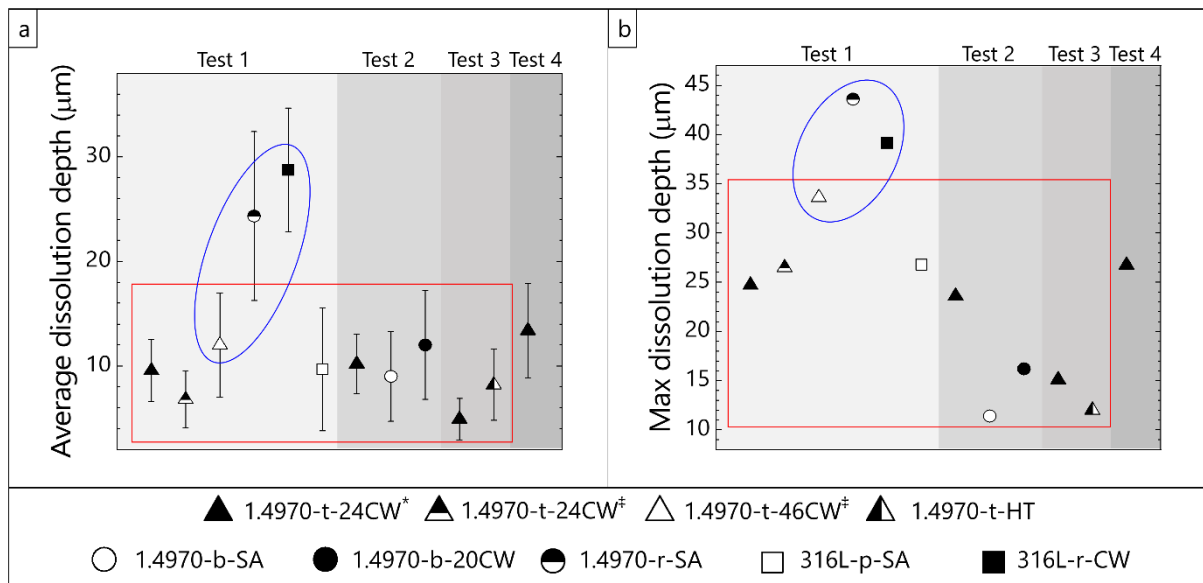
**Fig. 8.** (a) Average and (b) maximum depths of LBE dissolution attack for the 316L and DIN 1.4970 steels exposed in this study to oxygen-poor, static liquid LBE in tests 1-4. The red frames indicate the variation of dissolution depth values in DIN 1.4970 fuel cladding tubes for the first ~600 h of exposure; the blue frames indicate the 3 steels (1.4970-r-SA, 316L-r-CW, 1.4970-t-46CW) that suffered the most severe LBE dissolution attack within the first 619 h of exposure.

The relative severity of dissolution corrosion damages in the 316L and DIN 1.4970 austenitic stainless steels exposed in this work to oxygen-poor, static liquid LBE at 500°C for 600-1000 h is shown in Fig. 8. Both average (Fig. 8a) and maximum (Fig. 8b) dissolution corrosion depths for all uncoated steels are presented, and the collected data are grouped per test (tests 1-4) so as to allow the direct comparison of dissolution corrosion damages in steels that were exposed to identical LBE conditions, esp. in terms of LBE dissolved oxygen concentration. At a first glance, the depth (average & maximum) of LBE dissolution attack in 1.4970-t-24CW (brushed & polished surface state) is greater for the longer test of 1000 h (test 4) as compared to the shorter tests of 600-619 h (tests 1-3). This is quite straightforward to understand, as the depth of LBE dissolution attack is expected to increase with the time of exposure, for conditions permitting the continued steel dissolution. For steel exposures to baths of static LBE with a finite volume (here, ~0.5 litre), as those performed in this work, steel dissolution is expected to stop (at the absence of dissolved oxygen that can take species out of solution by forming oxides that precipitate out of the bath) when the LBE bath becomes saturated in dissolved species (Ni, Mn, Cr, Fe) at the selected exposure temperature. Taking into account that the solubilities of Ni, Cr and Fe (i.e., the main steel alloying elements) are  $2.30 \times 10^{-1}$ ,  $1.60 \times 10^{-3}$  and  $2.19 \times 10^{-4}$ , respectively, at 500°C [8], saturation of the LBE bath could not have occurred even upon the complete dissolution of the steel specimens in tests 1-4; moreover, complete dissolution of the steel specimens would not have been possible within 600-1000 h, based on the 316L dissolution corrosion rates determined at 500°C in an earlier study [8]. Hence, the herein LMC effects were not inhibited by the size of the test setup, and the reported

Before concluding the discussion on the relative performance of the steels used in this work, based on the data shown in [Fig. 8](#), one might want to address the effect of steel composition on the relative resistance to dissolution corrosion. The concentrations of the highly soluble in LBE steel alloying elements Ni, Cr and Mn (in mass%) were: (i) 15.05, 15.06 and 1.86, respectively, for the DIN 1.4970 steel heat, and (ii) 9.97-10.10, 16.68-16.73, and 1.75-1.81, respectively, for the two 316L steel heats. Even though one might expect higher dissolution corrosion rates for the steel with higher concentration in Ni, i.e., the DIN 1.4970, due to the fact that Ni is the steel alloying element with the highest solubility in LBE, the LBE-exposed fuel cladding tubes showed maximum dissolution corrosion damages that were comparable to those measured in 316L-p-SA. Moreover, the depth of dissolution corrosion damages in the DIN 1.4970 fuel cladding tubes were rather moderate, when compared to all other steels tested in this work (see [Fig. 8a](#)). On the same topic, a prior study by Klok et al. [47] reported lower local LBE dissolution attack in Ni-rich bands found in a 60% cold-deformed specimen of the 316L-p-SA steel heat that is also used in this work. This counter-intuitive observation was attributed to the effect of Ni on the steel stacking fault energy (SFE): Ni increases the material's SFE, limiting the formation of defects, such as deformation twins, during plastic deformation. The Ni-rich bands in 60% cold-worked 316L-p-SA were indeed characterised by a lower density of deformation twins, which resulted in the locally slower advancement of the dissolution front in these bands during the steel exposure to oxygen-poor, static LBE at 500°C for 1000 h [47]. It is, thus, reasonable to assume that the compositional differences of the 316L and DIN 1.4970 steels used in this work on the magnitude (depth) of dissolution corrosion damages could have been compensated by steel microstructural features affecting the steel dissolution corrosion (grain size, density of annealing/deformation twins, etc.). It should be pointed out that even though the 1.4970-r-SA (richer in Ni than 316L) is characterised by a very low density of deformation twins, it suffers the highest dissolution corrosion damages ([Fig. 8b](#)), primarily due to other microstructural features promoting dissolution corrosion (i.e., coarse grains, large fraction of annealing twins). The second most-affected steel, i.e., the 316L-r-CW, has a similar microstructure in terms of grain coarseness and fraction of annealing twins, plus a much higher density of deformation twins; however, the maximum depth of LBE dissolution attack in 316L-r-CW is ~10% lower than that in 1.4970-r-SA exposed to identical conditions (test 1). In the case of this specific steel pair, one could postulate that steel compositional differences (esp. the higher Ni content of 1.4970-r-SA compared to 316L-r-CW) might indeed be accountable for the observed differences in corrosion behaviour.

published data. As shown in Fig. 8, the dissolution corrosion damages in as-fabricated DIN 1.4970 fuel cladding tubes (1.4970-t-24CW, 1.4970-t-46CW) are roughly comparable with such damages in 316L-r-SA and 316L-r-CW (the latter benchmarking the “worst case scenario” in terms of LMC resistance). Therefore, one might safely postulate that the seemingly underestimated severity of corrosion damages in the 316L steel heats exposed in this work (by ~25% and ~50% for average and maximum corrosion depths, respectively) are likely to translate to the DIN 1.4970 steels that were exposed to similar conditions in tests 1-4. This puts forth the necessity of performing future tests on DIN 1.4970 stainless steels that ensure some form of mild LBE mixing during exposure, so as to assess the true resistance of such steels to dissolution corrosion (these tests cannot be performed in a forced convection loop due to the forbiddingly low LBE oxygen levels that would surely damage the steels used for the loop construction, esp. for long-term testing).

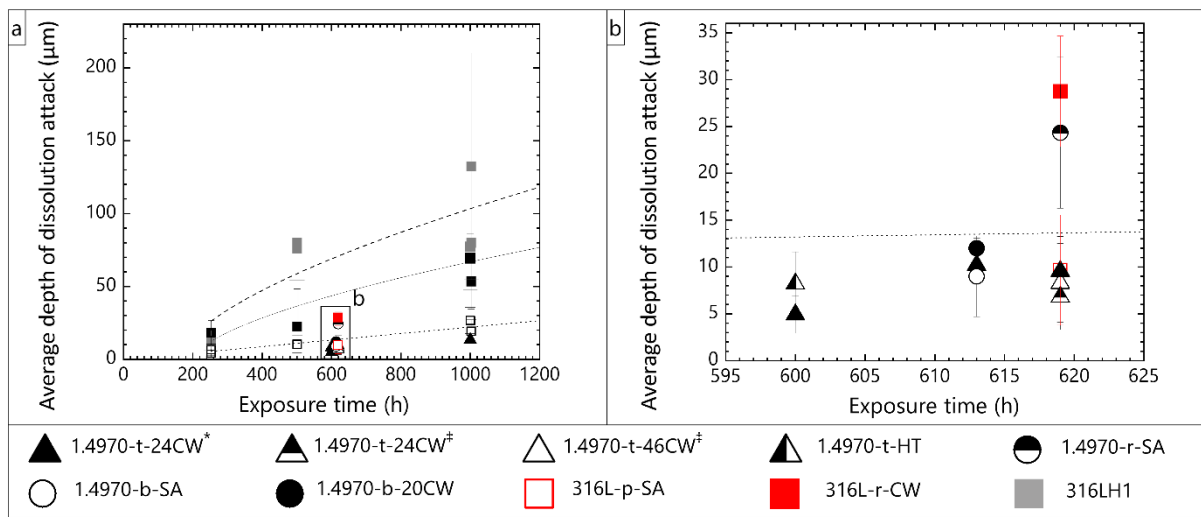
**Fig. 9.** (a,b) Average depth of LBE dissolution attack in the 316L and DIN 1.4970 steels exposed to oxygen-poor liquid LBE at 500°C for ~600 h in this work: the acquired data are enveloped by a frame in Fig. 9a and are plotted in Fig. 9b. The acquired data are plotted with average dissolution attack data reported earlier [8] for 316L steels (316L-p-SA, 316L-r-CW, 316LH1) exposed to oxygen-poor LBE at 500°C for 253-1003 h. The 316L-p-SA and 316L-r-CW heats used in this work were earlier named 316LSA and 316LH2, respectively [8].

The (average & maximum) LMC data collected in this work are put in perspective with respect to 316L dissolution corrosion data acquired in a previous study [8]. In that study, Lambrinou et al. [8] exposed simultaneously to oxygen-poor, static LBE at 500°C for 253-3282 h three different 316L steel heats, i.e., one solution-annealed heat (316LSA; this heat is here named 316L-p-SA) and two cold-worked heats (316LH1 & 316LH2; the 316LH2 heat is here named 316L-r-CW) [8]. The early-stage (600-1000 h) dissolution corrosion data acquired in this work from both 316L and DIN 1.4970 steels are plotted as function of time in Figs. 9-10 together with the early-stage (253-1003 h) 316L dissolution corrosion data reported in Ref. [8]. The 316L data acquired in this work on two of the steel heats used in Ref. [8] add new data points (619 h; test 1) from exposing these 316L steel heats to comparable test conditions (autoclaves of identical design, same conditioning gas). One may observe in the graphs in Figs. 9-10 that, even though the depths of 316L dissolution corrosion damages measured in this work are on the lower end of the dissolution depth ranges reported in Ref. [8], they still fall within these ranges. It is difficult to attribute the (consistently for both steel heats) relatively shallower depths of LBE dissolution attack in the same 316L steels to fluctuations in the LBE oxygen concentration (Figs. 2-3) due to the imperfect leak tightness of the used autoclaves, as similar fluctuations have also been reported in Ref. [8]. An unobtrusive difference in the supply of the conditioning gas might explain these small differences in the severity of the dissolution corrosion effects observed in this work for the same two 316L steel heats as compared to Ref. [8]: in the earlier tests [8], the reducing gas (Ar-5% H<sub>2</sub>) was supplied close to the bottom of the LBE bath by means of a ‘bubbling tube’, thus ensuring a form of mild

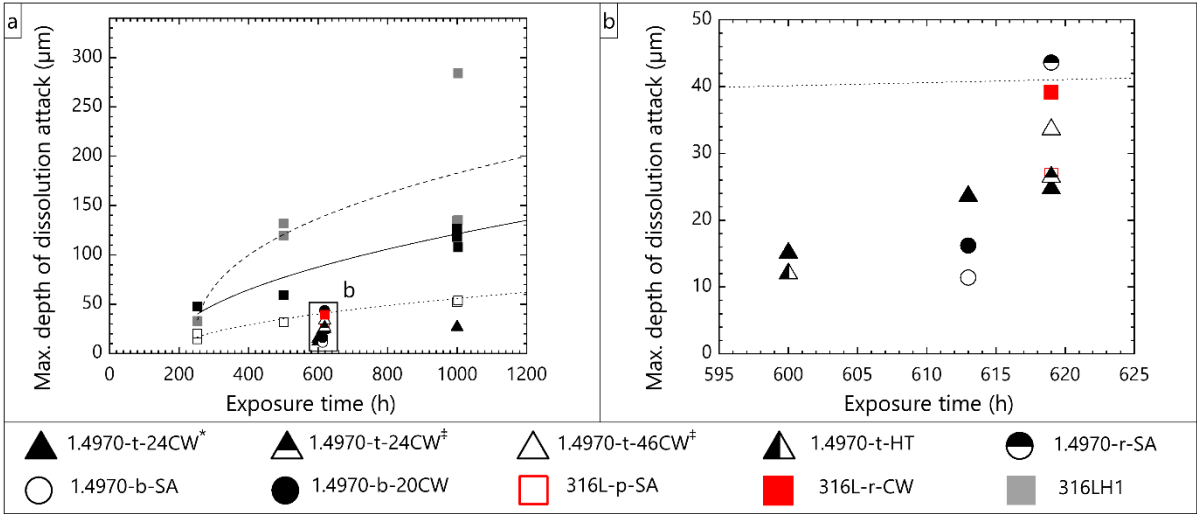
**Fig. 10.** (a,b) Maximum depth of LBE dissolution attack in the 316L and DIN 1.4970 steels exposed to oxygen-poor liquid LBE at 500°C for ~600 h in this work: the acquired data are enveloped by a frame in Fig. 10a and are plotted in Fig. 10b. The acquired data are plotted with maximum dissolution attack data reported earlier [8] for 316L steels (316L-p-SA, 316L-r-CW, 316LH1) exposed to oxygen-poor LBE at 500°C for 253-1003 h.

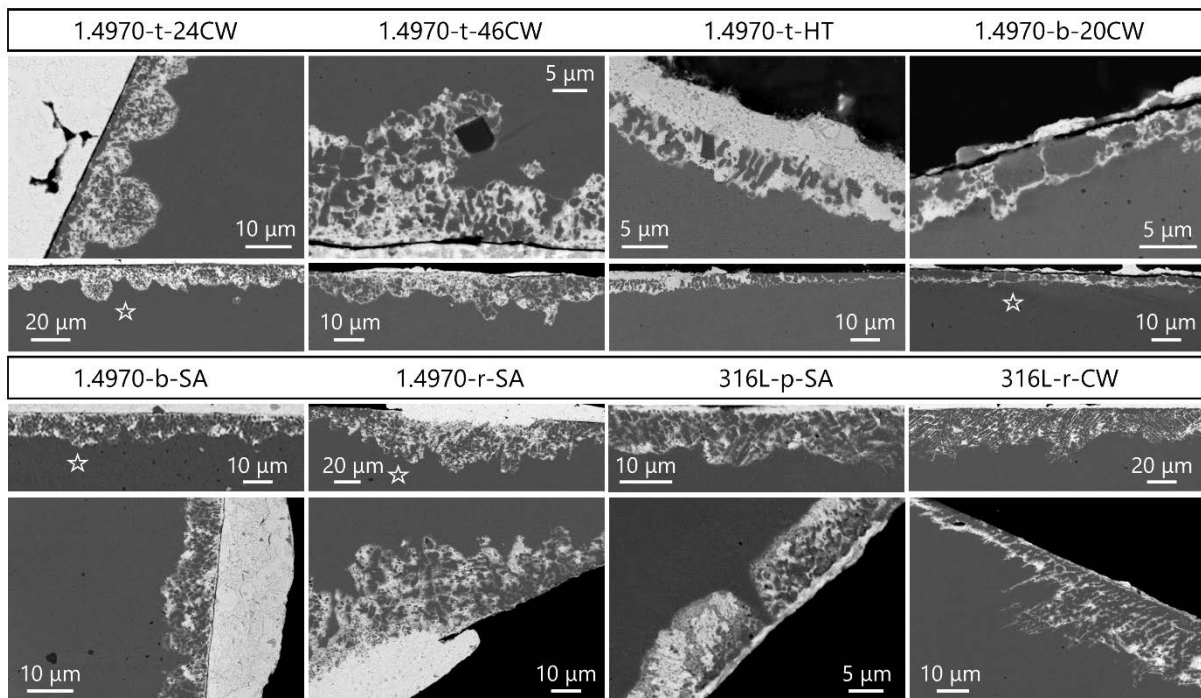
**Fig. 11.** BSE images (overviews and details) of the typical appearance of LBE dissolution attack in the 316L and DIN 1.4970 steels exposed to LBE for ~600 h in this work. Stars indicate locations in the overviews that appear magnified in the details. BSE images showing dissolution corrosion effects in 1.4970-t-24CW, 1.4970-t-46CW, 1.4970-r-SA, 316L-p-SA, and 316L-r-CW from test 1; 1.4970-b-SA, and 1.4970-b-20CW from test 2; 1.4970-t-HT from test 3.

In general, LBE dissolution attack in all 316L and DIN 1.4970 stainless steels used in this work started intergranularly, as GBs are preferred paths for the LBE ingress into the steel bulk [8]. The intergranular LBE penetration is typically followed by selective leaching of steel alloying elements (Ni, Mn, Cr), which are transported away by diffusion through the three-dimensional network of LBE penetrations that connect the steel interior with the LBE bath [8]. The selective removal of the austenite stabilisers Ni and Mn leads to the ferritisation of the dissolution-affected zone, a LMC effect that has been understood for 316L steels [8,19], and will be addressed for the DIN 1.4970 steel in section 3.5. Other preferred paths of LBE penetration into the steel bulk, especially cold-worked steels, are deformation twin boundaries, as previously reported for 316L steels [8,9,13,47]. The involvement of deformation twin boundaries in the dissolution corrosion process result in more perturbed dissolution fronts in cold-worked steels (e.g., 316L-r-CW, Fig. 11) when compared to solution-annealed steels (e.g., 316L-p-SA, Fig. 11). Intergranular LBE penetration and selective leaching-induced ferritisation are followed by the transgranular consumption of the ferritized steel grains in the dissolution-affected zone (e.g., 1.4970-t-HT, 1.4970-r-SA, 316L-p-SA, Fig. 11). Sites of locally-enhanced LBE dissolution attack (i.e., dissolution ‘pits’) are primarily observed in coarse-grained steels with a high fraction of annealing twins, such as 1.4970-r-SA (see Fig. 11) and 316L-r-CW. Lambrinou et al. [8] have previously reported the formation of a big (~100

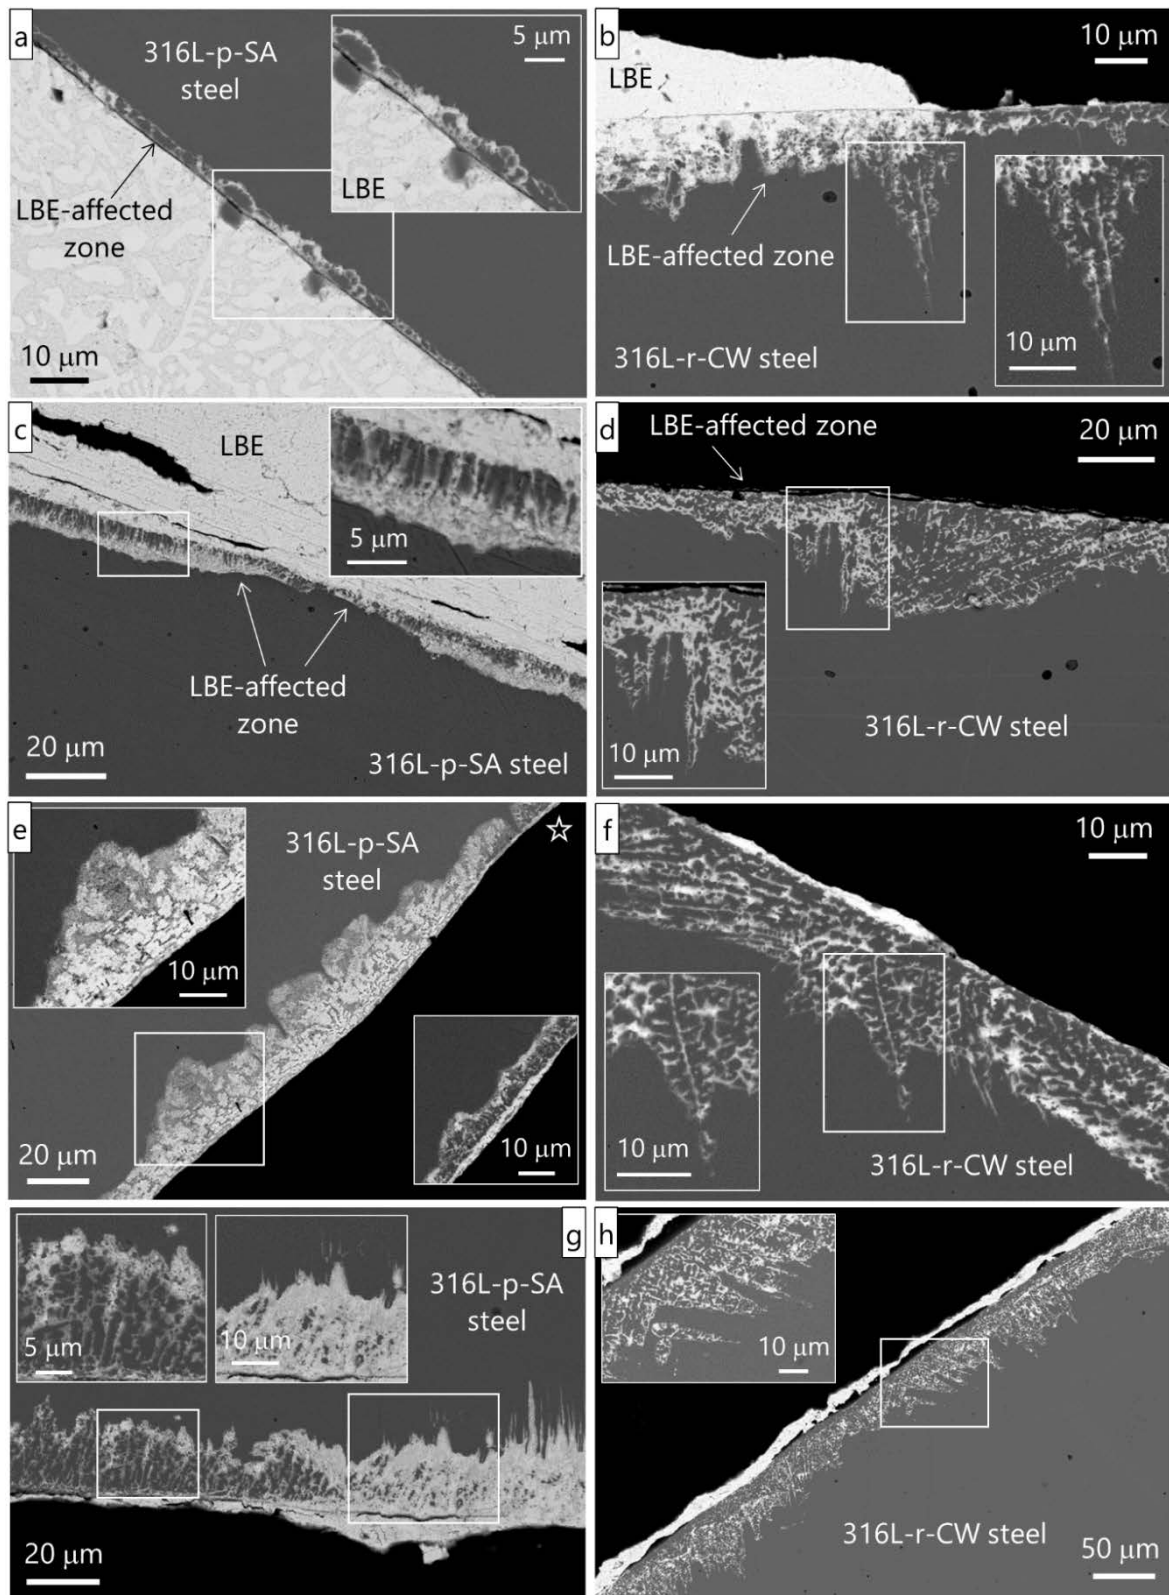
**Fig. 12.** BSE images of the time evolution of LBE dissolution attack in the 316L-p-SA and 316L-r-CW steels (316LSA and 316LH2, respectively, in [8]) exposed to oxygen-poor, static LBE at 500°C for (a,b) 253, (c,d) 501 and (g,h) ~1000 h (previous work [8], unpublished data) and (e,f) 619 h (this work).

BSE images of the time evolution of dissolution corrosion damages in the 316L and DIN 1.4970 steel tested in this work are shown in Figs. 12 and 13, respectively. Fig. 12 includes unpublished images of dissolution corrosion damages in 316L-p-SA and 316L-r-CW exposed to oxygen-poor ( $C_0 < 10^{-8}$  mass%), static liquid LBE at  $500^\circ\text{C}$  for 253, 501 and  $\sim 1000$  h in an earlier study [8]. In this work, the same 316L steel heats were exposed oxygen-poor ( $C_0 < 10^{-9}$  mass%), static LBE at  $500^\circ\text{C}$  for 619 h (test 1). The early stages (253-1000 h) of LBE dissolution attack the industrial size solution-annealed 316L-p-SA show that attack starts intergranularly (Fig. 12a), ferritising the first layer of grains ( $2\text{-}4 \mu\text{m}$ ) underneath the specimen surface. As time progresses and the LMC damages deepen (Figs. 12c and 12e), LBE dissolution attack becomes transgranular in the affected zone, gradually consuming the Fe-based (ferritized) grains until the whole dissolution zone loses any resemblance with the initial steel microstructure. In a real nuclear system and in the presence of LBE flow, the whole dissolution-affected zone will be completely removed, as it essentially filled by LBE with high concentrations of dissolved steel alloying elements; in completely static tests, as those performed in this work, the damaged zone is retained and may be studied by SEM, revealing the loading of LBE with dissolved species (darker, featureless areas in the damaged zone, Fig. 12e).

The change in dissolution corrosion mode from primarily intergranular (left inset, Fig. 12g) to primarily transgranular (right inset, Fig. 12g) over a short distance ( $\sim 70 \mu\text{m}$ ) on the steel surface may be attributed to compositional inhomogeneities in industrial-size stainless steel heats, such as the 316L-p-SA (cold rolled, 15 mm-thick plate) used in this work. The effect, known as 'chemical banding', has been observed in 60% cold-deformed 316L-p-SA exposed to oxygen-poor, static LBE at 500°C for 1000 h by Klok et al. [47]. The effect of local steel composition on the transition from selective to non-selective leaching in the 316L-p-SA steel was touched upon earlier by Lambrinou et al. [8], who identified the possible association of the local steel chemical composition (esp. its Ni content) with the local density of deformation-induced defects that promote dissolution attack.

Dissolution corrosion in cold-worked stainless steels, such as the 316L-r-CW used in this work, progresses by using preferred paths of LBE ingress (GBs, deformation twin boundaries) into the steel bulk. The higher density of deformation twins in such steels results in dissolution fronts that are highly perturbed; sharp protuberances of the dissolution front (Figs. 12b, 12d, 12f, 12h) are

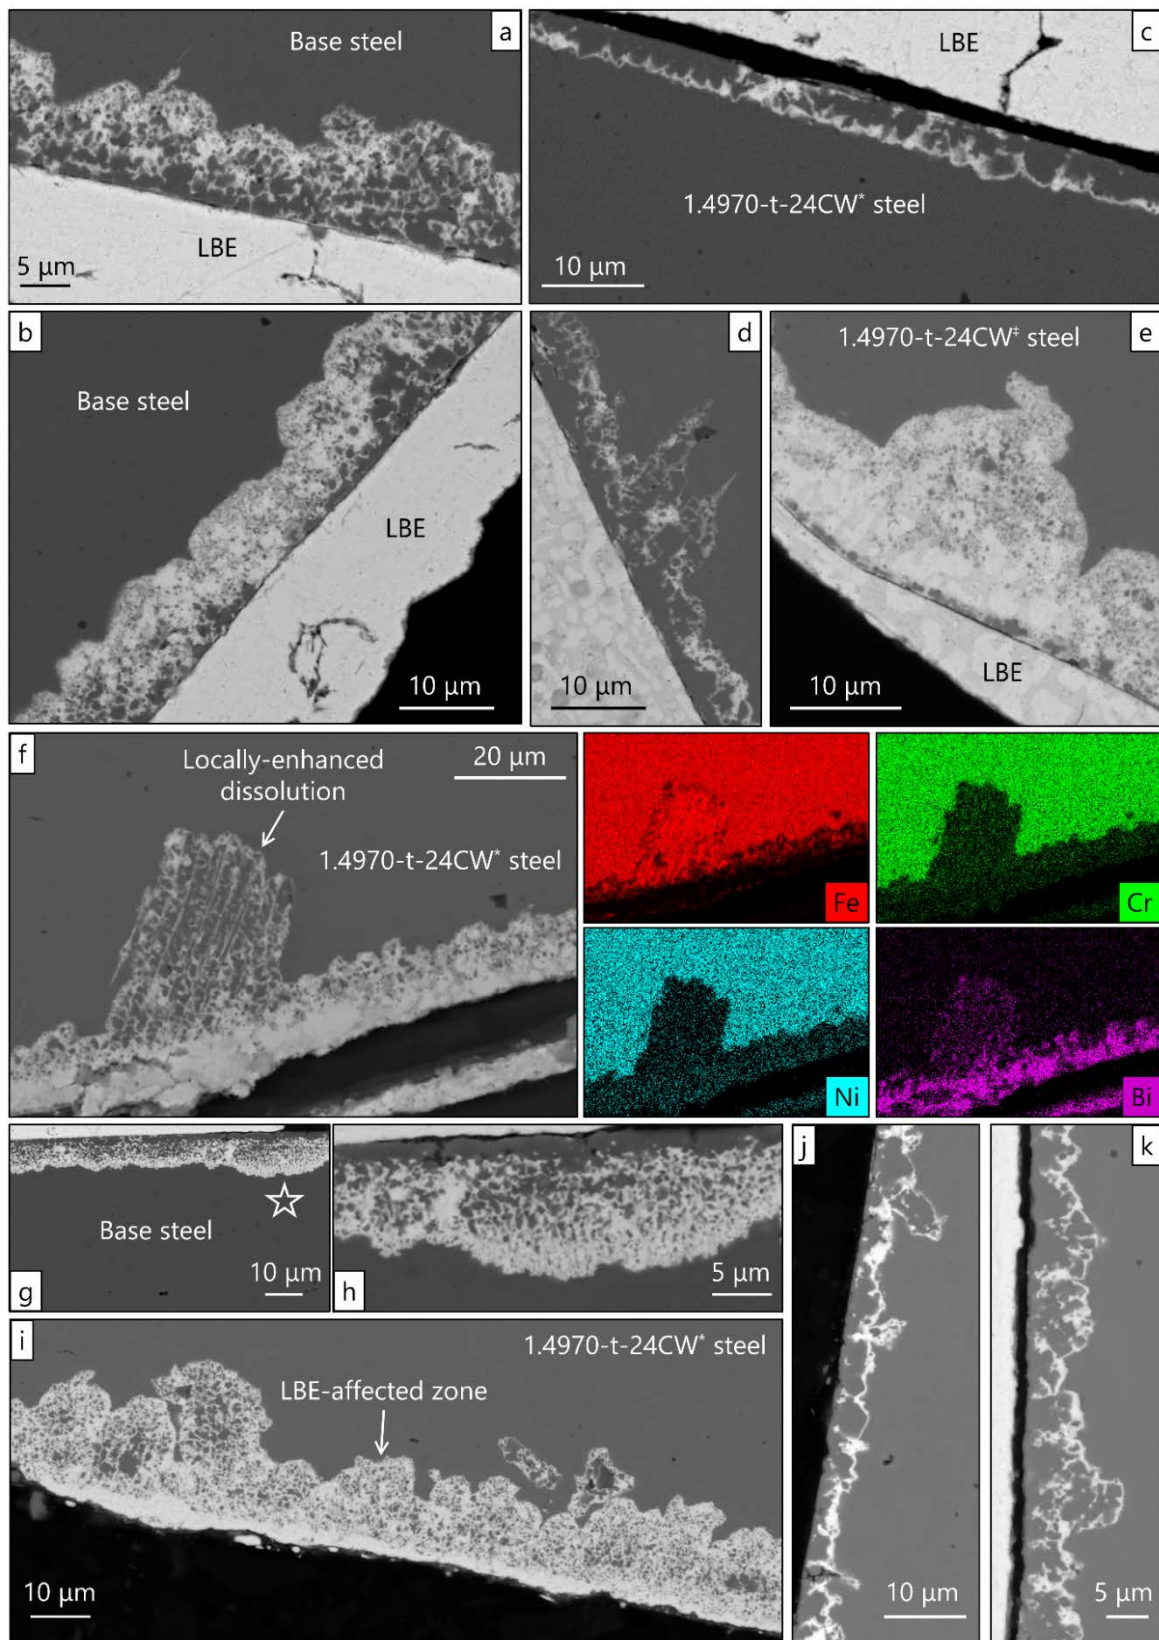
**Fig. 13.** BSE images of the time evolution of LBE dissolution attack in 1.4970-t-24CW exposed to oxygen-poor, static LBE at 500°C for (a-f) ~600 h and (g-k) 1000 h. (a-c) Variable depths (4-12.5  $\mu\text{m}$ ) of attack in 1.4970-t-24CW (brushed & polished). Dissolution attack starts intergranularly (c) and proceeds transgranularly (a,b) with depth. (d,e) Dissolution front perturbations in 1.4970-t-24CW (brushed). (f) Site of locally-enhanced LBE dissolution attack (>40  $\mu\text{m}$ ) in 1.4970-t-24CW (brushed & polished). (g-k) Variable depths (4-26  $\mu\text{m}$ ) of attack in 1.4970-t-24CW (brushed & polished).

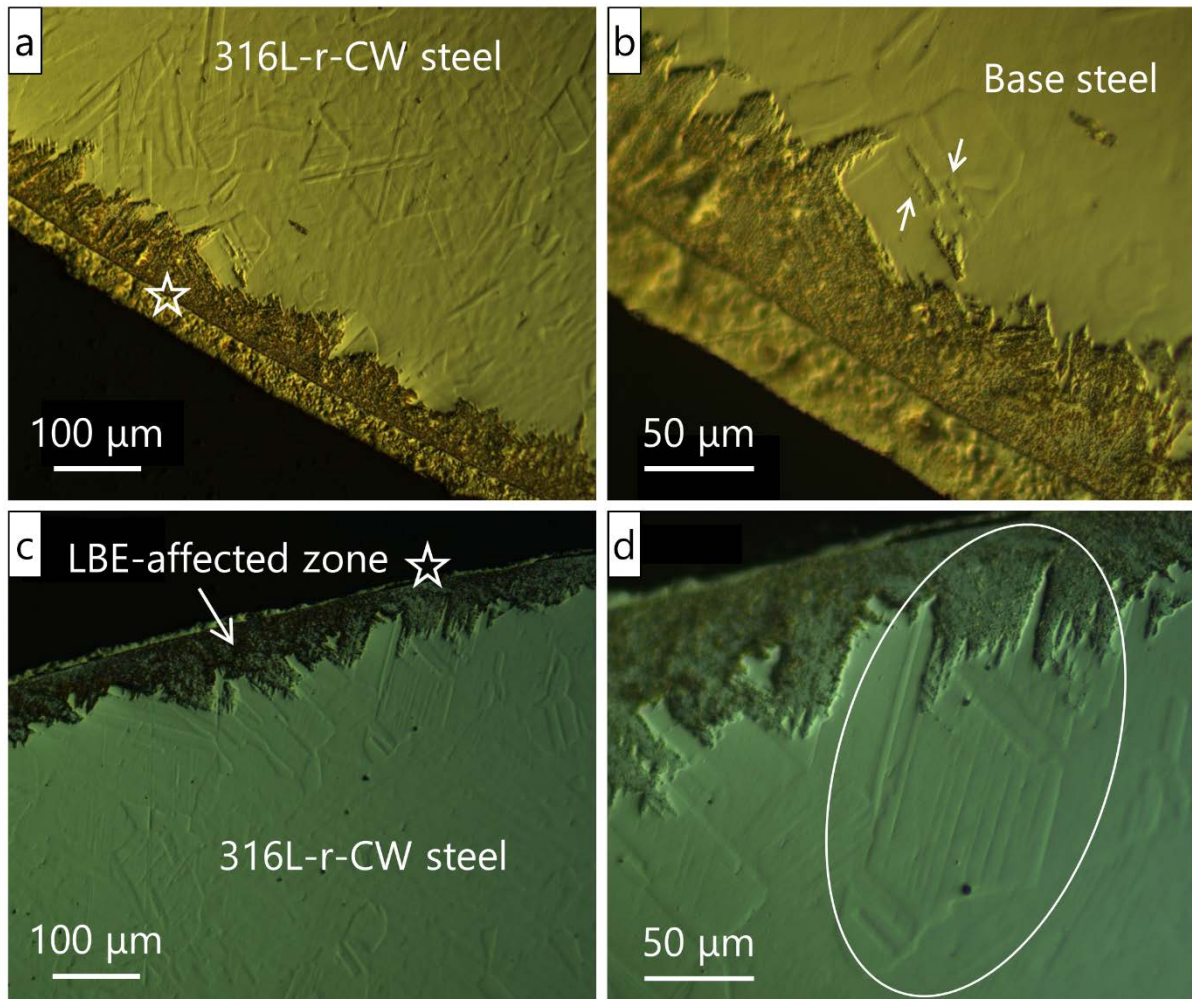
**Fig. 14.** LOM images of OPS-polished 316L-r-CW exposed to oxygen-poor static LBE at 500°C for 1003 h (previous work [8], unpublished data). (a,b) Overview and detail of an area showing LBE penetration along annealing twins (arrows). (c,d) Overview and detail of an area showing a set of closely spaced deformation twins (ellipse) that favours LBE penetration into the steel.

preferred paths for the LBE ingress into 316L steels is provided in Figs. 14a-14b and 14c-14d, respectively. These LOM images were acquired from OPS-polished specimens of the 316L-r-CW steel, which showed one of the three most severe dissolution corrosion damages in this study (Fig. 8b). The particular steel specimen shown in Fig. 14 (unpublished data) was exposed to oxygen-poor static LBE at 500°C for 1003 h in the framework of a prior study [8]; however, the observed contribution of annealing/deformation twins to the dissolution process is very important for the in-depth understanding of the early-stage (<1000 h) dissolution corrosion behaviour of stainless steels, which is the core objective of this work.
