# Early stages of dissolution corrosion in 316L and DIN 1.4970 austenitic stainless steels with and without anticorrosion coatings in static liquid lead-bismuth eutectic (LBE) at 500°C

**Keywords:** liquid metal corrosion; dissolution corrosion; lead-bismuth eutectic (LBE); austenitic stainless steels; anticorrosion coatings

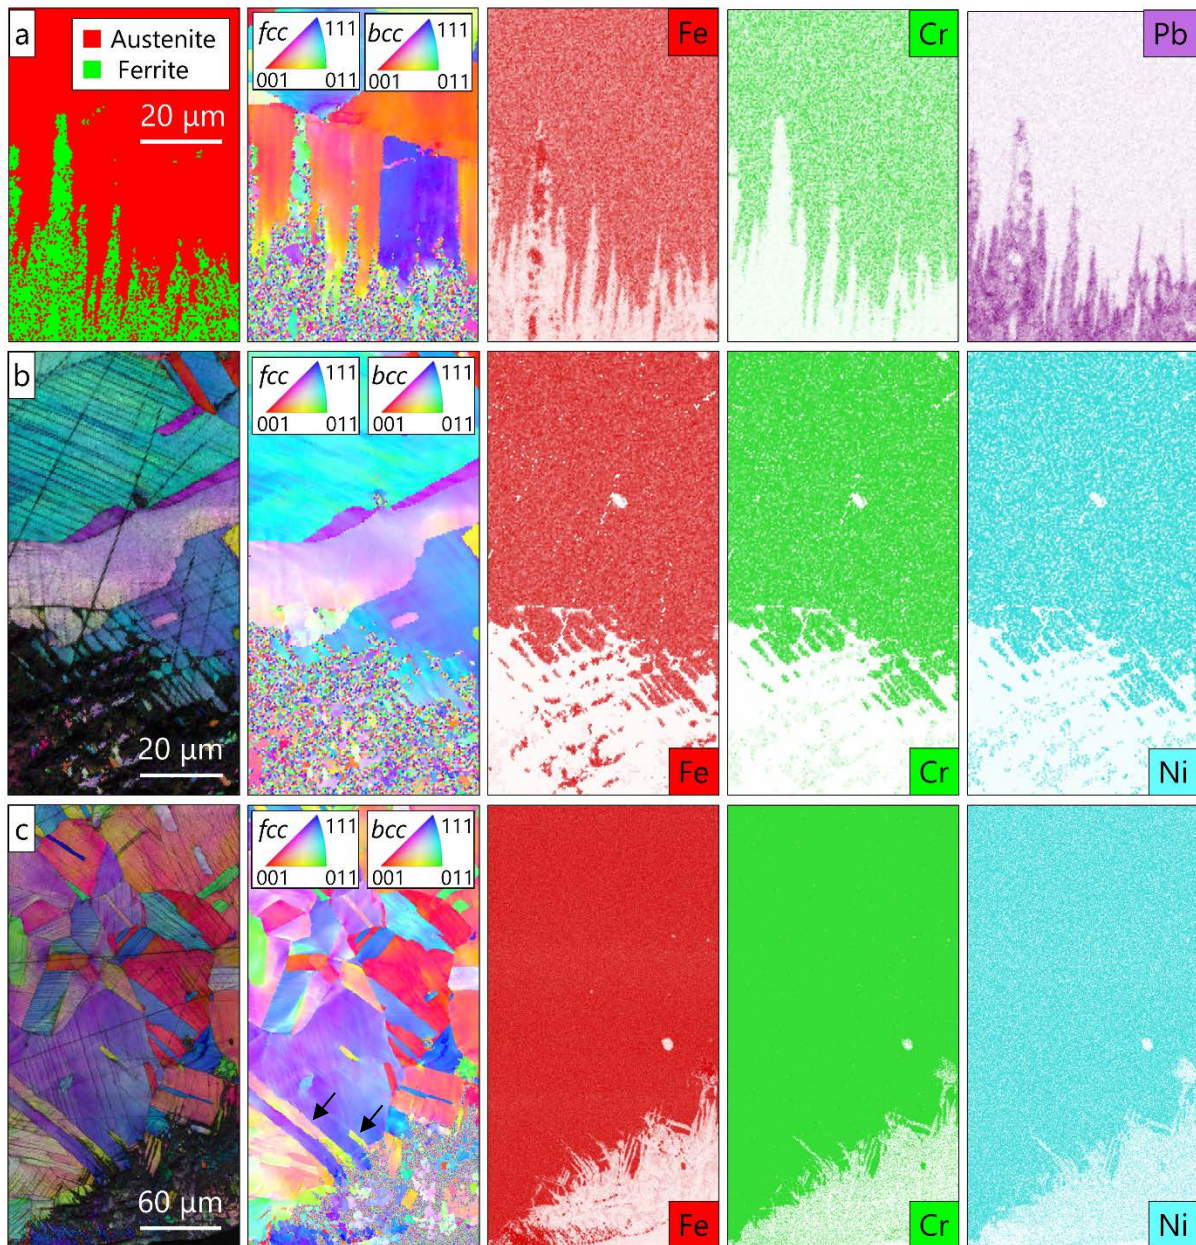
**Fig. 15.** (a) EBSD phase & orientation maps, and EDS elemental maps of the dissolution front in 316L-r-CW; the EDS maps show ferritized (Fe-rich, Cr-depleted) steel grains in the dissolution-affected zone. (b) EBSD orientation map and EDS elemental maps of the dissolution front in 316L-r-CW; the dissolution front advances with the help of ultra-fine deformation twins. (c) EBSD orientation map and EDS elemental maps of the dissolution front in 316L-p-SA; the dissolution front advances with the help of annealing twins (arrows) and much finer deformation twins.

Additional EBSD data showing the interaction of annealing/deformation twin boundaries with the dissolution process in 316L-p-SA and 316L-r-CW exposed to oxygen-poor, static LBE at 500°C for 619h (test 1) are presented in Fig. 15. The 316L-r-CW dissolution front morphology in Fig. 15a is very similar to that shown in Fig. 14d, which is clearly created by the presence of closely-spaced deformation twins. The EBSD phase map of Fig. 15a confirms the ferritisation of the dissolution-affected zone, while the accompanying EDS elemental maps point out that LBE dissolution attack

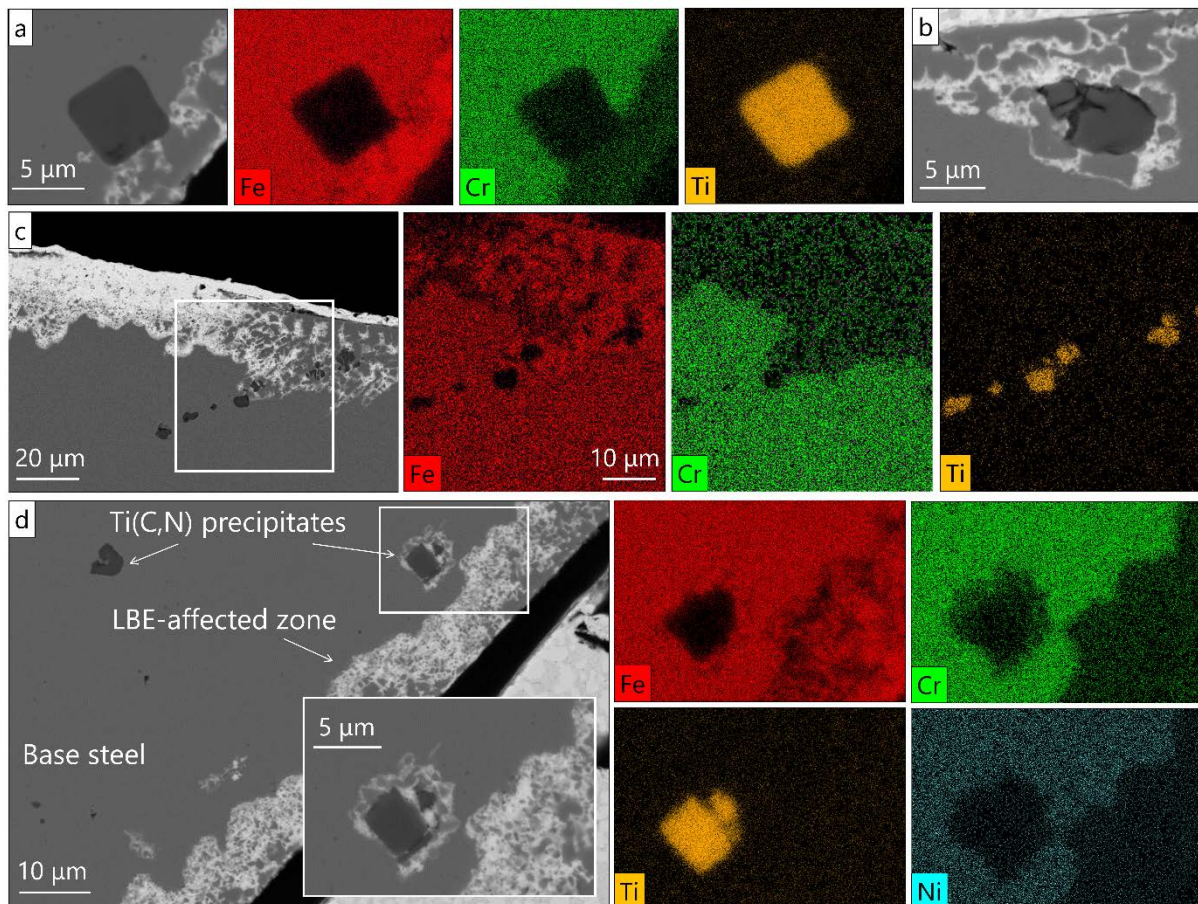
**Fig. 16.** BSE images and EDS elemental maps of Ti(N,C) precipitates in exposed DIN 1.4970. (a) First interaction of a single precipitate with the dissolution front of brushed 1.4970-t-24-CW. (b) Large precipitate advances locally the dissolution front in 1.4970-t-46CW by ~10 µm. (c) Linear arrangement of precipitates extends locally the dissolution-affected zone in 1.4970-r-SA. (d) Precipitates just ahead the main dissolution front favour locally the dissolution process in brushed 1.4970-t-24CW.

This study reports on the effect of the Ti(C,N) precipitates, which are intentionally formed in the DIN 1.4970 steel (see section 3.1), on the steel dissolution corrosion behavior, as there are no previously published data on this issue. Similar to what was previously observed with 316L steel precipitates, the interfaces between the DIN 1.4970 steel matrix and Ti(C,N) precipitates served as paths of preferred LBE ingress into the steel (Fig. 16). As may be seen in the SEM/EDS data of Figs. 16b, 16c and 16d, the Ti(C,N) precipitates promote the local advancement of the dissolution front (the magnitude of that advancement depends on their size). Linear arrangements of Ti(C,N) precipitates (Fig. 16c) that run through the fuel cladding wall thickness are very undesirable steel defects, as they could cause early fuel cladding failure due to LBE dissolution attack. It is important to realize that, since Ti(C,N) precipitates cannot be oxidized, the presence of large precipitates at the steel surface could easily lead to dissolution ‘pitting’, as LBE will surely penetrate through the steel/precipitate interface into the steel, even when the rest of the steel surface is covered by a protective oxide scale. Hence, the careful steel manufacture is of essence for fuel cladding tubes intended for use in Gen-IV LFRs, as the presence of large Ti(C,N) precipitates close to the steel surface must be avoided to the extent possible.

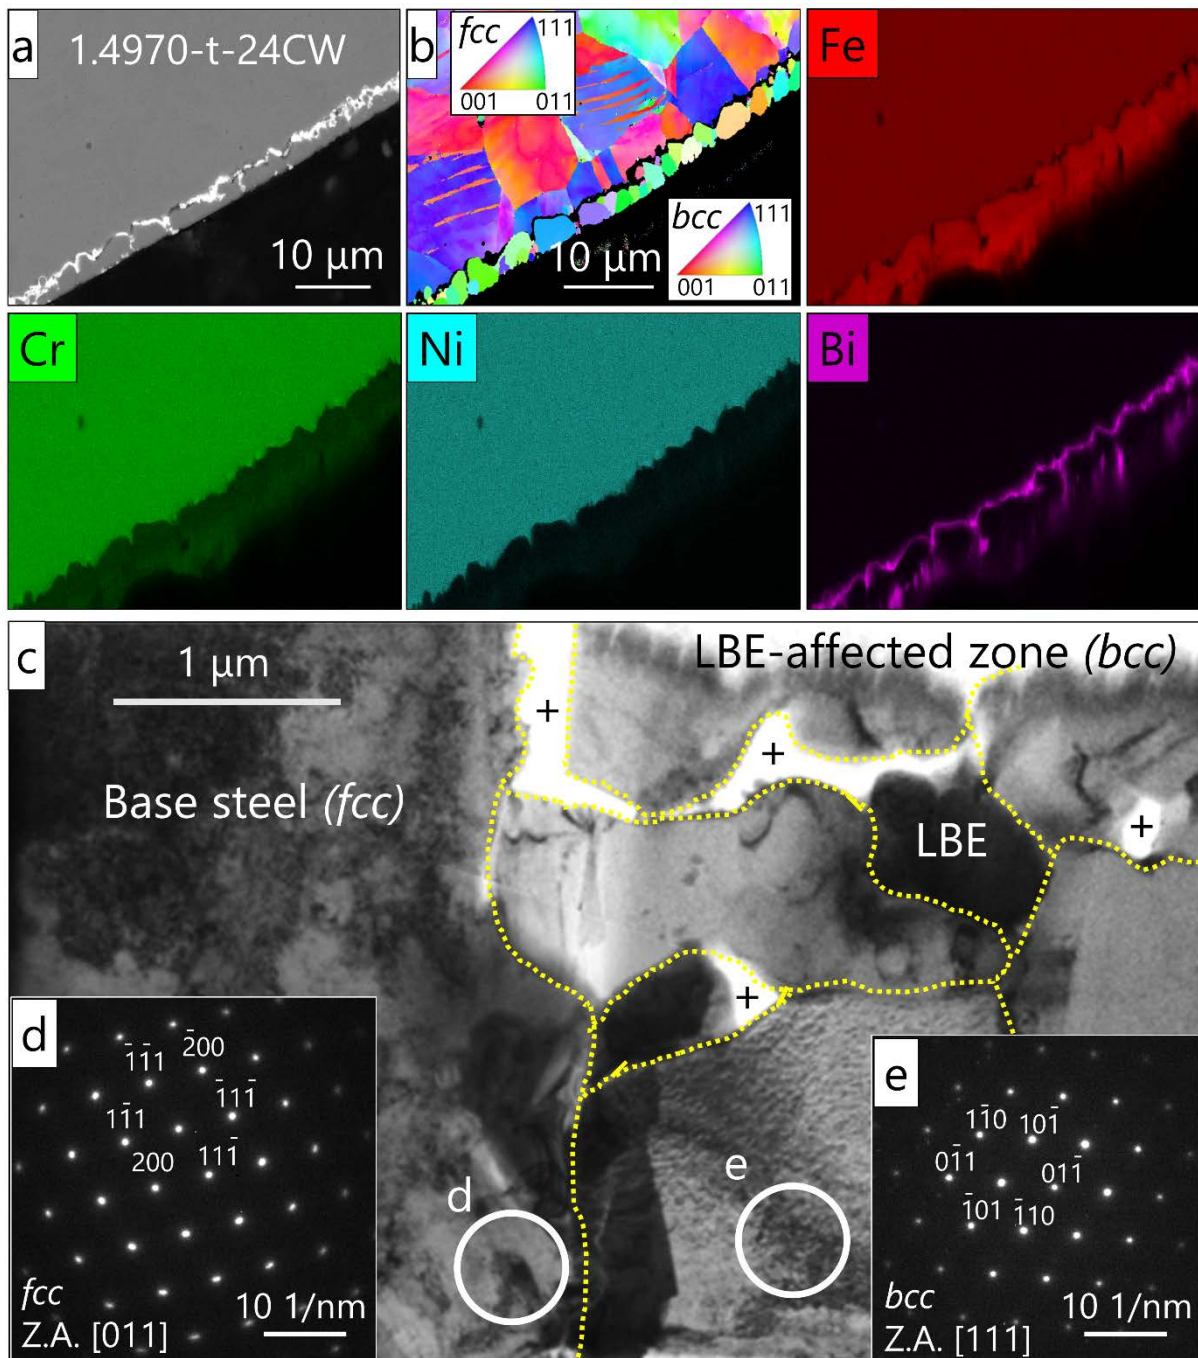
**Fig. 17.** Early-stage dissolution-induced ferritisation in 1.4970-t-24CW (test 3). (a) BSE image, and (b) EBSD orientation map and EDS elemental maps showing the ferritisation of the dissolution-affected zone, which is confined in a layer of grains just below the steel surface. (c) TEM BF image of the ferrite/austenite interface, and (d,e) SADPs of the circled areas in Fig. 17c confirming the ferritisation (area e) of the austenitic (area d) steel. The + symbol shows voids in the thin foil due to LBE removal.

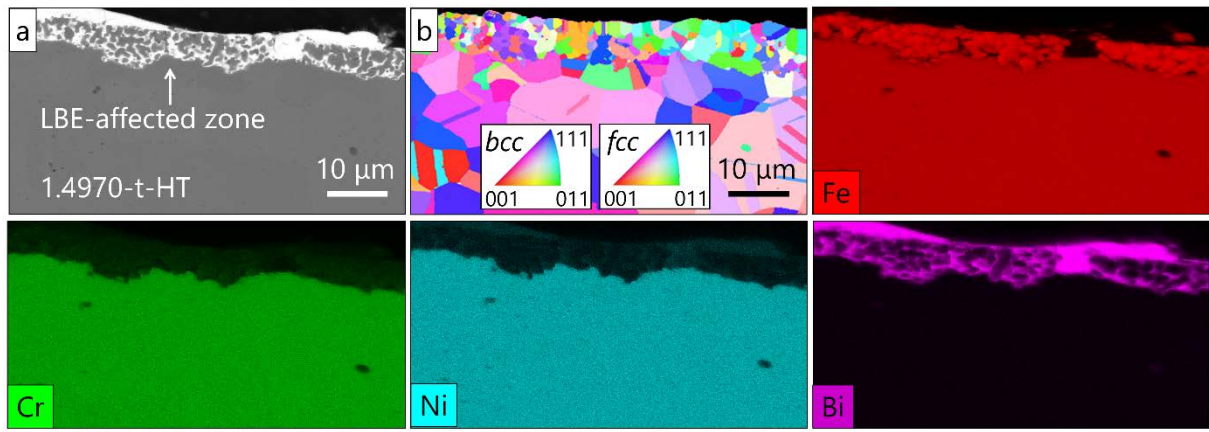
**Fig. 18.** Ferritisation of the dissolution-affected zone in 1.4970-t-HT (test 3). (a) BSE image, and (b) EBSD orientation map and EDS elemental maps of the dissolution-affected area.

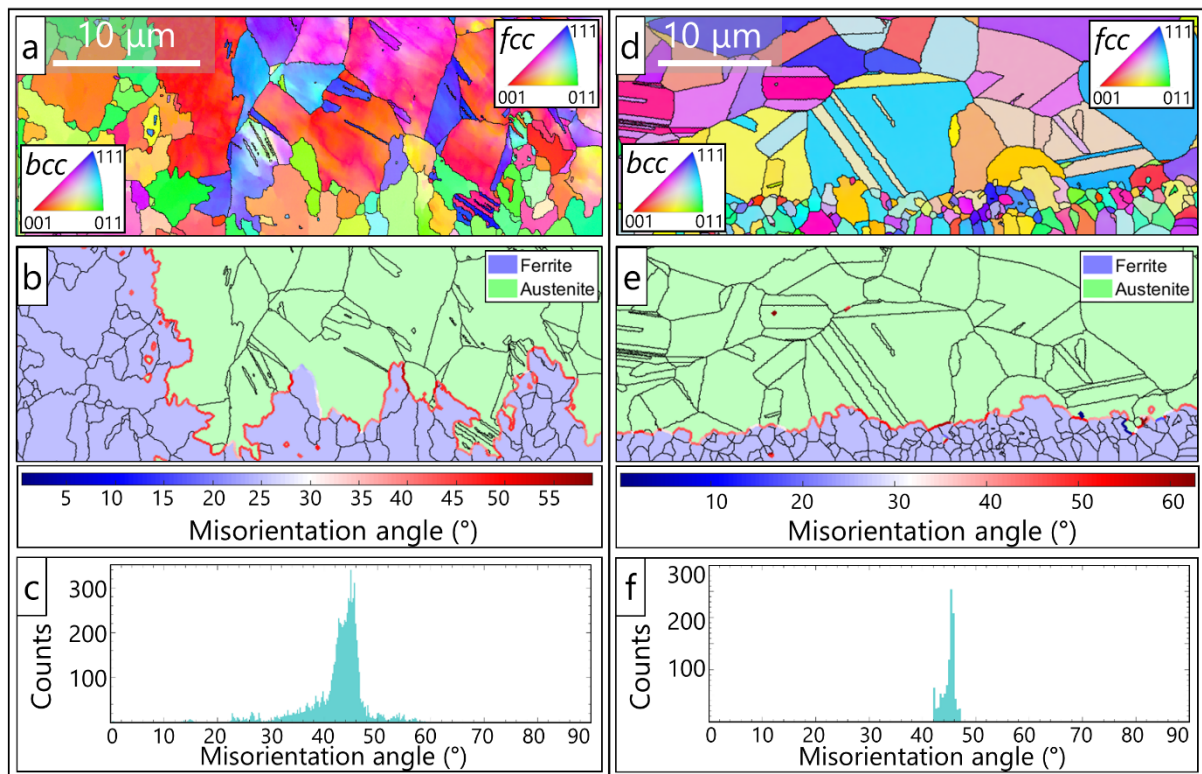
**Fig. 19.** EBSD orientation maps of the ferritized dissolution-affected zone in (a) 1.4970-t-24CW and (d) 1.4970-t-HT, with inverse pole figure colour maps for the *fcc* and *bcc* phases. Corresponding EBSD phase maps showing the  $\gamma/\alpha$  interface misorientation boundary in (b) 1.4970-t-24CW and (e) 1.4970-t-HT. Misorientation angle distributions at the  $\gamma/\alpha$  interface misorientation boundary in (c) 1.4970-t-24CW and (f) 1.4970-t-HT.

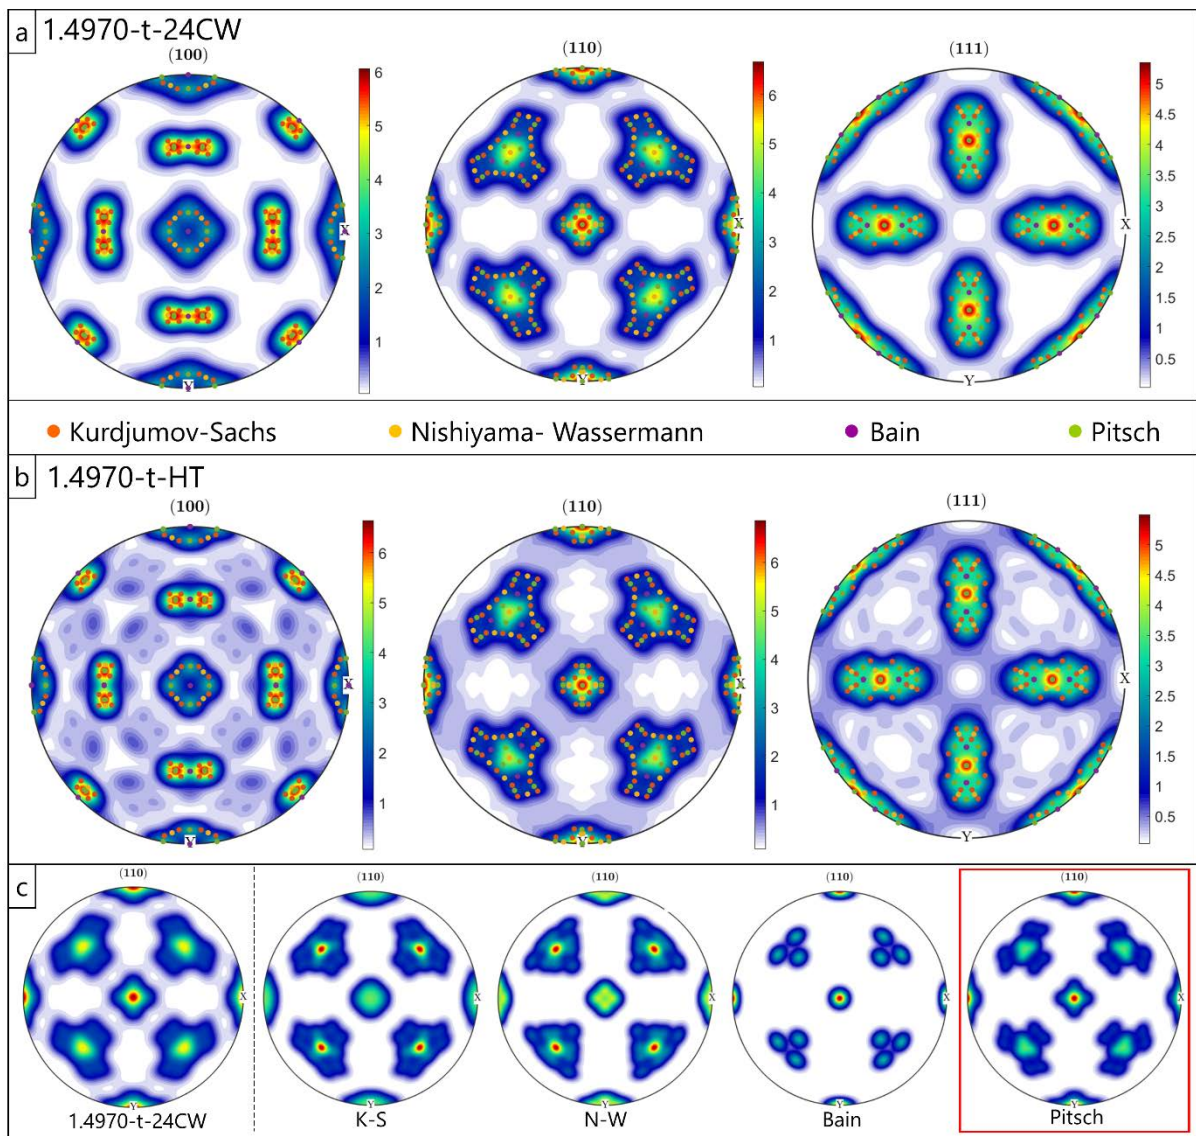
**Fig. 20.** Iso-density pole figures of the experimental data acquired from (a) 1.4970-t-24CW and (b) 1.4970-t-HT, plotted with the theoretical pole arrangements of the four OR models (colour bar in multiples of random distribution unit). (c) Comparison of estimated iso-density pole figures from experimental data with simulated ones, for the different theoretical ORs in (110) pole figures.

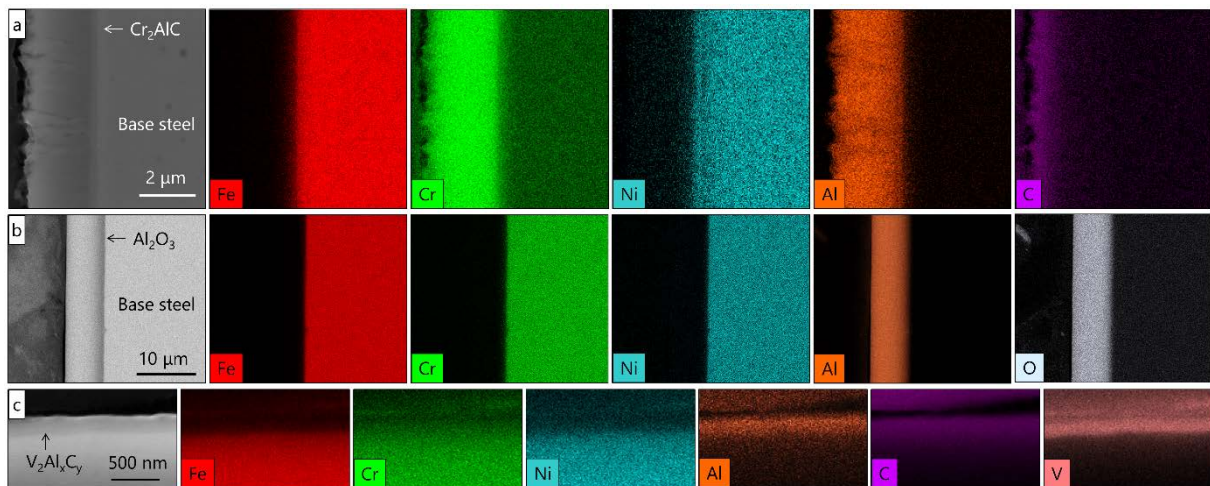
**Fig. 21.** SEM images and EDS elemental maps of as-deposited (a) Cr<sub>2</sub>AlC MAX phase, (b) Al<sub>2</sub>O<sub>3</sub>, and (c) V<sub>2</sub>Al<sub>x</sub>C<sub>y</sub> coatings on 1.4970-t-24CW.

The Al<sub>2</sub>O<sub>3</sub> coating deposited by PLD was compact, defect-free, uniform in thickness (~7 μm), and well-adherent to the 1.4970-t-24CW substrate fuel clad (Fig. 21b). In accordance with prior experience on PLD-deposited Al<sub>2</sub>O<sub>3</sub> coatings [15-19], the as-deposited coating was amorphous, since the only detectable sharp peaks in the acquired XRD patterns (not included) corresponded to the DIN 1.4970 steel substrate. TEM analysis of the Al<sub>2</sub>O<sub>3</sub> coatings confirmed the absence of nanoscale porosity or other defects, showing a low density of nanocrystalline domains (average size: 2-10 nm) that were homogeneously dispersed in an amorphous matrix, as reported earlier [18,55]. This particular microstructure is responsible for the appealing properties of these coatings, including a superior hardness that accounts for high resistance to erosion, scratching or fretting [17,18]. Recently, in-situ nanomechanical testing of free-standing Al<sub>2</sub>O<sub>3</sub> thin (50 nm-thick)

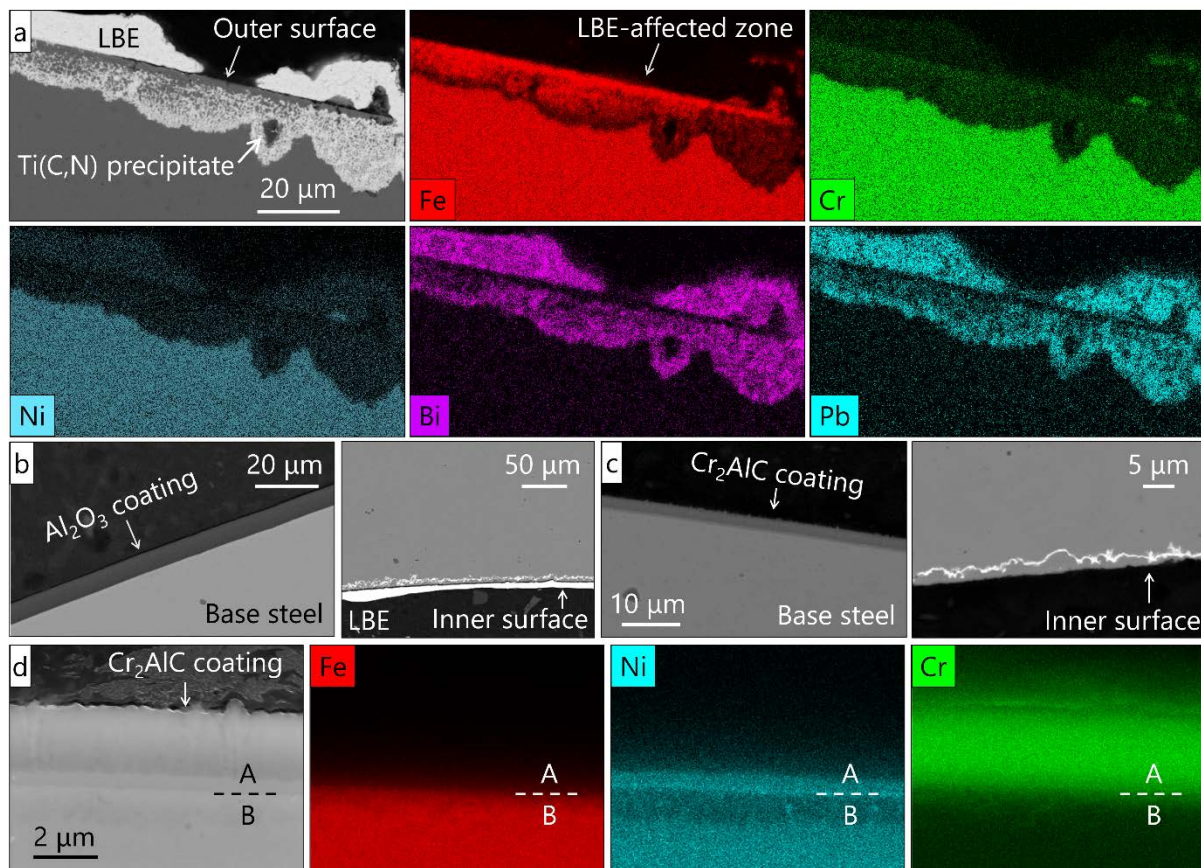
**Fig. 22.** (a) BSE image and EDS elemental maps of the dissolution-affected zone in uncoated 1.4970-t-24CW exposed to LBE for 1000 h in this work. BSE images of the outer tube surfaces in 1.4970-t-24CW coated with (b)  $\text{Al}_2\text{O}_3$  and (c,d)  $\text{Cr}_2\text{AlC}$  after LBE exposure. BSE images of the inner (uncoated) surfaces of the  $\text{Al}_2\text{O}_3$ - and  $\text{Cr}_2\text{AlC}$ -coated tubes are also shown for comparison in (b) and (c), respectively. The bottom part of the  $\text{Cr}_2\text{AlC}$  coating appears to be enriched in Ni, while the top steel layer ( $\sim 1 \mu\text{m}$ ) is Ni-impoverished; the interface between  $\text{Cr}_2\text{AlC}$  coating (A) and steel (B) is indicated by a dashed line.

both as-deposited and exposed  $\text{Cr}_2\text{AlC}$  coating is needed to show whether these assumptions are correct; however, the validity of assumptions fall outside the scope of this work, which assesses the relative protectiveness of candidate anticorrosion coatings against dissolution corrosion. The protectiveness of the  $\text{Al}_2\text{O}_3$  coating was excellent, as expected from previous exposures of PLD-deposited  $\text{Al}_2\text{O}_3$  coating in liquid Pb and Pb-16Li [16,18,57,58]. The low deposition temperature (RT) of the  $\text{Al}_2\text{O}_3$  coating did not cause any compositional modifications close to the steel surface. Since all DIN 1.4970 fuel cladding tubes were immersed open to the LBE bath, the inner steel surface was invariably affected by dissolution corrosion, as shown for the  $\text{Cr}_2\text{AlC}$ - and  $\text{Al}_2\text{O}_3$ -coated 1.4970-t-24CW in Figs. 22b-22c.
