# Fast and Robust Structural Damage Analysis of Civil Infrastructure Using UAV Imagery

**Abstract.** The usage of Unmanned Aerial Vehicles (UAVs) in the context of structural health inspection is recently gaining tremendous popularity. Camera-mounted UAVs enable the fast acquisition of a large number of images often used for mapping, 3D model reconstruction, and as an assisting tool for inspectors. Due to the number of images captured during large scale UAV surveys, a manual image-based inspection analysis of entire assets cannot be efficiently performed by qualified engineers. Additionally, comparing defects to past inspections requires the retrieval of relevant images which is often impractical without extensive metadata or computer-vision-based algorithms.

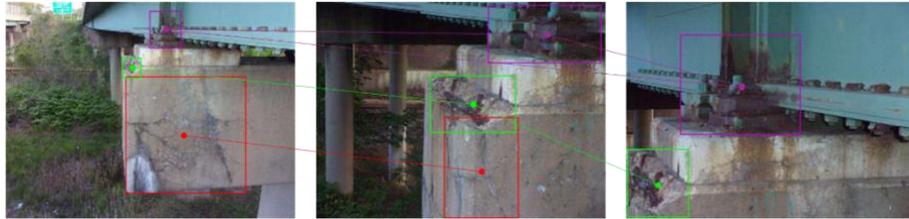
**Fig. 1.** Defect matching example. Different defect types are drawn in different colors. Defect matching is performed between all relevant image pairs. Multiple instances of the same defect were correctly matched across different drone images. Green bounding box: exposed reinforcement defect correctly detected across multiple images. Defect matching is represented by the lines between different occurrences of a specific defect.

The usage of object detection algorithms on the original drone imagery is conceptually simple and straightforward. This approach, however, creates an overabundance of predictions due to the overlap between images, thus leading to inconsistent predictions. Fig. 1 demonstrates predictions on three images. It can be seen that all three images capture the same region of the bridge, and object detection was performed for each image. Due to high data redundancy, the number of predictions will often be overwhelming for inspectors and asset managers to track and maintain. To manage all predictions efficiently, all occurrences of the same defect should be matched, as described in Section 3.2 and visualized by the colored line crossing the images in Fig. 1.

As can be seen in Fig. 1, once defect matching has been established across the image dataset, every defect is associated with all its occurrences. For example, the purple bounding box in Fig. 1 corresponds to corrosion. Without defect matching, three separate occurrences of the same instance of corrosion will be reported. However, using the aforementioned method, all occurrences of the defect are matched across all images capturing it and only a single defect, spanning across multiple images, will be reported.

For example, Fig. 1 demonstrates defect matching of the green defect between the leftmost image and the middle image, and between the middle image and the rightmost image. In this example, the defect matching between the leftmost and the rightmost images failed while the purple defect is matched across all possible image combinations. In this example, the pairwise metric score for the green defect matching will be lower than the chain metric score.

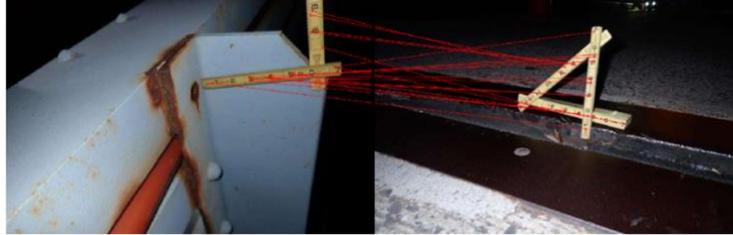
**Fig. 2.** False image retrieval due to a ruler. Red lines indicate feature matching caused by the ruler marks and numbers.

Using each method separately for image retrieval in drone imagery may result in false retrievals, as demonstrated in Fig. 2. Due to the similarity between the rulers, feature matching techniques might yield a false positive prediction of similarity between the images, since the region captured is different. Combining both methods, together with filtering utilities such as rulers, allows us to reduce the number of false matches. We used both similarity scores as follows:

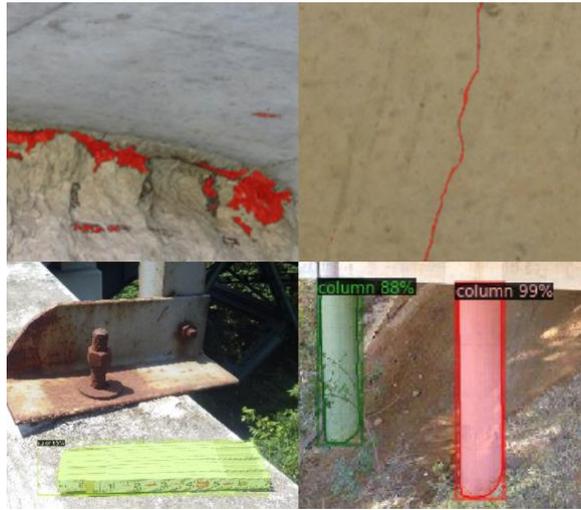
**Fig. 3.** Top row: semantic segmentation of corrosion (left) and cracks (right). Bottom row: instance segmentation of rulers (left) and columns (right).

Evaluation metrics for the instance and semantic segmentation tasks are available in Tables 2,3, respectively. Inference examples are available in Fig. 3. All metrics and visualizations are reported on a testing dataset. As seen in both qualitative and quantitative analysis, we reach high values of accuracy and average precision across multiple defects, elements and utilities.

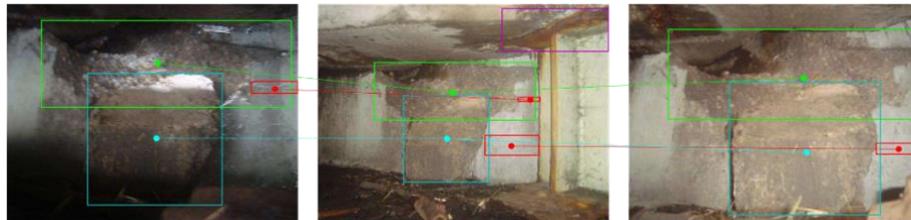
**Fig. 4.** Defect matching example. Different defect types are drawn in different colors. Defect matching is performed between all relevant image pairs. Multiple instances of the same defect were correctly matched across different non-UAV images. Red bounding boxes represent detected cracks. Red lines between images indicate that the defects were matched.

The results for the non-UAV imagery suggest we retrieved nearly 33% of the defect chains automatically. The low recall for the pairwise matches is likely due to the difference between images taken by human inspectors. Such images are often taken from various perspectives, lighting conditions and in different times, thus posing a challenge on both image retrieval algorithms and feature matching. The chain metrics are better than the pairwise metrics in the non-UAV imagery due to positive chains being found using few pairwise matches, and fewer instances of correct chains being split into multiple chains. Automatic non-UAV defect matching is demonstrated in Fig. 4. Note the changes in lighting conditions that is not common in drone imagery.
