Non-destructive Testing of Composite Fibre Materials with Hyperspectral Imaging – Evaluative Studies in the EU H2020 FibreEUUse Project

Index Terms—Hyperspectral imaging (HSI); non-destructive inspection; carbon fibre reinforced polymer (CFRP); H2020.

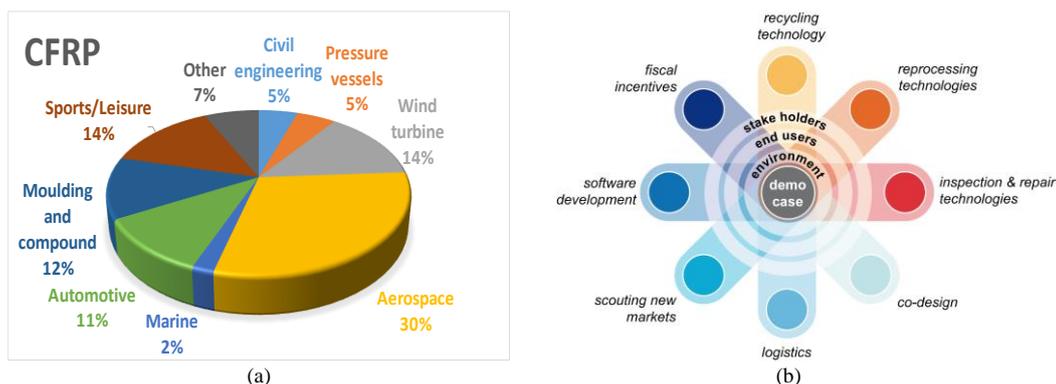
Fig. 1. (a) CFRP production in Europe for different industries, (b) the concept of FibreEUUse, source: <http://fibreuse.eu/>

Due to the unique characteristics of lightweight, high stiffness/strength and damping resistant, carbon fibre reinforced polymer composites (CFRP) has been widely used as structural materials in many areas such as aerospace, marine, transport, sports and civil engineering industries [1, 2], as illustrated in Fig. 1(a). Composites are relatively young and intrinsically durable materials, but composite-based components or products have a limited lifetime, which is usually less than 20-30 years, e.g. 20-25 years for a wind turbine [3], and ~10 years on average for recreational boats and car bodies [4]. Considering the continuously and quickly rising demand for composites in industrial manufacturing, correct waste management of End-of-life (EoL) CFRP becomes urgent and vital. Landfilling of EoL composites is still the most popular waste management strategy, which is a

composites, see in Fig. 1(b), through the integration of innovative remanufacturing technologies.

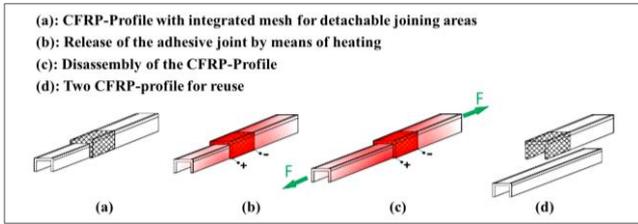
Fig. 2. Illustration of separation of bonded parts.

During the remanufacturing process, the EoL products will be disjointed into individual components (Fig. 2), which are then refurbished and reused in new products afterwards. As one of the most important modules in this workflow, non-destructive testing is crucially required to provide a reliable and efficient inspection to assess the condition of the composites in the remanufacturing chain.

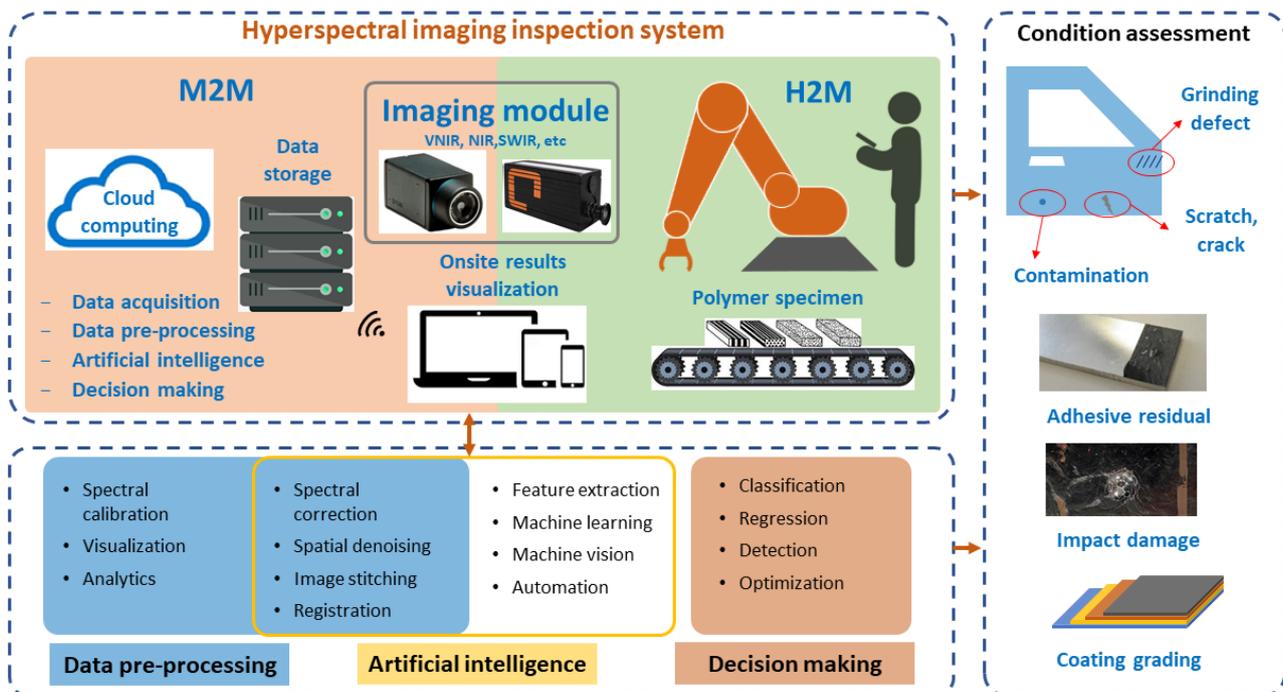
Fig. 3 depicts the concept of the hyperspectral imaging inspection system for the (re)manufacture industry, which is composed of three core modules, i.e. Imaging module, Machine-to-Machine (M2M) interaction Module, and Human-to-Machine (H2M) collaboration module. In the Imaging module, the optical sensors such as visible (VIS), near-infrared (NIR), and short-wave infrared (SWIR) hyperspectral cameras can provide a continuous spectral information over a certain spectral range, along with a good spatial resolution. M2M can actually provide a continuous information flow between the imaging devices and computer

Fig. 3. Hyperspectral imaging inspection system for condition assessment in manufacturing and remanufacturing sectors, where M2M and H2M denote Machine-to-Machine and Human-to-Machine interactions, respectively.

vision algorithms for data processing and analysis. Hereby, the sensors, onsite data acquisition machine, offsite data storage devices and cloud data processing units can connect and communicate to each other via the industrial IoT (mostly based on wireless network). In addition, H2M collaboration is also a very important module. Here, human workers, hyperspectral cameras and the specifically designed compliant robots can work together in carrying out complex and unstructured inspection tasks at the remanufacturing and repair production lines.

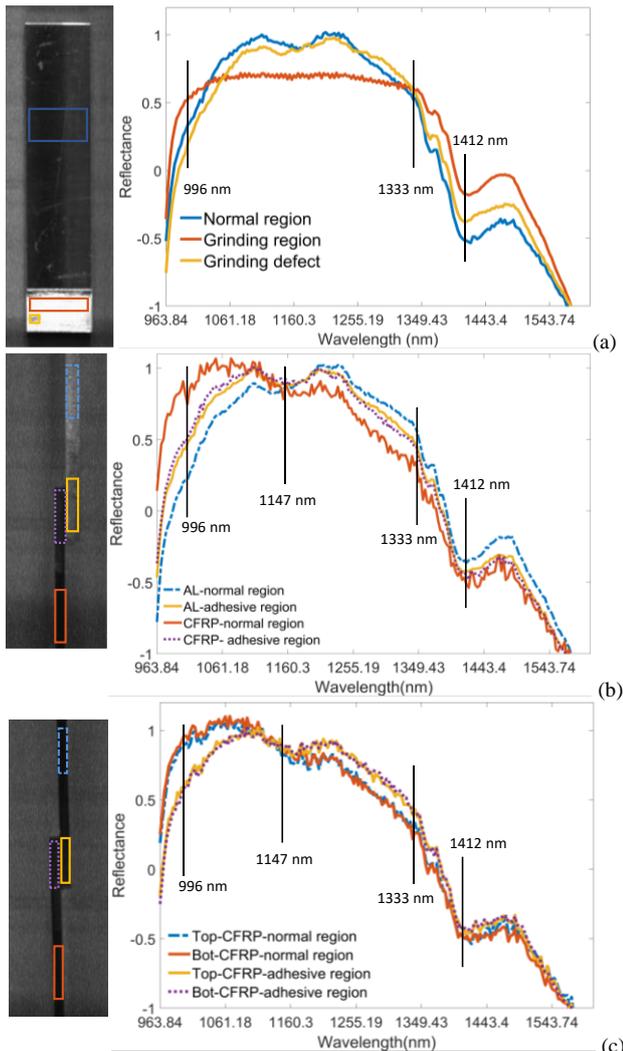
Fig. 4. Normalized spectra of different regions on the Al (a), CFRP+Al (b), and CFRP+CFRP (c). To the left are the colour images and to the right are the averaged spectrums from selected ROIs.

After data acquisition, two pre-processing steps are carried out, which include spectral calibration (Eq. (1)) and spectral correction (Eqs. (2-5)). To visualise the spectral characteristics of the surface conditions of the three samples, an image at the wavelength of 1267 nm is shown in Fig. 4, where the average spectral profiles over the whole bands of the selected regions of interest (ROI) are also plotted for comparison in Fig. 4(a-c).

For the Al sample, three regions, i.e., normal region, grinding region and grinding defect region, are compared with different spectrums. For the normal region, the intensity is low as the surface is furnished and has a relatively lower reflectance. The lowest intensity on its normalised reflectance can be found between 1333nm and 1600nm. For the grinding region, it has high reflectivity, which leads to high reflectance and appears white on the colour image. Its normalised reflectance has the highest intensity between 1333nm and 1600nm, with a standard deviation lower than that of the other two regions in the range of 996-1333nm. Due to poor laser treatment, some defects are caused in the grinding region. The defect region has a lower reflectivity than the other grinding region, which looks grey on the colour image. Its normalised reflectance is in between of other two regions in the spectral range of 1333- 1600nm. Although its profile has the similar

trend to the normal region within 996-1333nm, there are still some gaps between the two spectra, which shows their difference. Therefore, it can be concluded that NIR spectra is able to differ the furnished (normal) region, grinding region and grinding defect region.

In Fig. 4(b), four representative regions are highlighted in differently coloured boxes on the colour image. The blue and yellow boxes denote the normal region and the adhesive region on the Al side, respectively. The red and purple boxes are the normal region and the adhesive region on the CFRP side, respectively. In the colour image, it can hardly recognise the adhesive residual on the materials. However, apparent difference between the normal region and the adhesive region can be seen on the spectral profile. As seen in Fig. 4 (b), the wavelength 1147nm is an important turning point: the Al-normal region (blue line) has a lower reflectance before 1147nm but higher reflectance afterward than the Al-adhesive region (yellow line). On the contrary, opposite reflectance trends of the CFRP- normal region (red line) and the CFRP-adhesive region (purple line) are shown. In addition, the spectral profile of the Al-normal region (blue line) and the CFRP normal region (red line) can be well distinguished. The Al-adhesive region and the CFRP-adhesive region have similar spectral reflectance throughout the whole wavelength. These findings can validate the two capabilities of HSI, i.e., material identification and detection of adhesive residual.

Similarly, Fig. 4(c) presents four spectral profiles of two pairs of CFRP samples, which include two adhesive regions (yellow and purple boxes) and two normal regions (red and blue boxes). As can be seen, in each pair of samples, the spectral profiles show a high degree of similarity. However, the spectral profiles from the two pairs are much different, which indicate the inter-class dissimilarity between the normal and adhesive regions. Again, this finding also validates that HSI can potentially characterise different components/materials. Thus, it is tested for distinguishing the adhesive residual in this study, which can benefit the laser treatment during the disassembly stage and provide useful information for the grading of adhesive cleaning and other surface conditions.

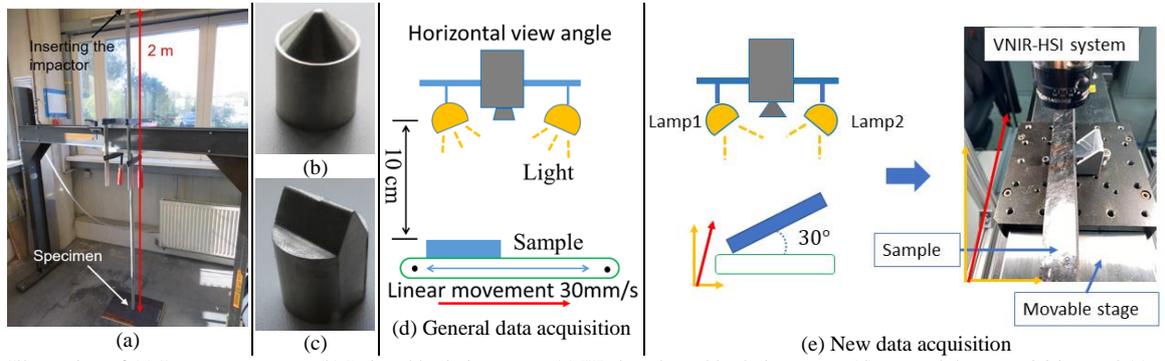
Fig. 5. Illustration of (a) Impact test setup, (b) Pointed body impactor, (c) Wedge-shaped body impactor, (d) general data acquisition and (e) new data acquisition in the second case study.

[23]. For the BMC process, it is usually done by applying pressure and heat to the mould where a bulky mixture of fibres, resin paste and fillers is placed [24]. In our experiment, the first sample is manufactured via RTM using endless carbon fibre textile and epoxy matrix. The second sample is produced via BMC using new carbon long fibres, i.e., 45% fibre content with 25mm fibre length. The third sample is also manufactured by BMC using thermal recycled carbon long fibres i.e., 45% fibre content with 25mm fibre length. For a compact presentation, the three samples are named by RTM, BMC and rBMC respectively in the remaining paper. The experimental setup consists of a down pipe with a height of 2 meters. Each falling body has a weight of 607 g, which results in an impact energy of 11.9 joule. The impact test setup and results of the impact tests are shown in Fig. 5.

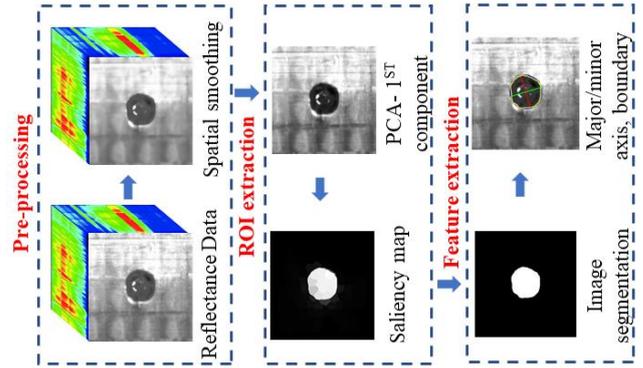
Fig. 6. Illustration of image processing framework.

Accurate distinguishing the types of damage is always of interest for determining the suitable repairing strategy for the damaged fibre composites. As such, an integrated HSI based damage detection system with machine learning and computer vision technologies is proposed. This is a multi-stage image processing framework (Fig. 6) that is composed of three key modules, i.e., pre-processing, saliency detection and feature output. It can detect the damaged regions and calculate the roundness (R_d) and rate of the major axis vs. the minor axis (RMM), see in Eqs. (10-11), as detailed below.

After data acquisition, two pre-processing steps are carried out, which include spectral calibration and spatial denoising, following the same procedure defined in Eq. (1) and Eqs. (6-9), respectively. Afterwards, ROI extraction is implemented from the first principal component of the hypercube through a saliency detection module [25] for generating a gray-scale saliency map of the damaged regions.

In the feature extraction step, a hard threshold is applied to convert the saliency map to a binary image, where the ROI will be highlighted as white pixels with the background in black. The boundary of ROI can be approximated by an ellipse with the associated parameters determined, including

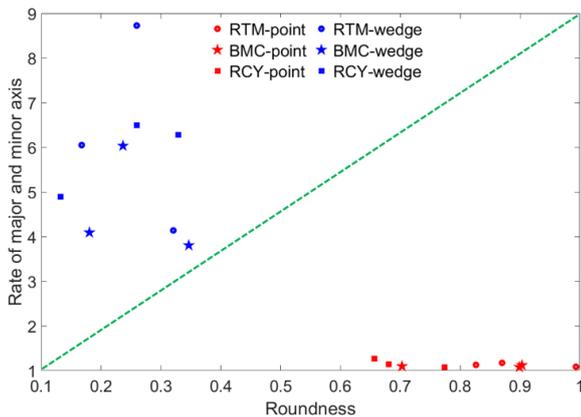
Fig. 8. Scatter plot of damage features.

After damage detection, the representative features of the damage regions i.e., roundness and the RMM can be extracted and plotted in Fig. 8 for visual comparison. With satisfied measures of the precision and recall, the RMM values for point body damage are consistently close to 1. The roundness varies from 0.65 to 1, and this is because the shape formed by the damaged region is not always round. For the wedge-shape body damages, due to a high precision and a low recall, both the RMM and roundness have large variance, where $RMM \in [3.8, 8.8]$ and $roundness \in [0.13, 0.35]$. However, the features of these two damages are still very distinguishable, which again shows the capacity of HSI in NDT on the fibre material, and its potential for facilitating smart decision-making of requested repairing strategies.

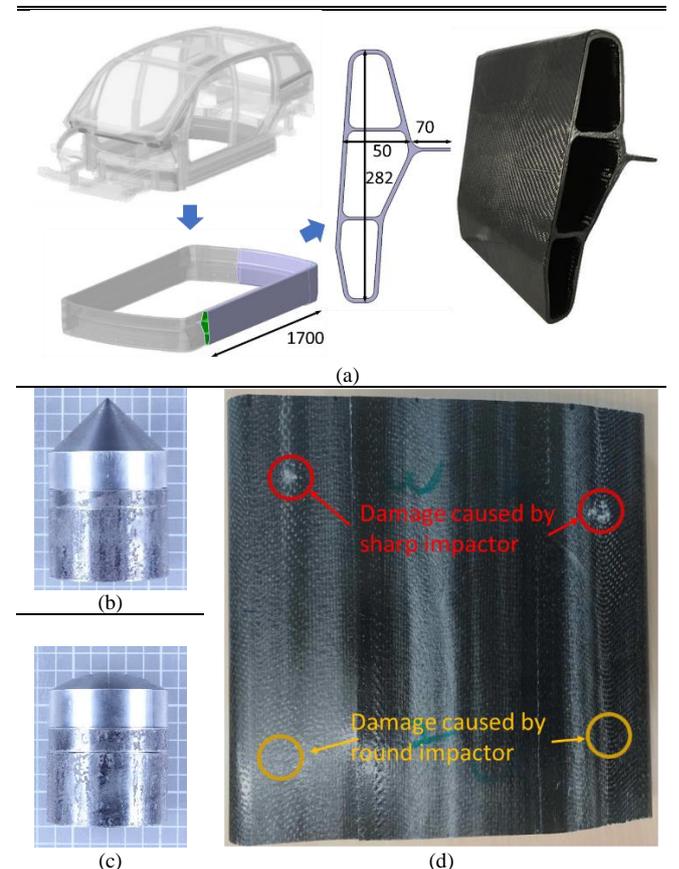
Fig. 9. Illustration of the body structure (a), sharp impactor (b), round impactor (c), and sample surface with damages (d), all dimensions in mm.

In the third study, a large automotive body structure sample that is made of UD-fibre (0°), biaxial fabric ($0^\circ/90^\circ$, $-45^\circ/45^\circ$) and a unsaturated polyester resin is damaged by a sharp impactor and a round impactor (Fig. 9). The experimental setup consists of a down tube with a height of 5.6 meters. The falling body has a mass of 2kg, which results in an impact energy of 109.8 joule. As seen in Fig. 9(d), the damage caused by the sharp impactor is noticeable, but the damage caused by round impactor is almost invisible.

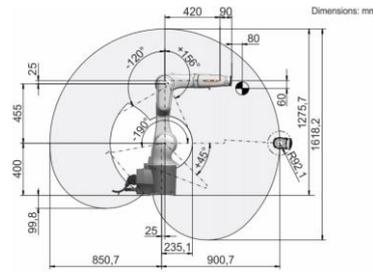
Fig. 10. Cobot system in the lab environment, (a) robot characteristics for KUKA KR06 R900, (b) working envelope with dimensions comprised during operation, (c) laboratorial cobot workplace.

In addition to the two HSI cameras, a robotic manipulator, the KR06 R900 [26] from KUKA is used in this case study, mainly for its universality in many industrial applications.. The robot is a 6-axis serial manipulator, with characteristics and working envelop shown in Fig. 10 (a) and (b).The real setting in the lab environment is shown in Fig. 10 (c), where the large automotive body structure is fixed to a holder mounted on the robot. The working distance between the camera and the sample surface is 25 cm. The movement of the robot is manipulated by an accompanying controller. During the camera scanning, the robot will drag the sample moving along Axis2 with a speed of 16mm/s. A laptop will record the hyperspectral data into the 'ENVI' format. The proposed system can also be implemented with any other

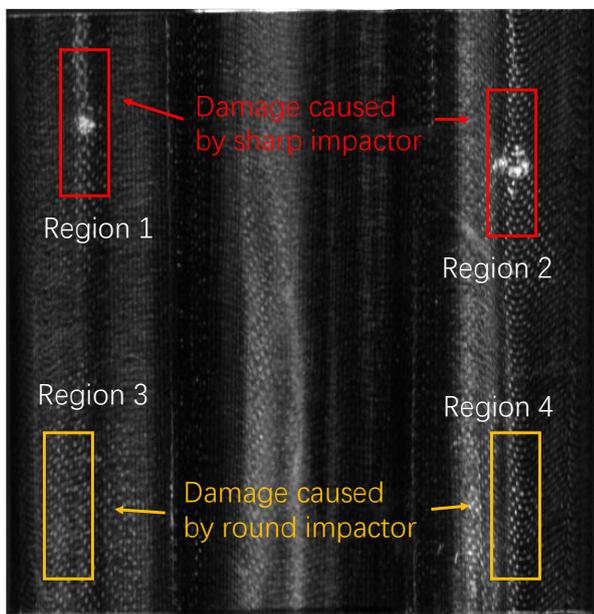
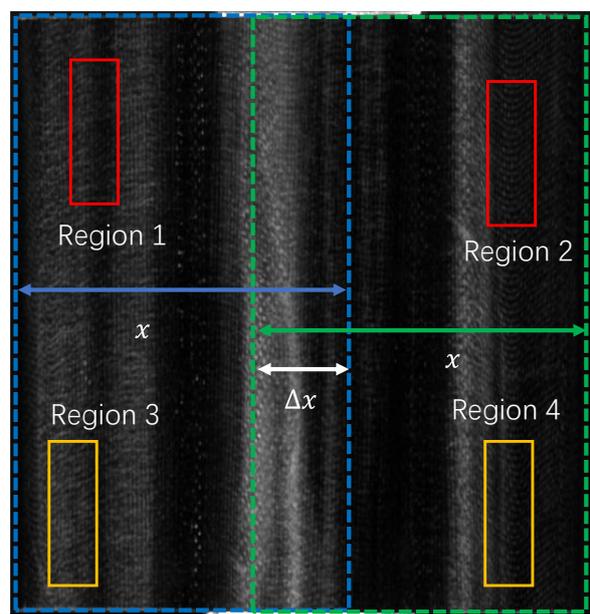
Fig. 11. Visualized 1st PCA component of sample front surface with damage (a) and without damage (b).

For visualisation purpose, image stitching is first applied to each HSI band, before conducting the PCA on the hypercube to extract the most representative features from the data. The 1st PCA component is shown in Fig. 11.

In Fig. 11(a), regions #1 and #2 highlight damages caused by sharp impactor, and regions #3 and #4 highlight damages caused by round impactor. In Fig. 11(b), regions #1-#4 are the corresponding healthy regions in Fig. 11(a). For the sharp impactor, it can break the fibre into the contacted region and deform the fibre in the surrounding regions. Therefore, it will make the damaged surface more sensitive to the light and

produce higher reflectance. As seen in Fig. 11, compared with healthy regions, impactor-contacted regions show a bright colour, with many white dots formed on deformed regions in the PCA domain. For round impactor, it won't break the fibre but will deform it in a larger area. As a result, there are only sparse white dots showing in the PCA domain.

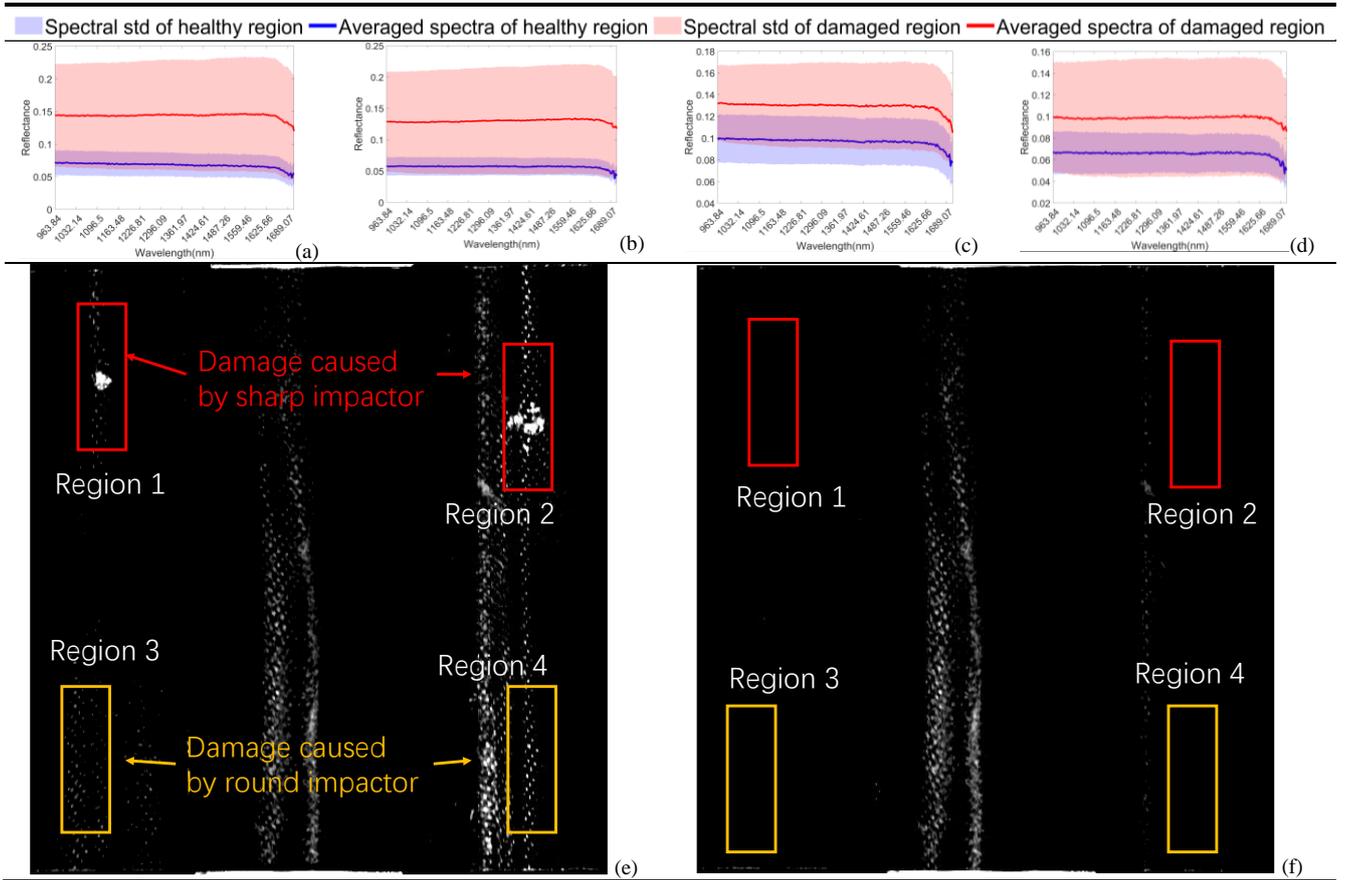
Fig. 12. Averaged spectral profile (a-d), and enhanced feature map of damaged regions (e) and healthy regions (f).

To further highlight the difference between the damaged regions and healthy regions. We present averaged spectral profile for those regions in Fig. 12(a-d), where the standard deviation (std) is also plotted using shaded area. As the impactor will break and/or deform the fibre and change the reflectance of the neighbouring areas, both the reflectance and spectral standard deviation of the damaged regions are always higher than those of the healthy regions. By further suppressing the intensity of the background pixels, we can enhance the features in the PCA domain. As shown in Fig. 12, the pixel intensity in the healthy regions (Fig. 12(f)) appears darker than the damaged regions (Fig. 12 (e)) after the background suppression. On a different note, the damaged regions show bright colour on the feature map, which indicates obvious defects on the sample surface, again validates the efficacy of HSI in NDT of CFRP materials.
