# A Multi-Stage model based on YOLOv3 for defect detection in PV panels based on IR and Visible Imaging by Unmanned Aerial Vehicle

*Keywords:* PV panel inspection, hotspots, UAV, detection, YOLOv3.

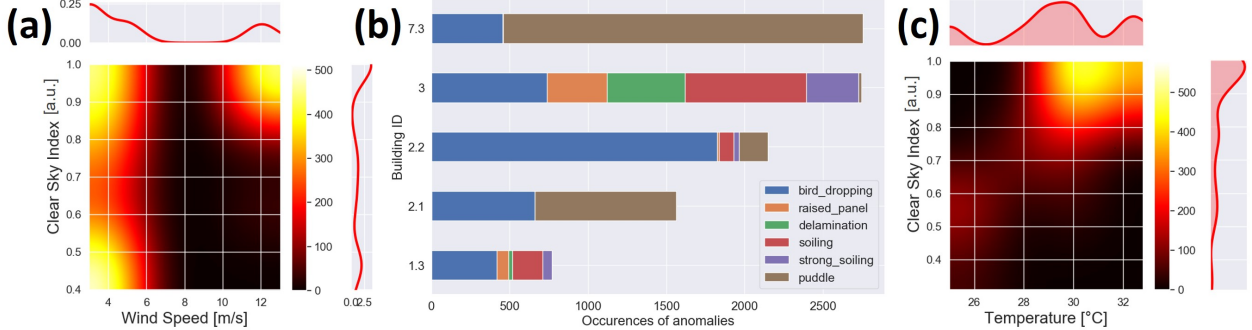
Figure 2: 2D distribution of aerial images in the plane (a) (wind speed, CSI) for Plant\_Sicilia and (c) (ambient temperature, CSI) for Plant\_Campania, respectively, where CSI is the ratio between the measured global horizontal irradiance and the clear-sky horizontal irradiance. (b) Number of occurrences of defects for Plant\_Campania grouped by building and defect class.

Similarly, inspections on Plant\_Campania were realized in summer 2018 with air temperature higher than 26 °C and usually in condition of high solar irradiation (Fig. 2(c)). Also, flights were scheduled on different buildings characterized by various levels of scene brightness, soiling and bird dropping severity, dust deposition due to dirty rainfall, stagnant water, as well as panel oxidization due to damaged adhesion to the building roof (Fig. 2(b)).

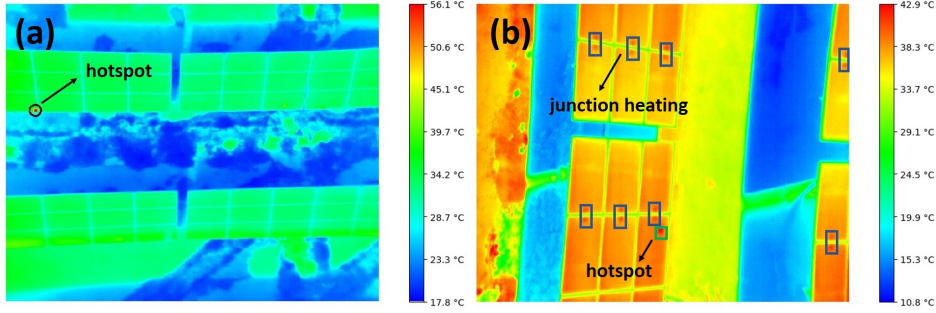
Figure 3: (a) Hotspot example highlighted by a black circle; (b): examples of hotspot (green rectangle) and junction box (blue rectangle) instances. The colorbar denotes the scene temperature expressed in units of Celsius degree. The PV system under consideration is Plant\_Sicilia.

Six flights were executed collecting around 500 RGB images for each. In particular, we selected and manually annotated 2038 radiometric LWIR images all of size 640x512 for hotspot detection corresponding to different UAV flights and including PV panels with different shape, size, and orientations. Typically, at diurnal hours when UAV flights are performed, PV modules are often 15-20 °C warmer than ground, which is always present in the background of the image (Fig. 3). Hotspots are even hotter and appear often as a red region over a cold blue background, because the defective cells are negatively biased and photovoltaic effect is replaced by heat energy dissipation. In addition, local heating with respect to neighborhood normal modules may vary from few Celsius degrees (Fig. 3(b)) to tens of Celsius degrees (Fig. 3(a)).

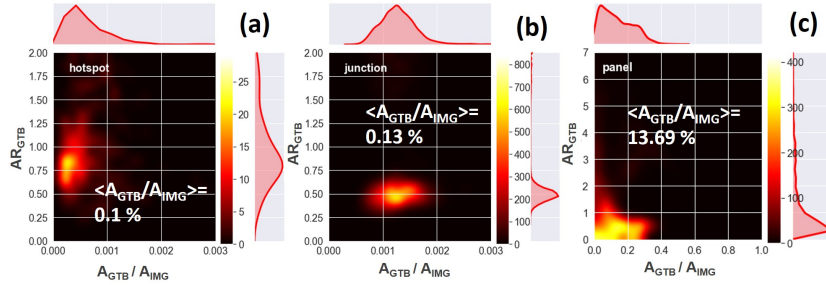
Figure 4: 2D distribution of GTBs of (a) hotspots (b) junction boxes and (c) PV panels in the plane  $(A_{GT B} / A_{IMG}, AR_{GT B})$ , where  $A_{GT B}$  is the GTB area normalized with respect to the image area  $A_{IMG}$ ; and  $AR_{GT B}$  is the GTB aspect ratio, i.e. the ratio between GTB width and height. The marginal distributions are also reported as shaded red areas. The plant under consideration is Plant\_Sicilia.

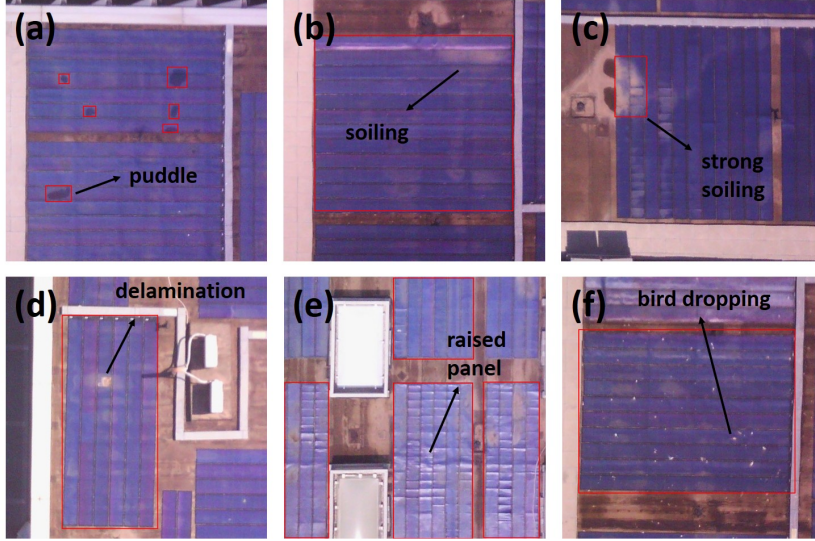
Figure 5: Examples of GTBs (red rectangles) for the defect classes of Plant\_Campania: (a) puddle, (b) soiling, (c) strong soiling, (d) delamination, (e) raised panel and (f) bird dropping.

Fig. 5 shows some examples of GTBs for the mentioned classes. As can be seen, the defects were annotated either at instance (puddle, strong soiling) or panel (soiling, delamination, raised panel, bird dropping) level depending on the localization of their features over well-defined and delimited areas or their irregular distribution over the whole PV panel, respectively.

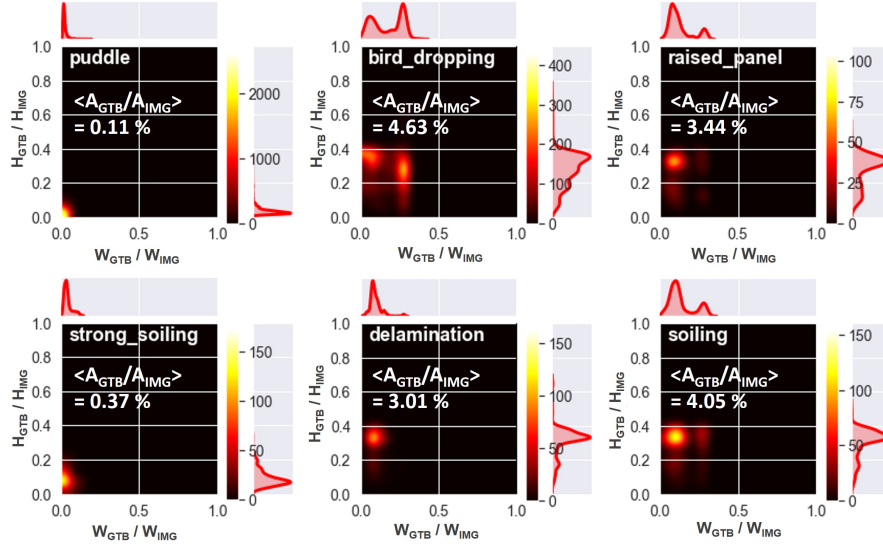
Figure 6: 2D distribution of GTBs in the plane  $(W_{GTB}/W_{IMG}, H_{GTB}/H_{IMG})$  for each defect class, where  $W_{GTB}$  ( $H_{GTB}$ ) is the GTB width (height) and  $W_{IMG}$  ( $H_{IMG}$ ) is the image width (height). The marginal distributions are also shown as shaded red areas. The PV system under consideration is Plant\_Campania.

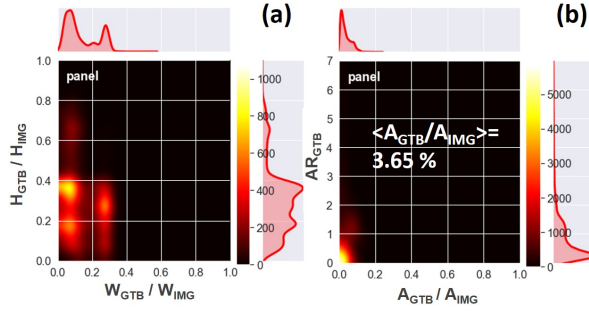
Figure 7: 2D distribution of GTBs of PV panels in the plane (a)  $(W_{GTB}/W_{IMG}, H_{GTB}/H_{IMG})$  and (b)  $(A_{GTB}/A_{IMG}, AR_{GTB})$  where  $W_{GTB}$  ( $H_{GTB}$ ) is the GTB width (height),  $W_{IMG}$  ( $H_{IMG}$ ) is the image width (height),  $A_{GTB}$  ( $A_{IMG}$ ) is the GTB (image) area and  $AR_{GTB}$  is the GTB aspect ratio. The marginal distributions are also shown as shaded red areas. The PV system under consideration is Plant\_Campania.

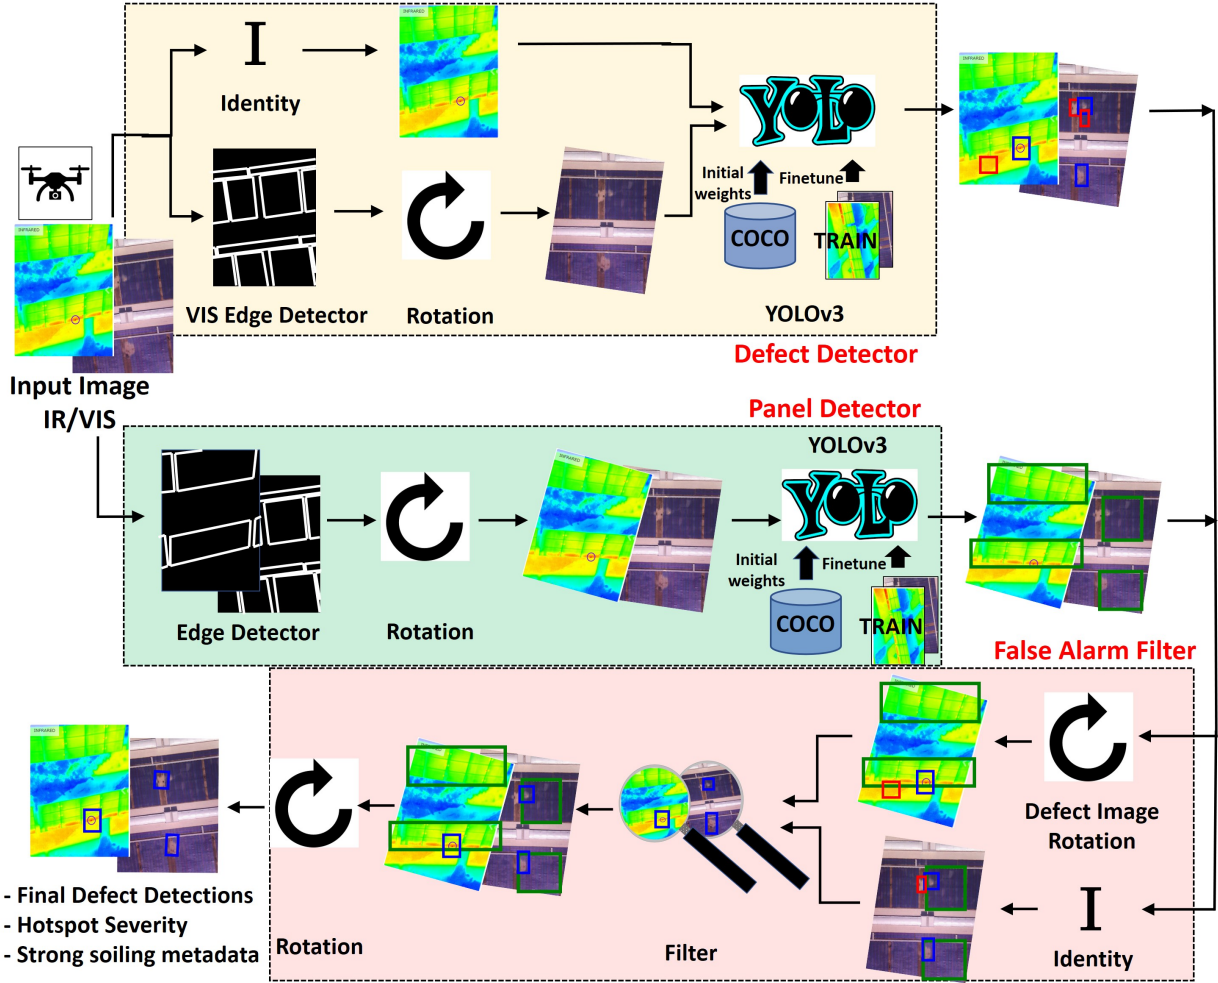
Figure 8: Pipeline of the proposed model. The input image (either IR or VIS) is fed into the Panel and Defect detectors based on YOLOv3 architecture and Computer Vision. The resulting outcomes are processed by the False Alarm Filter, which screened out all defect proposals (red rectangles) outside the detected panel areas (green rectangles), returning only defects inside (blue rectangles) expressed into the reference system of the input image. In addition, in case of IR images the defect severity and the corresponding suggested maintenance action are provided, whereas for VIS images the strong\_soiling coverage is returned.

The model pipeline is depicted in Fig. 8: the input image captured by UAV is fed into the Panel and Defect detectors, both based on a sequence of Computer Vision techniques, geometrical transformations and Artificial Intelligence based on YOLOv3 deep neural network (Fig. 9). Since YOLOv3 works with rectangular bounding boxes, in case of ground truth delimiting the whole panel area, performances are better if the edges of the panels are aligned to the edges of the image. Consequently, for panel detection, and also for defect detection in VIS images where ground truths for soiling, delamination, raised panels and bird dropping extend over the whole panel rectangles (Fig. 5), the image is preliminary rotated to maximize

localization skills by first detecting the linear edges of the panels and then rotating it according to the identified predominant directions. Then defects and panels are detected on the resulting images by using YOLOv3.

Finally the outcomes are ingested into the False Alarm Filter which operates as following: (i) it expresses defect proposals into the reference system of panels (actually the rotation is necessary only for IR images), (ii) it discards the defect proposals (red rectangles) detected outside the proposed panel areas (green rectangles) which can be due to sun's glare or other external agents and (iii) it returns only the defects identified inside the panels (blue rectangles) by anti-transforming them into the original reference system of the input image. Details about the building blocks of the model are provided in the following sections.

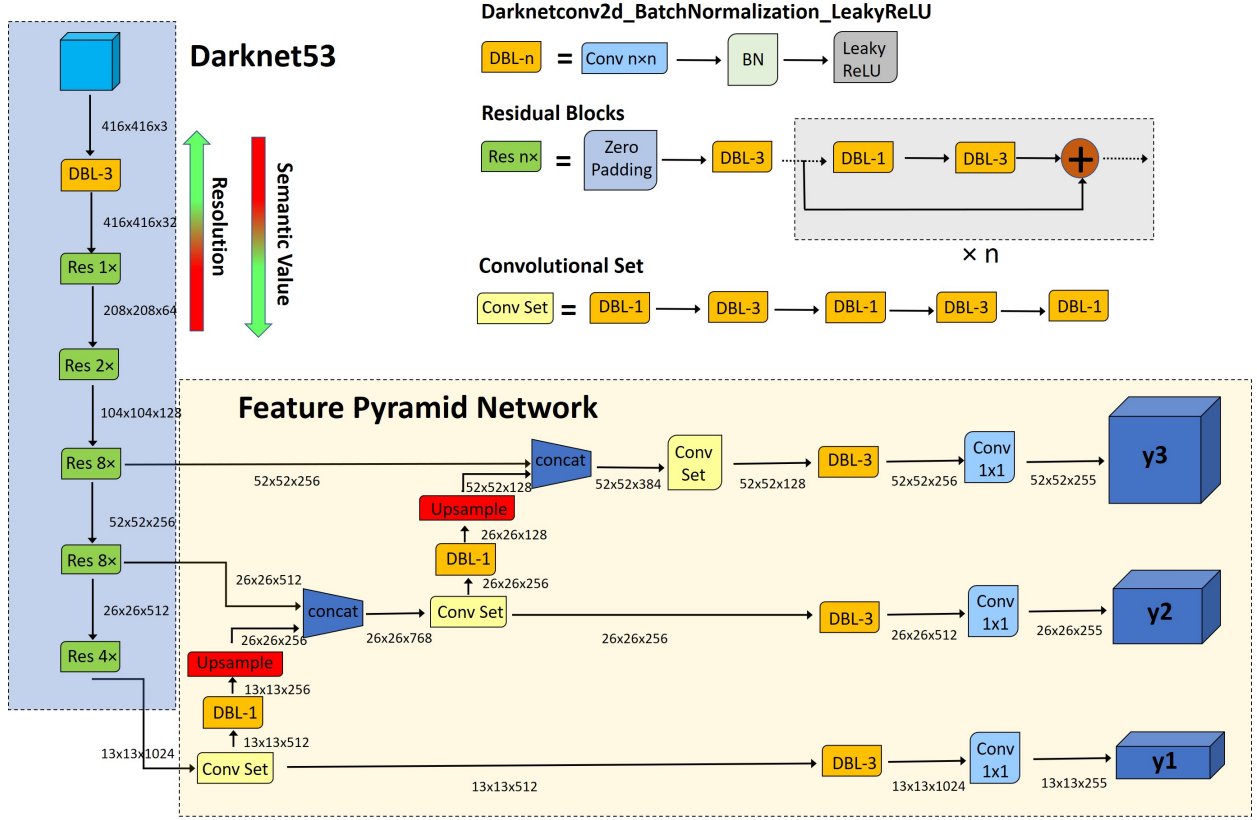
Figure 9: YOLOv3 architecture composed by the backbone Darknet-53 and the Feature Pyramid Network making multi-scale object prediction.  $\oplus$  denotes the element-wise summation operation, whereas "concat" corresponds to lateral connection along depth. In the figure we assume  $C=80$  classes (COCO dataset [45]).

YOLOv3 [37] is a single-stage end-to-end network composed by a backbone and a head subnet (Fig. 9). The backbone is represented by the Darknet-53 network and is responsible for features extraction from input image. In order to expand the receptive field and get more contextual information useful for detecting

small targets, it applies downsampling based on strided convolutions. To overcome the problem of vanishing gradients with the increase in network depth and extract more robust features, it implements skip connection by using a sequence of residual units [39].

The head subnet is built on top of the backbone and makes prediction at three different scales  $13 \times 13$ ,  $26 \times 26$  and  $52 \times 52$  by means of a Feature Pyramid Network (FPN) [40]. FPN alleviates the problem of detecting objects of different scales by implementing feature fusion via a top-down pathway and lateral connections between feature maps of different resolutions. Indeed deep low-resolution features bring a high semantic value, but the position information of the corresponding feature maps is weakened, resulting more suitable for detecting large objects due to the large receptive field. On the other hand, earlier high-resolution features have semantically low value and are better for detection of smaller objects due to limited receptive field. FPN makes YOLOv3 more accurate than Single Shot Detector [41], where detection is done separately on feature maps having different scales, and competitive with double-stage detectors, such as

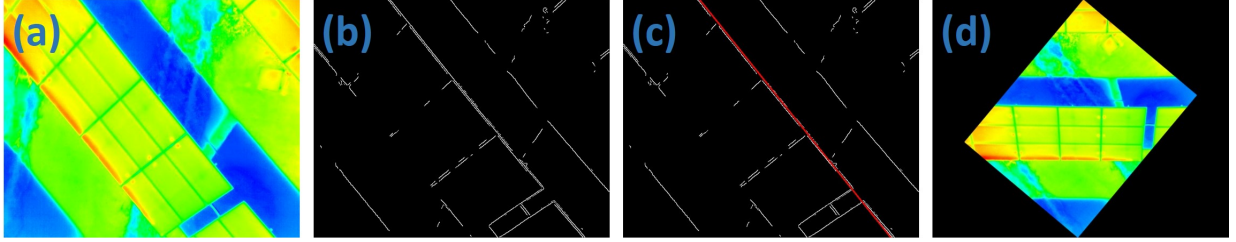
Figure 10: Image rotation methodology: (a) input image, (b) edge detection based on Canny detector, (c) predominant linear edge (red) identified by Hough transform, (d) rotated image.

We adopted the well-known Canny edge detector [42] which represents a good compromise between accuracy, computational time and algorithm complexity. It is a multi-stages algorithm composed by the following steps:

- (i) *Noise reduction*: a 5x5 Gaussian filter is exploited to smooth the input image
- (ii) *Computation of the image intensity gradient*: a Sobel operator is applied to the smoothed image to get the first derivative of the image intensity in both horizontal and vertical directions, i.e.  $G_x$  and  $G_y$ , respectively. From the two resulting images, edge gradient magnitude  $G$  and direction  $\alpha$  for each pixel are computed as follows:

The two thresholds above  $G_{min}$  and  $G_{max}$ , which mostly influence the number of detected edges, were set empirically by a trial and error approach on training set to default values of 450 and 550, respectively. Moreover, to face the issue of missing edges in some circumstances, we designed an iterative in-house algorithm that dynamically changed the thresholds depending on the input image. In brief, starting from the values above, the number of detected edges  $N_{edges}$  are counted and, if  $N_{edges} < N_{thr}$ , then  $G_{min}$  and  $G_{max}$  are decreased by 50, and the edge detection is repeated. The procedure is stopped once a suitable number of pixels set to 1 is achieved, i.e.  $N_{edges} \geq N_{thr}$ . Finally, to set the optimal value of  $N_{thr}$ , we apply the inflection point (Elbow) method on the distribution of sorted increasing values of  $N_{edges}$  computed on training images by using default values for  $G_{min}$  and  $G_{max}$ . We found  $N_{thr} = 1000$ .

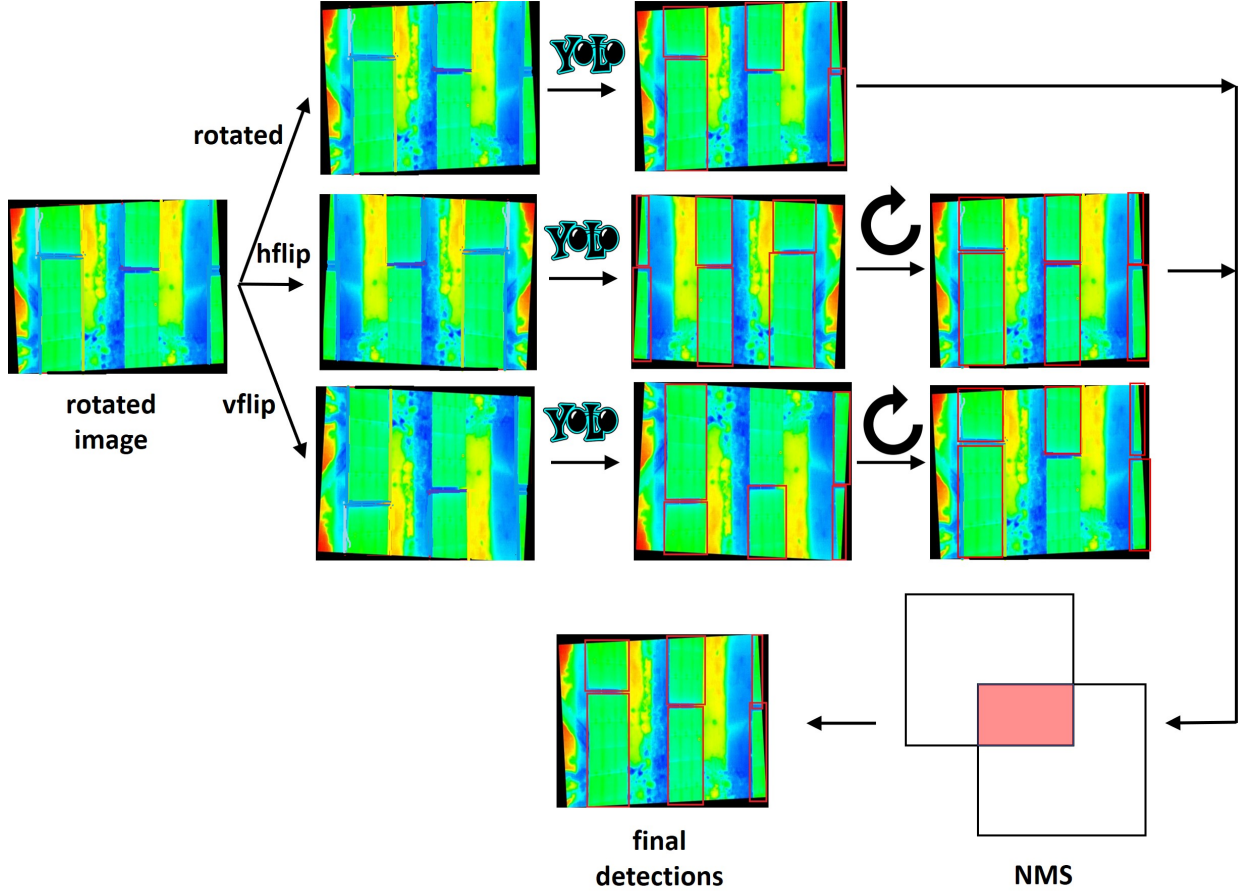
Figure 11: Test Time Augmentation (TTA) workflow: the initial rotated image is augmented by horizontal and vertical flip, then inference based on YOLOv3 is applied on the three images. Finally detections are expressed in the same reference system, pruned by means of NMS and returned.

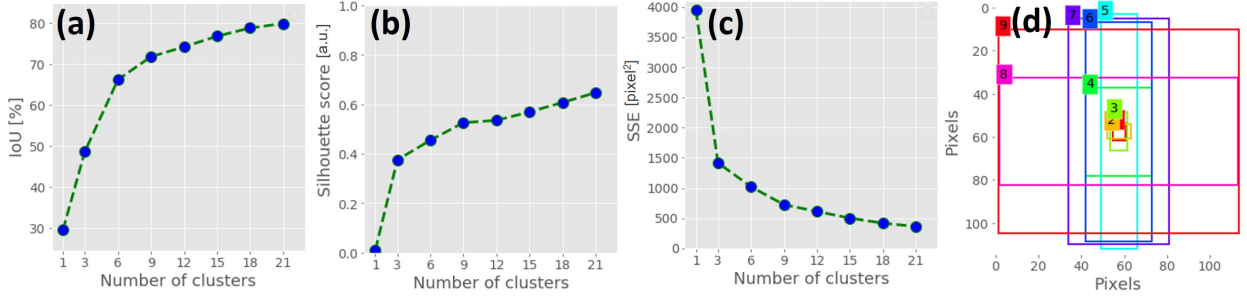
Figure 12: k-means clustering applied to training dataset of defect detector for Plant\_Campania: (a) IoU, (b) silhouette and (c) SSE as a function of number of clusters. (d): resulting anchors.

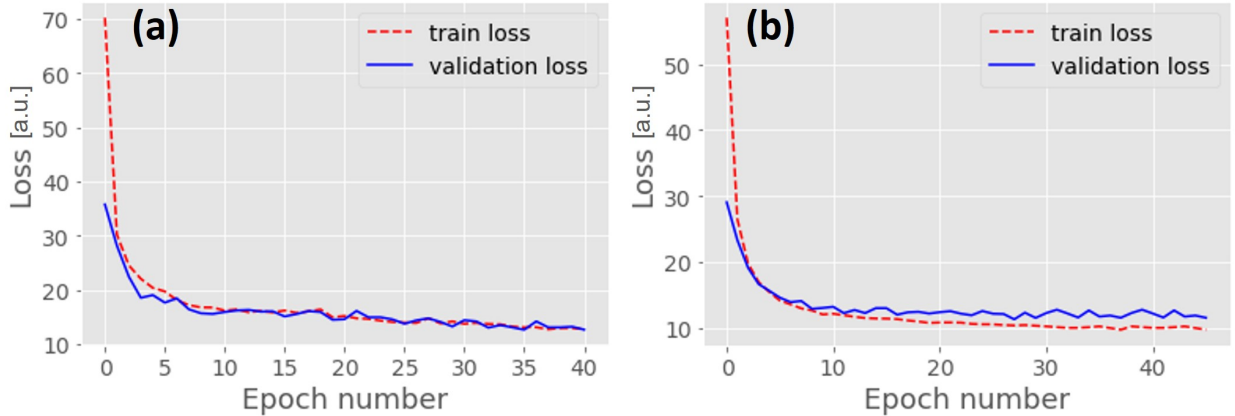
Figure 13: Training (red) and validation (blue) losses for (a) defect detector and (b) panel detector. The PV system under consideration is Plant\_Sicilia.

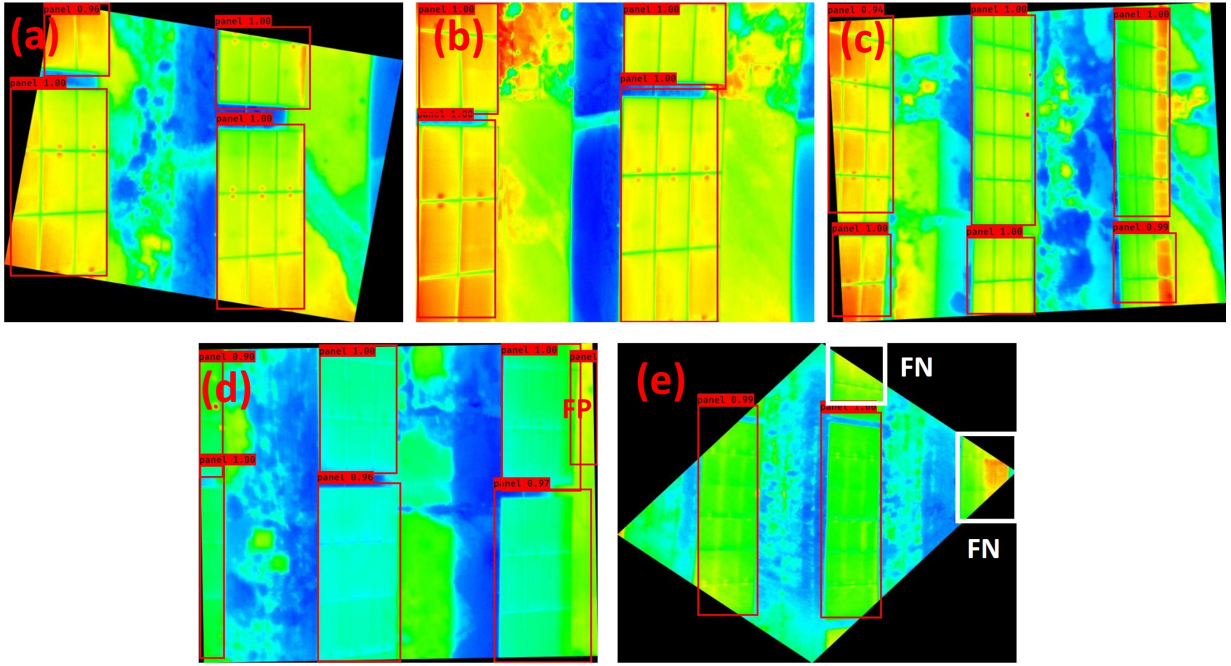
Figure 14: Examples of detections (red boxes) made by the panel detector on test images of Plant\_Sicilia. (a), (b), (c): TPs; (d): FP; (e): FN (white box).

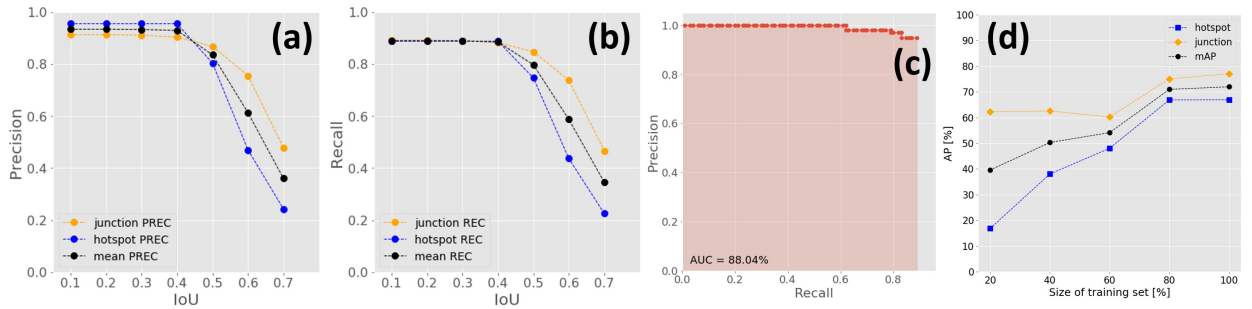
Figure 15: (a) Precision and (b) Recall as a function of IoU for hotspot and junction classes; (c) Precision-Recall curve for hotspot class @0.4; (d) APs and mAP @0.5 as a function of the training set size, expressed as a percentage of the full data amount available. Results correspond to test set of defect detector for Plant\_Sicilia.

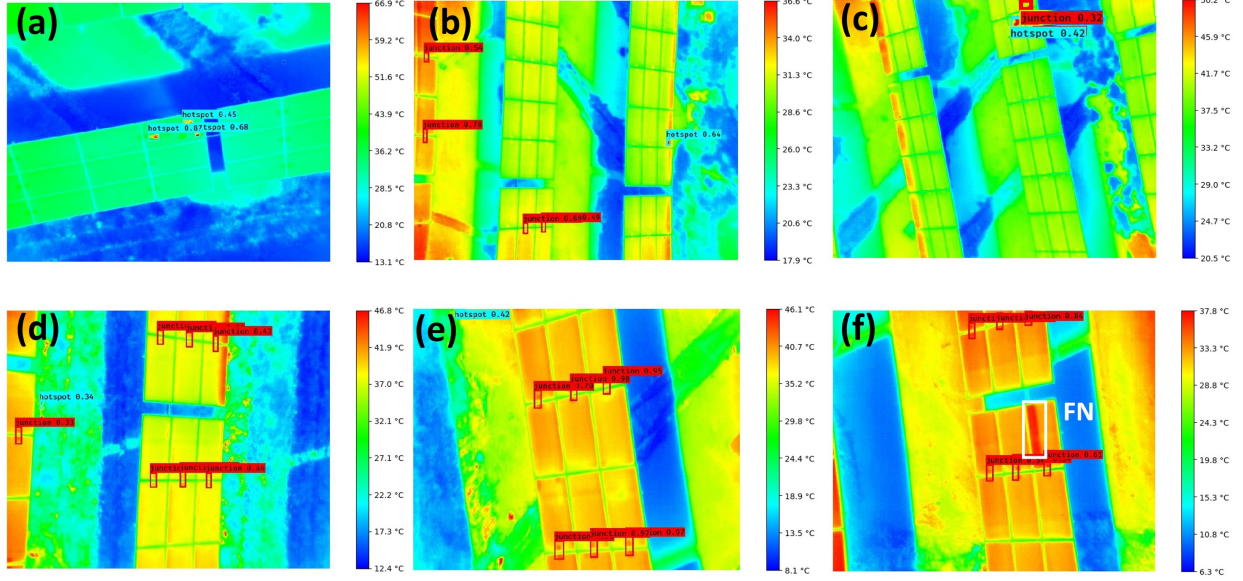
Figure 16: Examples of hotspot detections (sky blue boxes) made by the defect detector on test images of Plant\_Sicilia. (a), (b), (c): TPs; (d), (e): FPs, (f): FN (white box). In the same images the detections for junction box class are also superimposed (red boxes). The colorbar denotes the scene temperature expressed in units of Celsius degree.

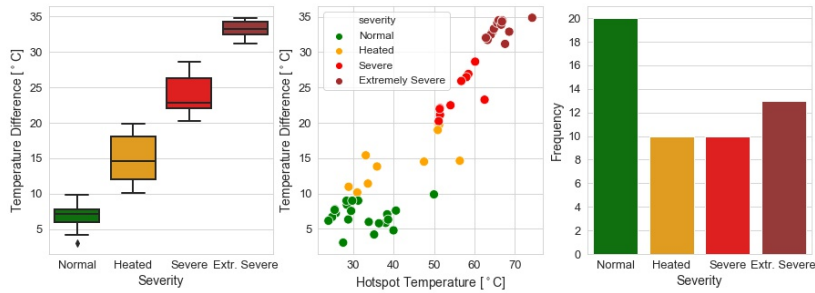
Figure 17: (a) Box chart of the temperature difference between hotspot and neighbour healthy PV module grouped by defect severity; (b) scatter plot of temperature difference between hotspot and healthy area as a function of hotspot temperature; (c) frequency of detected hotspots grouped by severity. Data refer to TPs @0.5 of Plant\_Sicilia.

The model outputs also the temperature gradient  $\Delta T$  between the detected hotspot and a neighbour healthy PV module of the same detected panel bounding box area, as well as the related severity and the suggested action to solve the issue based on the lookup Tab. 4. The model identifies 23 critical hotspots, requiring module substitution, out of 53 correctly identified hot areas @0.5 (Fig. 17c). Of these, 13 defects

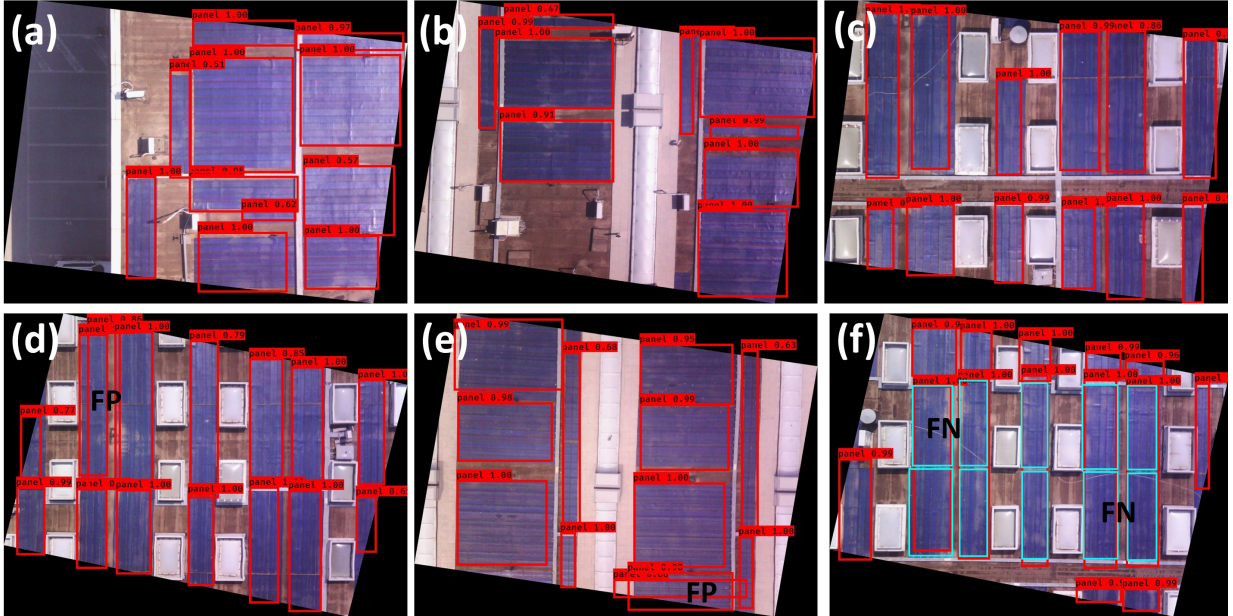
Figure 18: Examples of detections (red boxes) made by the panel detector on test images of Plant\_Campania. (a), (b), (c): TPs; (d), (e): FP; (f): FN and FP (in sky blue the GTBs).

As revealed by Fig. 18a-c, the model is sensitive to panels of different shape and orientation. Unlike Plant\_Sicilia, the confidence score may be as low as 0.45 due to the more significant variability in panel

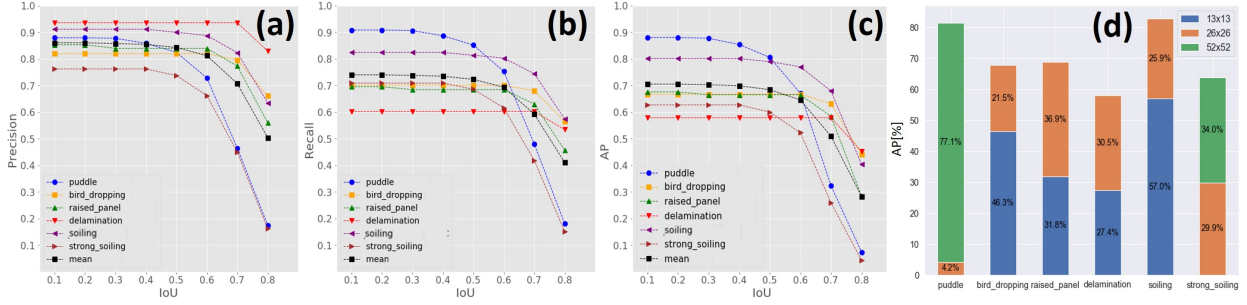
Figure 19: (a) Precision, (b) Recall and (c) AP of defect detector as a function of IoU; (d) AP@0.5 as a function of defect class grouped by YOLOv3 output scale. The PV system under consideration is Plant\_Campania.

In Fig. 19(a)-(c) the PREC, REC and AP are shown as a function of IoU, whereas the numerical values @0.5 are reported in Tab. 11. Metrics for classes bird\_dropping, raised\_panel, delamination, and soiling are flat until IoU= 0.6, in contrast with puddle and strong\_soiling for which degradation starts @0.4 as a consequence of the modest size < 0.4% (Fig. 6) and the ground truths annotated singularly for each instance. The same reason, as well as the different statistics (Tab. 2), may explain the gap in REC@0.5 (PREC@0.5) of almost 12.8% (16.2%) between similar classes soiling and strong\_soiling. In general, the larger the statistics available, the higher the recall achievable. The detector is most sensitive to class puddle, with a REC@0.5 of almost 85.2%, and less sensitive (60.3%) but more precise (93.6%) for class delamination. Handling unbalancing may help to improve performances for minority classes. On average, an IoU of 0.5 is a satisfactory balance point with a mAP roughly equal to 68.5% and a mean F1-score of 77.5%.

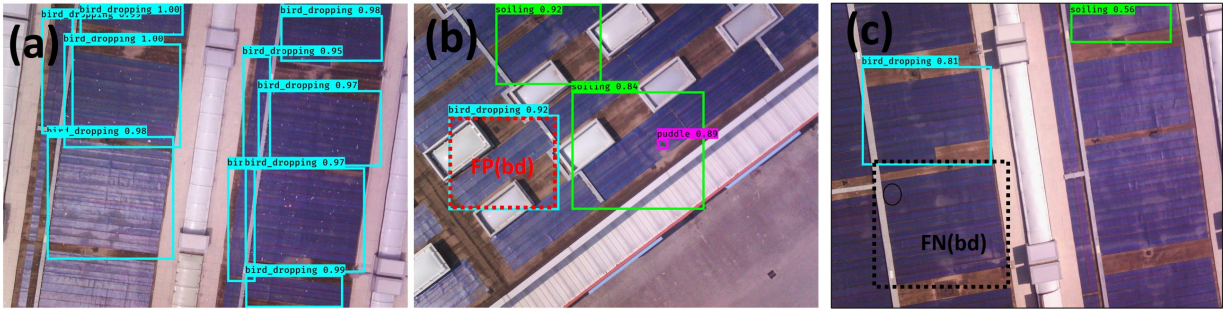
Figure 20: (a) TP (sky blue boxes), (b) FP (highlighted in red) and (c) FN (highlighted in black) for class bird\_dropping (bd) of Plant\_Campania.

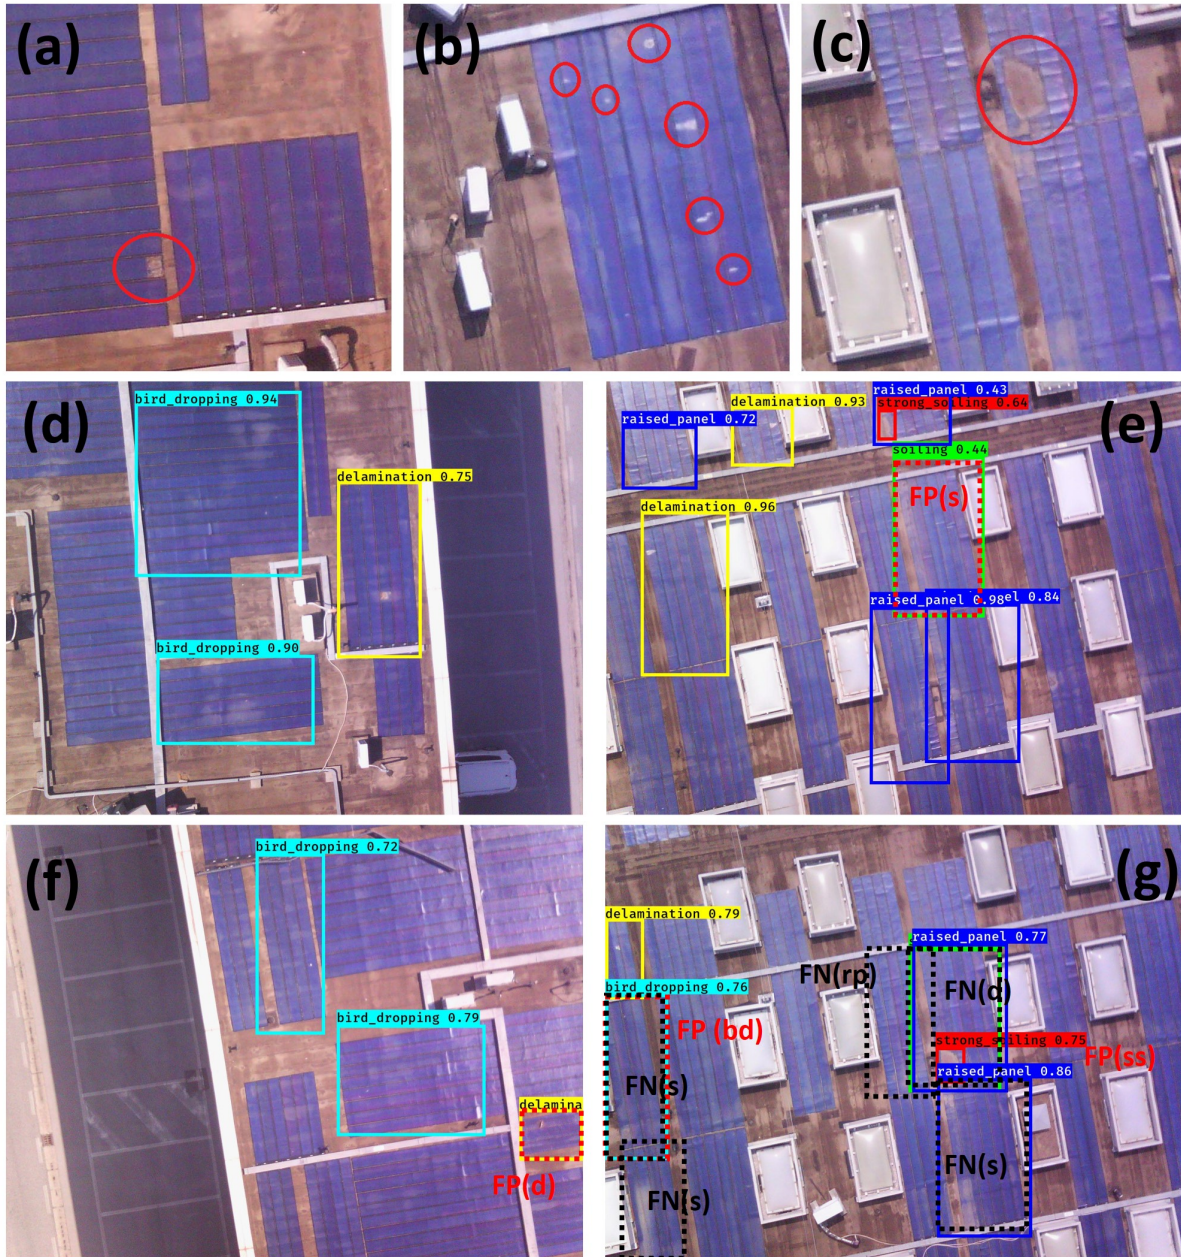
Figure 21: (a)-(c): some occurrences of delamination; (d)-(e) TP (yellow boxes), (f) FP (highlighted in red) and (g) FN (highlighted in black) for class delamination (d) of Plant\_Campania. FP and FN of classes soiling, bird\_dropping and raised\_panel are also included.

Class delamination has few instances corresponding roughly to 5.3% of the overall dataset (Tab. 2). More critically, such instances can differ in shape and colour. Indeed they can be in an advanced status,

affecting the entire cell and being visible as a square spot (Fig. 21a), or also extending over multiple cells (Fig. 21c). Delamination may be also at an early stage, characterized by an irregular shape (Fig. 21b). The color may be variable as well, changing from grey (Fig. 21b) to rusted once the degradation becomes more severe (Fig. 21a,c). While the model can detect anomalies of all the mentioned types (Fig. 21d-e), such heterogeneity can justify the not excellent REC@0.5 of almost 60.3%, due in some circumstances to misdetections as strong\_soiling because of similar colour and shape (Fig. 21g), or simultaneous occurrence of other anomalies (e.g. raised\_panel, Fig. 22a) which degrades the quality of meaningful features extracted

by YOLOv3. Nevertheless, the precision is close to 94% with very few FPs (Fig. 21f).

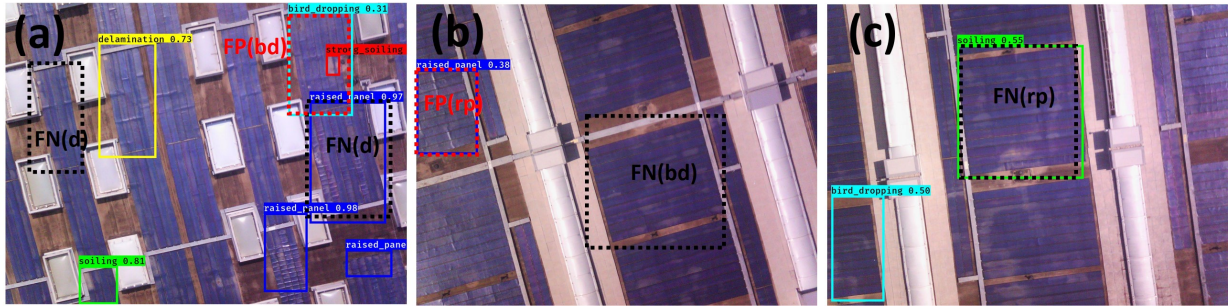
Figure 22: (a) TP (blue boxes), (b) FP (highlighted in red) and (c) FN (highlighted in black) for class raised\_panel of Plant\_Campania. FP and FN of classes bird\_dropping and delamination are also included.

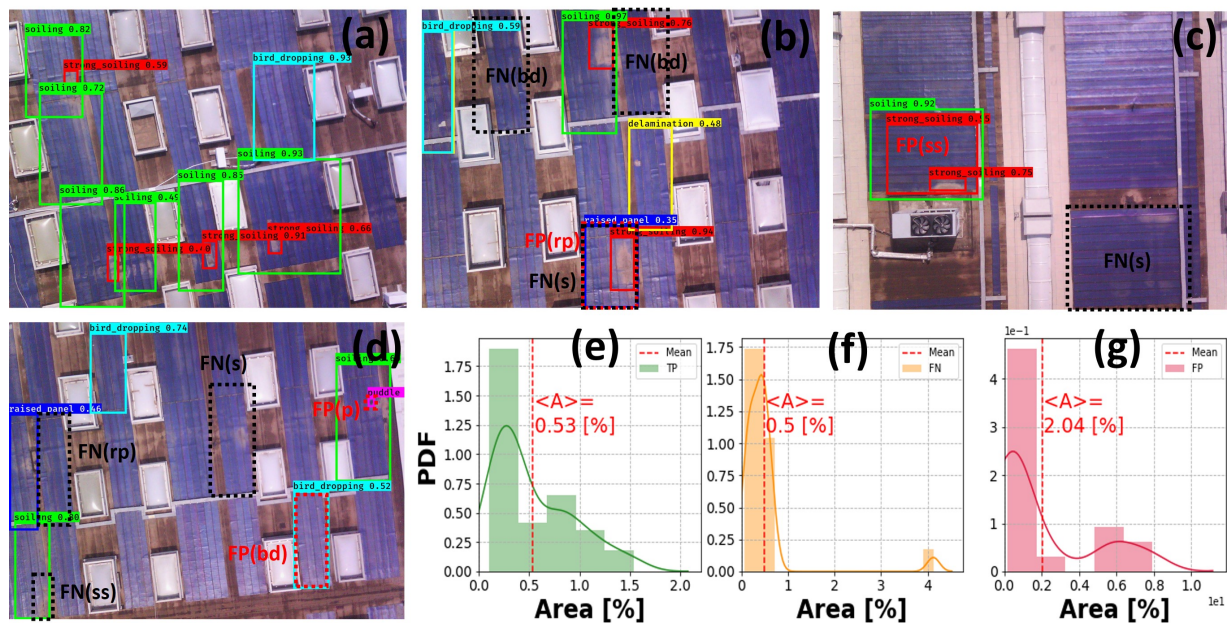
Figure 23: (a)-(b) TP (red boxes), (c) FP (multiple detections of the same instance) and (d) FN (highlighted in black) for class strong\_soiling of Plant\_Campania. FP and FN of classes soiling, bird\_dropping, raised\_panel and puddle are also included. (e)-(g): PDF of the normalized area of TP (e), FN (f) and FP (g) instances. The mean area value is also superimposed for convenience as a red dashed line.

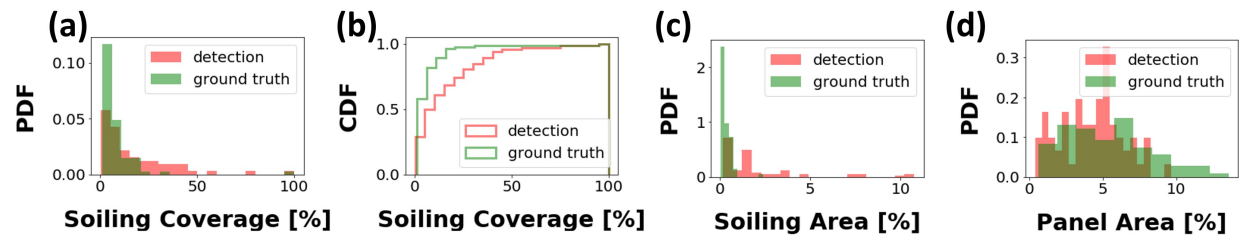
Figure 24: (a)-(b): PDF (a) and CDF (b) of the predicted (red) and ground truth (green) soiling coverage; (c)-(d): predicted (red) and ground truth (green) normalized soiling area (c) and panel area (d). The PV system under consideration is Plant\_Campania.

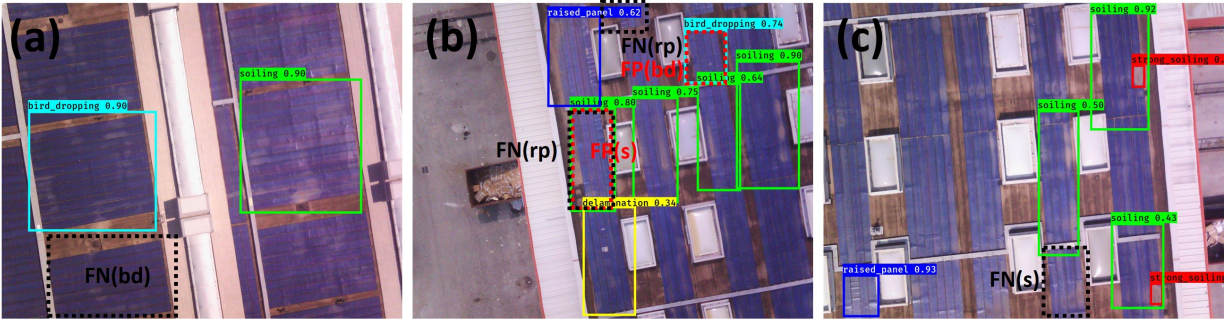
Figure 25: (a) TP (green boxes), (b) FP (highlighted in red) and (c) FN (highlighted in black) for class soiling of Plant\_Campania. FP and FN of classes soiling, bird\_dropping and raised\_panel are also shown.

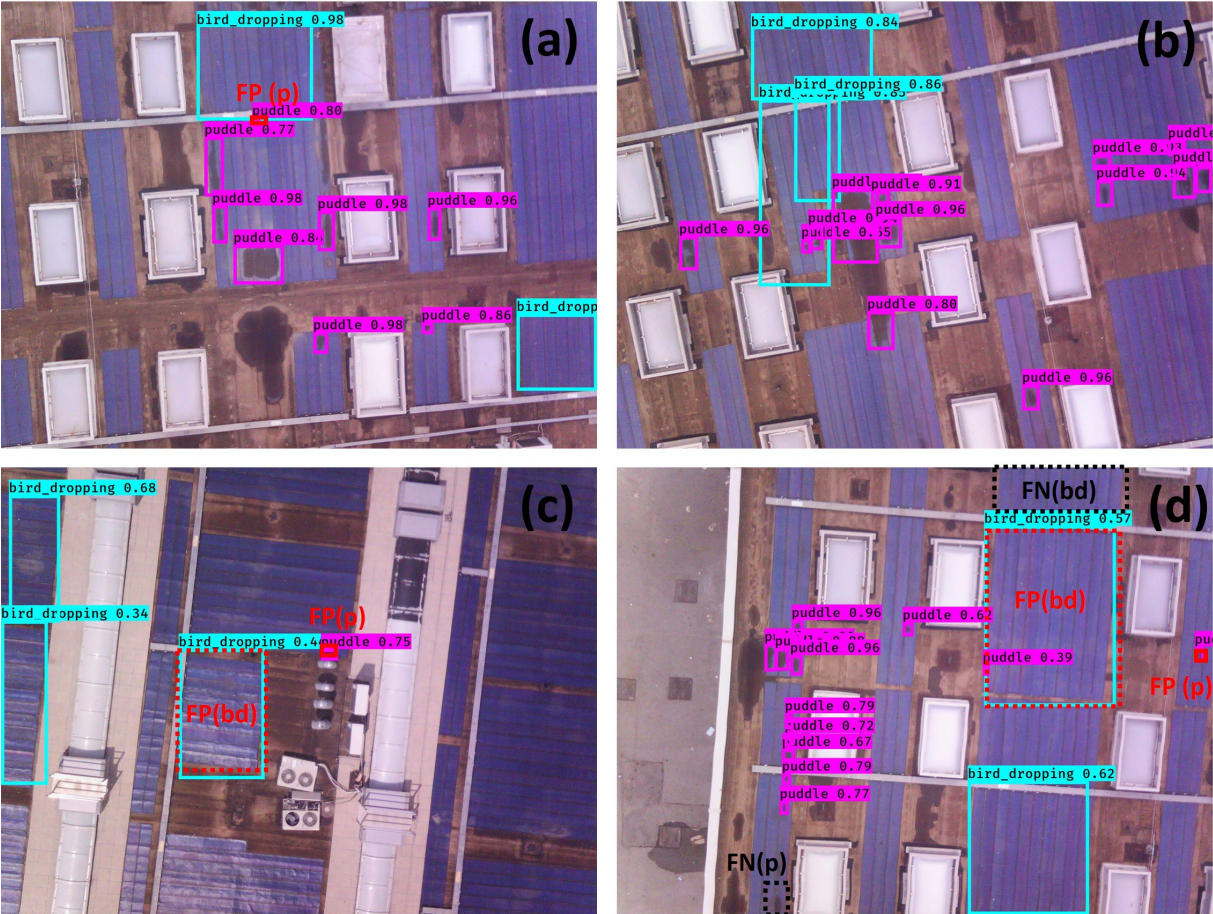
Figure 26: (a)-(b) TP (violet boxes), (c) FP (highlighted in red) and (d) FN (highlighted in black) for class puddle of Plant\_Campania. FP and FN of class bird\_dropping are also included.
