# Structural reorientation and compaction of porous MoS<sub>2</sub> coatings during wear testing

MoS<sub>2</sub>  
Tribology  
Wear testing  
Transmission electron microscopy  
Nanoindentation

## ABSTRACT

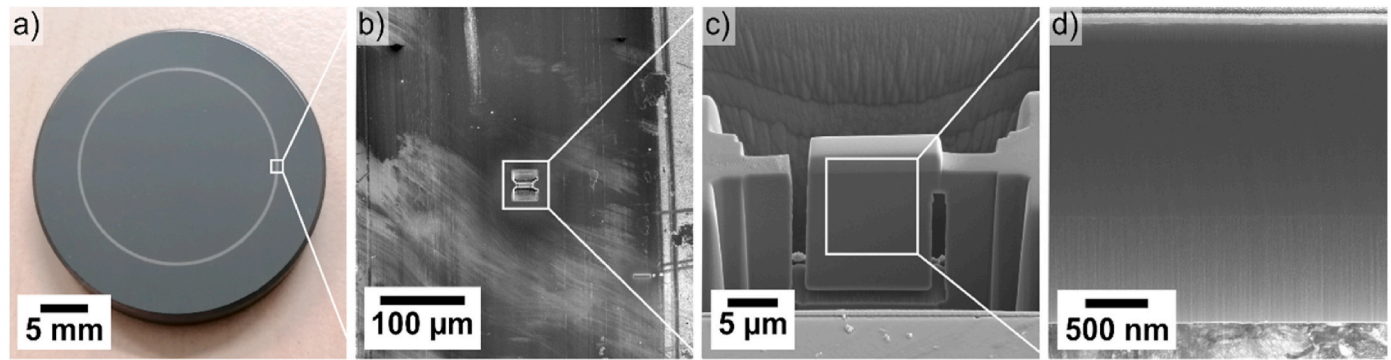
**Fig. 1.** Process and positioning of post-test lift-out. a) Sample with wear track after ball-on-disk testing. b) Lift-out position in wear track. c) Pre-cut lamella prior to lift-out. d) Final lamella in an SEM imaged in scanning transmission electron microscopy mode.

The sputter-deposited coatings were tested in a rotary tribometer (HTV-SST; KTMfK, Germany) with a ball-on-disk configuration. A detailed description of the tribometer is given in Ref. [21]. The tests ( $n = 1$ ) were carried out under vacuum conditions (initial pressure: 0.01 Pa) and in a rotational sliding mode with a sliding speed of 0.1 m/s. The normal force was set to 10 N, resulting in a Hertzian pressure of 1.17 GPa at the contact center. Steel balls (grade G10, ISO 3290,  $R_a \leq 0.02 \mu\text{m}$ ) with a diameter of 8 mm made of bearing steel 100Cr6 (1.3505, AISI 52100) were used as counterbodies. In the tribological tests, a track radius of 11.5 mm was adjusted and the termination criterion was set at 1000 cycles to ensure that no coating failure occurred. In order to compare the friction coefficients from the macroscopic tests with those of the microscopic tests, a few tests were carried out under ambient air with the test parameters mentioned earlier. Friction coefficients were averaged over 1000 cycles. After the tribological loading, a cross-section lamella of the material under the wear track was prepared to investigate the microstructure in a deformed state. The lift-out position and process are displayed in Fig. 1. The lift-out process, as well as the TEM investigation were performed analogously to the undeformed state described in section 2.2.

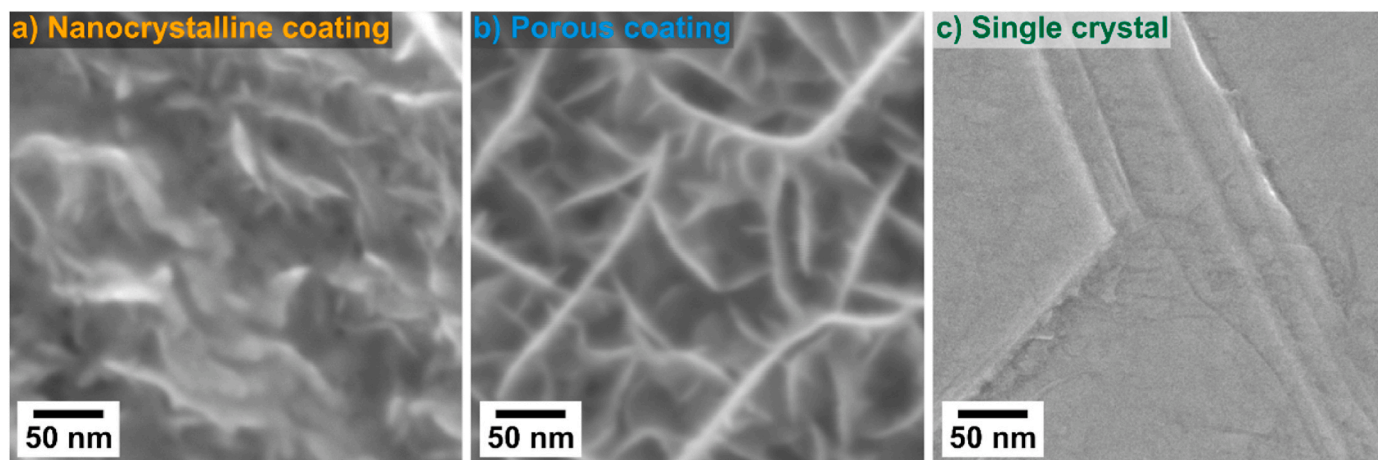
**Fig. 2.** Pristine surface structure of the samples in secondary electron (SE) contrast. a) Nanocrystalline coating. b) Porous coating. c) Bulk single crystal. The samples show strikingly different surface structures: A dense, plate-like surface for the nanocrystalline coating, dendritic crystallites with open porosity for the porous coating and a flat surface with surface steps for the single crystal.

The surface morphology of the PVD coatings and the  $\text{MoS}_2$  single crystal are shown in Fig. 2. The surface of the nanocrystalline coating (Fig. 2a) shows a mixture of plates and filament-like structures, albeit with hardly any apparent voids. In contrast, the coating deposited with the threefold rotation (Fig. 2b) exhibits a striking open porosity. It consists of a hierarchical, dendritic surface structure separated by large voids between the dendrites. A similar surface structure of  $\text{MoS}_2$  coatings has been observed in various publications, emphasizing how common porous coatings are [5,7,17,28–32]. Fig. 2c shows the smooth surface planes of the single crystal with a roughness  $R_a$  of  $38 \text{ nm} \pm 11 \text{ nm}$  with few surface steps with a height of  $330 \text{ nm} \pm 120 \text{ nm}$ , marking the end of individual  $\text{MoS}_2$  basal plane stacks.

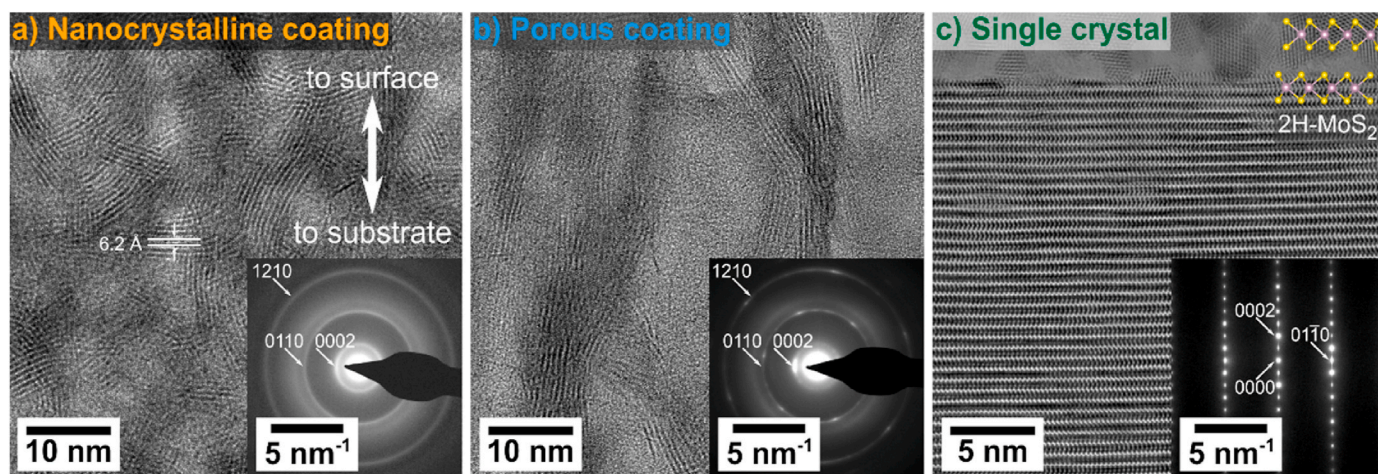
**Fig. 3.** Nanomorphology and crystalline structure of MoS<sub>2</sub> films studied by high-resolution transmission electron microscopy and selected area electron diffraction (insets). a) Nanocrystalline coating. b) Porous coating. c) CVD-grown 2H-MoS<sub>2</sub> single crystal investigated along the  $[\bar{2}110]$  zone axis with included crystal structure model. The structure of the coatings differs strongly from a perfect single crystal.

The TEM investigation of lift-out lamellae provides a more detailed understanding of the microstructure of the specimens (Fig. 3). The elongated crystallites in Fig. 3a–b shows extensive lattice fringes with a lattice spacing of 6.2  $\text{\AA}$ , corresponding to the distance between two consecutive basal planes of  $\text{MoS}_2$  [33]. The elongated  $\text{MoS}_2$  sheets consist of the stacking of 3–10 layers. Their relative orientation to the substrate determines the coating texture. The SAED patterns of the respective coatings further assist in the assessment of the texture. Since the area probed by SAED is significantly larger than the HRTEM micrographs shown in Fig. 3, the combination of both techniques ensures reliable findings. The nanocrystalline coating (Fig. 3a) features nanometer-sized, randomly oriented crystallites of about 10  $\text{MoS}_2$  layers, similar to microstructure (ii) described in the introduction. The SAED pattern shows continuous rings, which corresponds to the expected pattern of a polycrystalline sample with randomly oriented crystallites. The porous coating (Fig. 3b) shows vertically oriented crystallites, similar to microstructure (iii). The thickness of about 6–10

layers of the MoS<sub>2</sub> sheets is comparable to the size of the nanocrystals in Fig. 3a. The length of the crystallites is determined by their respective orientation and competitive growth. In the corresponding SAED pattern, a preferred orientation is apparent as distinct peaks with higher intensity are clearly observable on top of continuous diffraction rings with lower intensity. The {0002} peaks correspond to the edge-on orientation of the MoS<sub>2</sub> sheets, which is also apparent in the HRTEM image in Fig. 3b. In contrast, the diffraction spots on the {01 $\bar{1}$ 0} diffraction ring stem from similar crystallites, albeit projected along the [0001] zone axis. Both observations are in agreement with a prismatic texture of the coating.

Depending on the local orientation of the crystallites in the plane of the film, the {0002} basal planes appear in edge-on or in-plane orientation. The 34.4° angular range of the (0002) peak in the SAED pattern indicates that the crystallites are oriented between  $\pm 17.2^\circ$  from the surface normal. Fig. 3c shows the cross-section of the CVD single crystal oriented along  $[\bar{2}110]$  zone axis (see SAED pattern inset). The MoS<sub>2</sub> planes are well aligned, maintaining perfect 2H-MoS<sub>2</sub> geometry except for the presence of few dislocations, which is in good agreement with microstructure (i) from the introduction.

Indexing of the experimentally acquired SAED patterns in Fig. 3 is

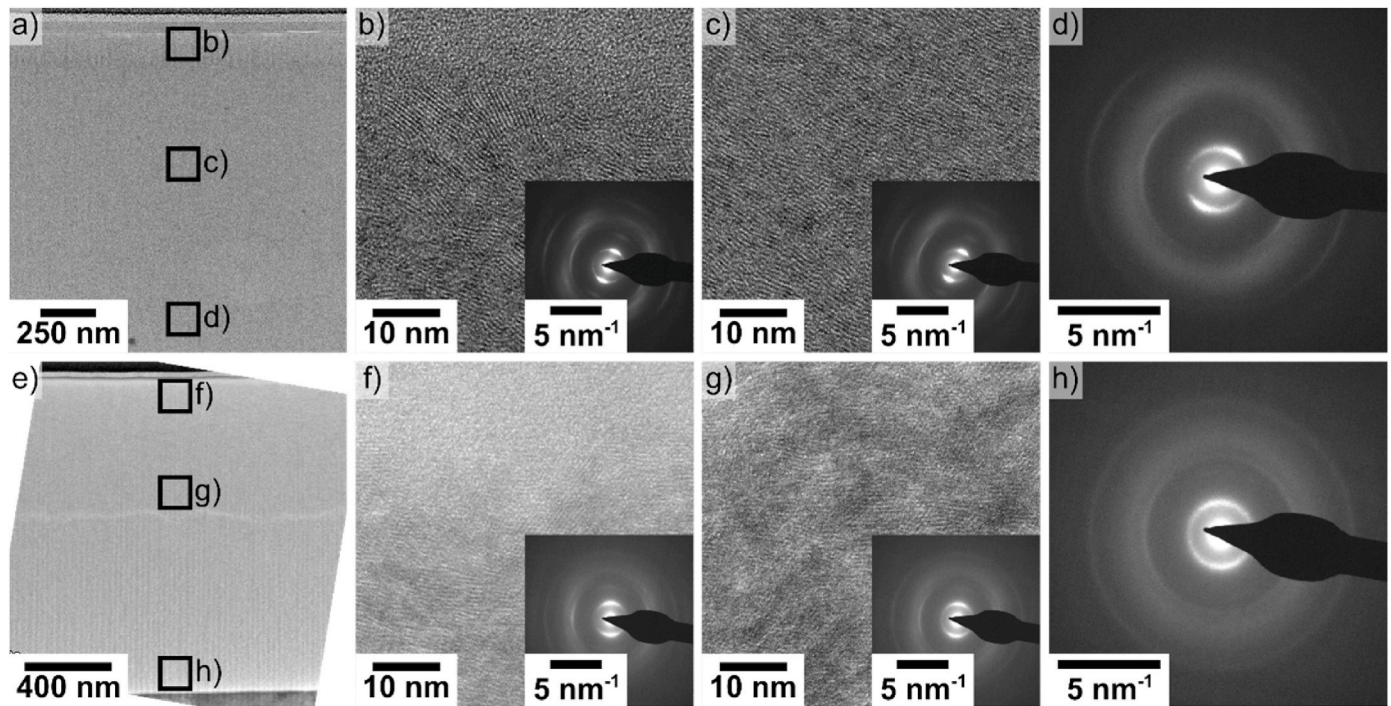
**Fig. 4.** Microstructural HRTEM and SAED investigations after short wear testing. a-d) Nanocrystalline coating. e-h) Porous coating. After tribological testing, the nanocrystalline and porous coatings are reoriented into a predominantly basal texture.

The microstructural TEM characterization after short wear testing of the nanocrystalline coatings is shown in Fig. 4a–d. The mechanical loading resulted in the formation of a texture. Compared to Fig. 3a, the basal planes (see Fig. 4b) show a more uniform orientation, which is roughly parallel to the surface. The small inclination arises from the off-

center position of the FIB lift-out within the curved wear track. The reorientation extends deep into the coating, as evidenced by Fig. 4c. This conclusion is also supported by the SAED inset, where the intensities in the first and second ring, corresponding to (0002) and (01 $\bar{1}$ 0), have clearly changed to a stronger texture with highly localized ring fragments (compare to Fig. 3). The texture can still be recognized close to the substrate in Fig. 4d, but is less pronounced than near the surface. This effect is evidenced by the increase in angular range of the (0002) ring fragment in the SAED patterns, from  $\pm 19.3^\circ$  at subsurface to  $\pm 20.4^\circ$  in the center of the coating and to  $\pm 40.4^\circ$  close to the substrate. This shows that the preferred orientation of the MoS<sub>2</sub> sheets is progressively weakening in deeper coating areas.

An overview TEM micrograph of the initially porous coating in worn state is shown in Fig. 4e, where the positions of the HRTEM and SAED measurements of Fig. 4f–h are indicated. The horizontal artefact, as well as the vertical curtaining, originate from FIB milling and should be

disregarded. Similar to the polycrystalline coating, Fig. 4f as well as Fig. 4g show significant reorientation after short wear testing. MoS<sub>2</sub> crystallites in vertical orientation cannot be found anymore in the deformed state. Instead, the microstructure is rearranged to a basal texture with strong character in the upper part of the lamella and with a weaker character 600 nm below the coating surface. Near the substrate, a preferred orientation is almost completely lacking (Fig. 4h). The angular range of  $\pm 21.7^\circ$ ,  $25.28^\circ$  and  $33.43^\circ$  for the subsurface, center and substrate-near areas evidence an increasing misorientation deeper into the coating, analogous to the nanocrystalline coating. Note that due to the larger thickness of the TEM lamella in the deeper investigated area, the electron beam travels through a thicker layer, which leads to a lesser crystallinity in Fig. 4g–h, due to more diffuse and inelastic scattering intensities in the HRTEM images and SAED patterns.

Both investigated MoS<sub>2</sub> coatings show a significant reorientation after short wear testing. The initial random orientation of the nanocrystalline coating is turned into a basal texture during tribological loading. Similar reorientation under tribological loading has been observed in Refs. [13,22,23,36–39]. The process is assisted by the easy glide of MoS<sub>2</sub> sheets with respect to each other. This reorientation corresponds to a self-optimization of the coating, as the basal texture corresponds to the lowest energy configuration [40] (fewer random high angle grain boundaries). A similar process is at play in the porous coating, albeit to a lesser extent. Here, it is likely that the initially vertical MoS<sub>2</sub> crystallites break apart under the applied stress and that the resulting products are stacked together to fill the existing voids. During this process, the energy minimization driving force is in competition with the existing geometry of the voids to be filled. This likely explains why the reorientation yields an imperfect basal texture, see Figs. 5 and 4b,f.

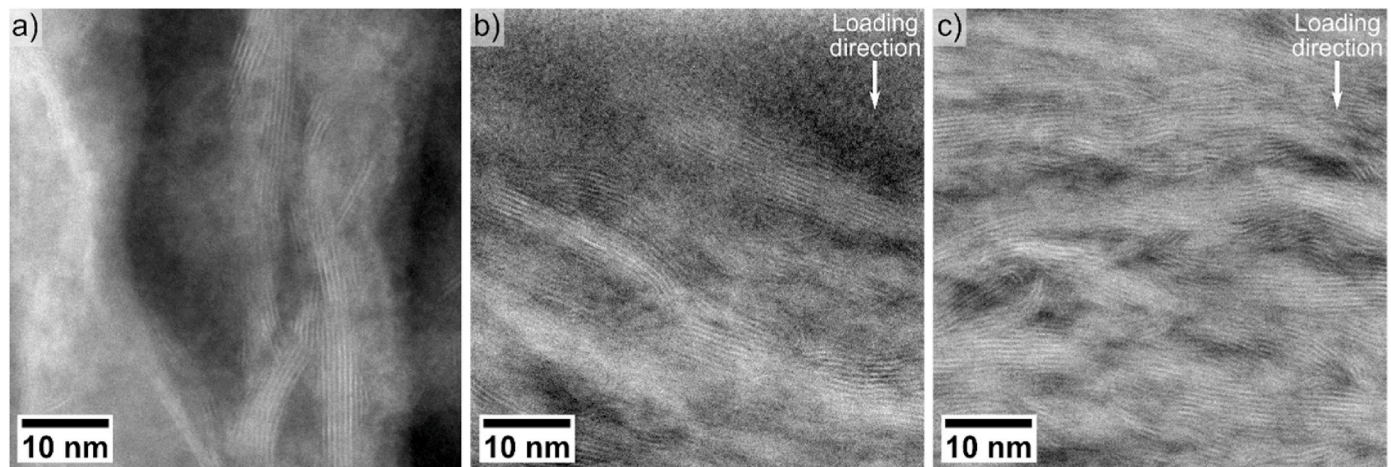
**Fig. 5.** Porosity evolution in the porous coating in HAADF-STEM contrast. a) Initial state prior to tribological loading. b) Upper part of the lamella after short tribological loading. c) Middle part of the lamella after short tribological loading. The porous coating shows significant compaction after tribological testing.

The residual porosity after tribological loading in the vertically textured coating is evaluated from Fig. 5. The HAADF-STEM contrast shows high intensity where atoms with high atomic number (Z contrast) are located and low intensity where either atoms with lower atomic number or fewer atoms are located. Therefore, the intensity distribution in HAADF-STEM imaging is thickness dependent and the contrast can be used to identify pores. The pores with an approximately ellipsoidal shape (Fig. 5a) have a size of 12 nm  $\times$  50 nm in the initial state of the coating, which is effectively reduced after short tribological loading to 2 nm  $\times$  5 nm. This is the case for both the surface-near area (Fig. 5b) and below (Fig. 5c). The vertical crystallites are reoriented, stacked and compacted by the wear process. Additionally, the pores are reshaped to elongated horizontal voids in-between compacted crystallites.

major role in the tribological behavior of these films. It is also worth mentioning that the filling process of the pores is not yet fully completed after 1000 cycles (ball-on-disk testing at 1.17 GPa), since small residual pores are still visible in the cross-sections, see Fig. 5.

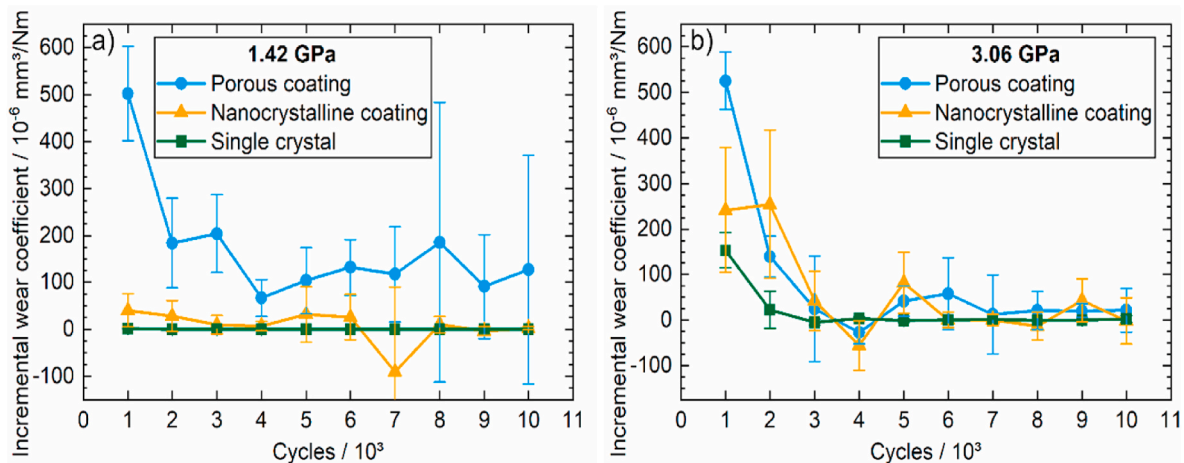
Fig. 6. Incremental wear coefficient from nanomechanical wear testing in ambient air. a) Testing at a Hertzian contact pressure of 1.42 GPa. b) Testing at a Hertzian contact pressure of 3.06 GPa. After initial transition, the samples reach a steady-state.

The results from the nanomechanical sliding wear tests are depicted in Fig. 6 for increasing Hertzian contact pressures: 1.42 GPa (Fig. 6a) and 3.06 GPa (Fig. 6b). The tests on the single crystalline sample show no significant wear rate at all over the whole course of the experiment at 1.42 GPa. By increasing the pressure to 3.06 GPa, this trend changes. There is a significant amount of volume loss during the first 1000 cycles. During the next 1000 cycles, the worn volume decreases dramatically and remains negligible after 3000 cycles. The porous and nanocrystalline samples follow similar global trends at a pressure of 3.06 GPa, with an initial transient associated with a high wear coefficient and a follow-

up steady-state phase associated with lower values. This initial transient is visible for the porous coating at a Hertzian pressure of 1.42 GPa, but the nanocrystalline coating hardly shows any initial transient. A pronounced initial transient is identified on the nanocrystalline coating at 3.06 GPa. The wear ultimately becomes negligible after 3000 to 4000 cycles. The porous coating shows an overall higher wear coefficient at a contact pressure of 1.42 GPa, especially under a steady-state phase lasting until the interruption of the test. At 3.06 GPa, the steady-state sets in as fast as the nanocrystalline coating and the wear coefficient decreases to values as low as with the single crystal. Some datapoints represent negative wear rates, which means that volume is introduced into the system. This artefact can be traced back to wear debris being pushed into the track during profiling. One representative residual wear track on each sample is shown in Fig. 7. The wear tracks in the figures should be compared to the cumulative wear volume measured throughout the test.

The porous coating experiences a higher apparent wear rate than its dense counterparts at a low contact pressure, see Fig. 6a. This is likely a result of the compaction process. The indentation of the counterbody is not solely due to material removal during the wear process, but also to the collapse of pores beneath it, leading to the compaction of the coating. Its contribution to apparent wear can be assessed by comparing the cross-sections and residual depths of the porous (178 nm ± 8 nm) and fully dense nanocrystalline (45 nm ± 15 nm) coatings after 1000 cycles under a contact pressure of 1.42 GPa. Assuming that abrasion takes place to the same extent, the difference of 132 nm, i.e. 74 %, should be attributed to compaction.

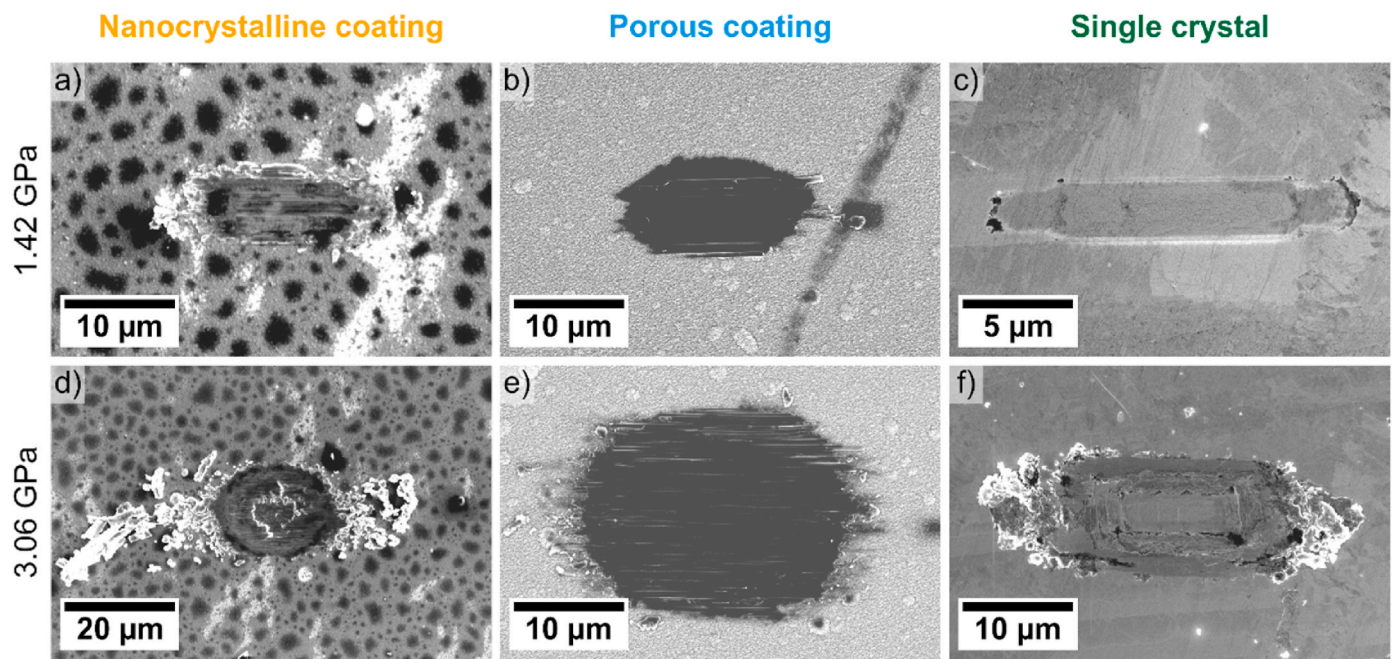
Fig. 7. Representative residual wear tracks after nanomechanical wear testing. a-c) Tests at Hertzian contact pressures of 1.42 GPa. d-f) Tests at Hertzian contact pressures of 3.06 GPa. The width of the residual wear track is a direct measure for the extruded volume, since the width is determined by the indentation of the spherical counterbody. Note the different scale in c) and d).

The nanocrystalline coating is associated to the strongest formation of wear debris (Fig. 7a) under a Hertzian contact pressure of 1.42 GPa. The dark contrast in the image corresponds to surface contamination or oxidation, since the coating was exposed to ambient air for several days during and after wear testing. The track on the porous sample (Fig. 7b) is much wider than those of the single crystal and the nanocrystalline coating. The wear track on the single crystal (Fig. 7c) shows a very smooth surface with little deformation and no significant wear debris.

By increasing the contact pressure to 3.06 GPa on the nanocrystalline coating, a large amount of wear debris formed, which are separated from the wear track by up to 20  $\mu\text{m}$  (Fig. 7d). Furthermore, in the center of the track an inhomogeneity of the tribological film is visible, where only a thin lubrication layer remains on the substrate. The porous coating shows a larger track width, resulting from a deeper indentation (Fig. 7e). The single crystal shows a deformed wear track with pile-ups at both sliding direction ends (Fig. 7f). Overall, the largest volume of coating is lost during wear on the porous coating, despite the fact that only a low amount of wear debris has formed, hinting at a different abrasion behavior than for the other samples.

From the pre- and post-wear test TEM imaging, a compaction effect is clearly evidenced for the porous coating. Little  $\text{MoS}_2$  material is lost during this process, as evidenced by the near absence of debris in Fig. 7b, e. This means that the original amount of solid lubricant is preserved for follow-up operations. As will be shown below, this compaction plays a

The magnitude of the abrasion behavior can be assessed from the pile-up formed at the edges of the wear tracks, see Fig. 7. While the single crystalline sample and the nanocrystalline coating form pile-ups, the porous coating allows the counterbody to sink into to the coating surface. Intrinsically, pile-ups increase the contact area between the

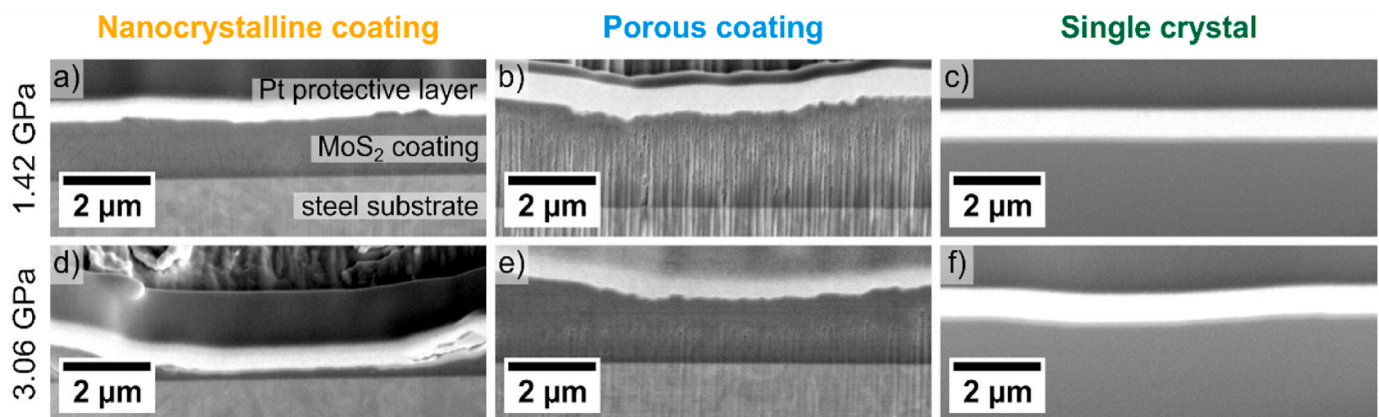
Fig. 8. FIB milled cross-sections of the residual coating thickness below the wear tracks. View direction is parallel to the sliding direction. a-c) Tests at Hertzian contact pressures of 1.42 GPa. d-f) Tests at Hertzian contact pressures of 3.06 GPa. The nanocrystalline coating shows a dense and homogenous lubrication layer, while the porous coating shows contact pressure dependent compaction.

Cross-sections of the wear tracks are provided in Fig. 8. As the wear tracks are several micrometers wide, only the center of the track is shown in the cross-sectional views. For the nanocrystalline sample (Fig. 8a), the surface of the wear track appears to be very smooth and a clear residual indent is observable for a contact pressure of 1.42 GPa. The porous coating shows a strongly densified surface-near region (Fig. 8b,e). This area extends further through the coating as the contact pressure is increased. The surface of the wear track is rougher compared to the tests on the single crystal. For the single crystal no significant abrasion is observable for testing at 1.42 GPa (Fig. 8c) and a small

residual indent is present at a Hertzian pressure of 3.06 GPa (Fig. 8f). As the contact pressure increases (Fig. 8d), the nanocrystalline coating is almost entirely removed, with only a very thin residual coating remaining at the substrate interface. Note that the indentation depth after testing at 3.06 GPa is about the same ( $\approx 1 \mu\text{m}$ ) for the nanocrystalline and the porous coating, while the initial coating thickness for the porous coating (2.4  $\mu\text{m}$ ) was higher than for the nanocrystalline coating (1.2  $\mu\text{m}$ ).

The higher apparent wear value is only found at low pressures. This is likely due to the contact-pressure dependent progress of compaction. As seen in Fig. 8, the compacted zone does not extend through the whole coating thickness until the high-stress regime. When this is the case, we presume that more material is transformed into a low-friction configuration, which could explain why the corresponding wear rates approach the performance of dense coatings, both here and during macroscopic testing [21].

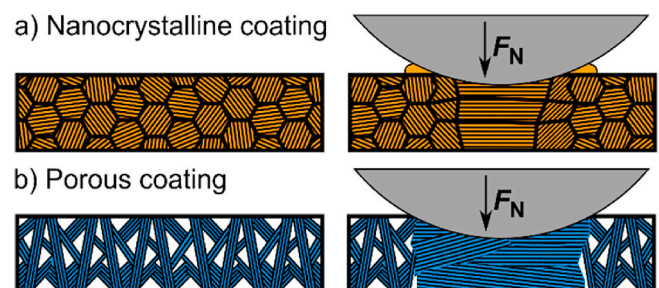
Fig. 9. Schematic representation of the compaction and reorientation behavior of a) inherently dense and b) porous, vertically oriented coatings after short tribological testing. Nanocrystalline coatings are worn by abrasive processes, where porous coatings show significant compaction. Both types of coatings reorient into a low-friction basal-textured state.

Our observations can be summarized with the sketches shown in Fig. 9.

For an inherently dense coating, the material removal processes are mostly limited to abrasion and plastic deformation, producing large amounts of wear debris, forming pile-ups and compacting them at either end of the sliding track. Most of the accumulating deformation takes place during an initial transient, see Fig. 6. Furthermore, a reorientation of the underlying lubrication layer sets in, which ultimately results in a lower wear rate during steady-state deformation.

For porous coatings, the transition is dominated by compaction and less material is removed, which leads to lower wear debris formation and an effective sink-in of the counterbody. We believe that after transition, the combination of reduced wear rate and the reincorporation of wear debris particles leads to a steady state characterized by a low wear
