# PMFault: Faulting and Bricking Server CPUs through Management Interfaces

Or: A Modern Example of Halt and Catch Fire

Abstract. Apart from the actual CPU, modern server motherboards contain other auxiliary components, for example voltage regulators for power management. Those are connected to the CPU and the separate Baseboard Management Controller (BMC) via the I2C-based PMBus. In this paper, using the case study of the widely used Supermicro X11SSL motherboard, we show how remotely exploitable software weaknesses in the BMC (or other processors with PMBus access) can be used to access the PMBus and then perform hardware-based fault injection attacks on the main CPU. The underlying weaknesses include insecure firmware encryption and signing mechanisms, a lack of authentication for the firmware upgrade process and the IPMI KCS control interface, as well as the motherboard design (with the PMBus connected to the BMC and SMBus by default). First, we show that undervolting through the PMBus allows breaking the integrity guarantees of SGX enclaves, bypassing Intel's countermeasures against previous undervolting attacks like Plundervolt/V0ltPwn. Second, we experimentally show that ov

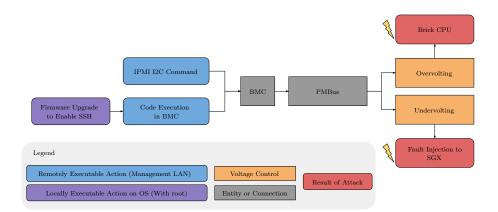
Figure 7: Overview of the PMFault attack. With root access to the OS or access to the BMC via Ethernet or KCS, the attacker can perform a malicious firmware upgrade of the BMC and then takeover the PMBus. The attacker can also use the ipmi i2c command to directly control the PMBus via BMC. With control over the CPU voltage, the attacker can overvolt to brick the CPU or undervolt to inject faults into SGX.

In this section, we show how under/overvolting through the PMBus leads to attacks on SGX and also permanent physical damage to the CPU. The attack requires any flaw that gives a software attacker access to the PMBus. As mentioned in Section 4.3, this can e.g., be a malicious firmware upgrade or the use of the IPMI-to-I2C functionality. The attack is generic in the sense that *various* flaws can lead to the same outcome: remote fault injection attacks on SGX and bricking the CPU. Figure 7 shows an overview of the attacks.

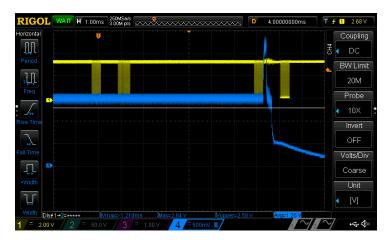
Figure 8: Oscillocope capture of voltage change during overvolting, VOUT\_COMMAND set to OxFF (with 10 mV VID table). Yellow: PMBus clock, blue: Vcpu. Vcpu shoots up to 2.84 V during overvolting.

We found that this procedure allows changing the CPU voltage up to  $\sim 2.84\,\mathrm{V}$  for  $\sim 1\,\mathrm{ms}$ , which is outside the typical operating range of Intel CPUs. By increasing the voltage beyond the specified operating voltage range (0.55 V–1.52 V) [Cor18] of a 7th Gen Intel E3-1220V6 CPU two times, we permanently destroyed the CPU and left the system in an unbootable state within a few seconds. We successfully repeated the experiment with a second, identical CPU. An example of overvolting is shown in Figure 8.
