Quantitative Data Analysis: CRASAR Small Unmanned Aerial Systems at Hurricane Ian

Thomas Manzini¹, Robin Murphy¹, and David Merrick²

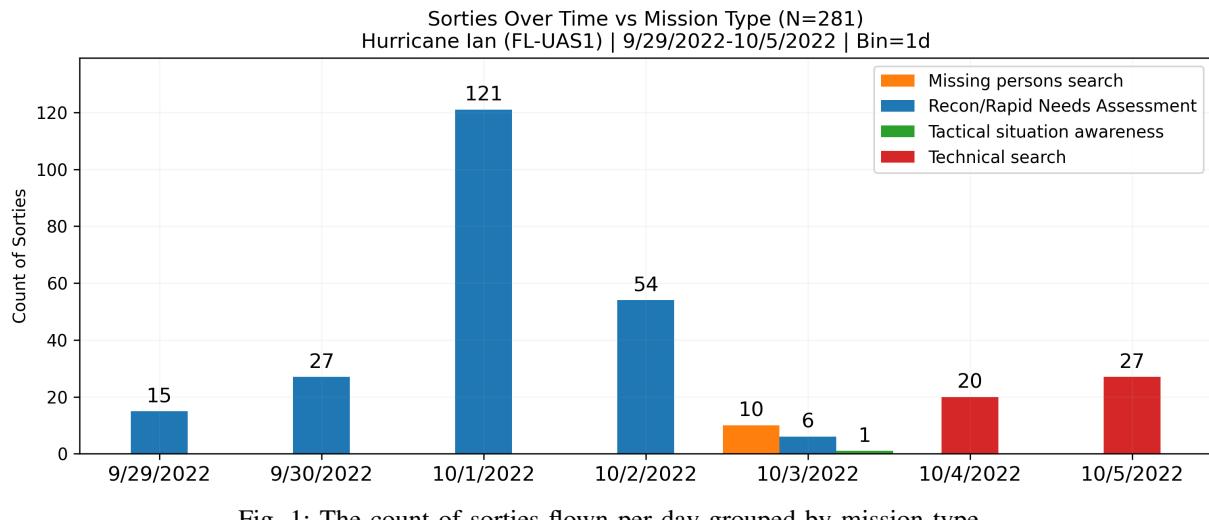
Fig. 1: The count of sorties flown per day grouped by mission type.

A plot of the distribution of sorties compared to the different assigned mission types are provided in Figure 1. This figure highlights how operational objectives shifted as the response progressed. At the start of the response, missions were primarily focused on rapidly reacting to the ongoing needs of the response. However, following the first 72 hours (the nominal response period), an initial shift is observed where efforts focused instead on mapping. This was then followed by an additional shift as objectives change and squads are tasked to focus on technical search activities. This shift in objectives is also observed in changes in controls mode as shown in Figure 2. Viewing this change in objectives via the control mode, the primary control mode initially starts in FPV as squads fly damage assessment and reconnaissance missions, the control mode switches to planned flying as objectives change to mapping, and then back to FPV as objectives again transition to technical search.

For individual sUAS pilots, further emphasis should be placed on training for the common mission types described in Figure 1. Additionally, sUAS pilots should verify sensor settings, such as viewing angle, prior to any data capture. Finally, sUAS pilots should be reminded to not perform unnecessary flights that do not further their assigned mission. These flights delay data transfer and incur additional risk.

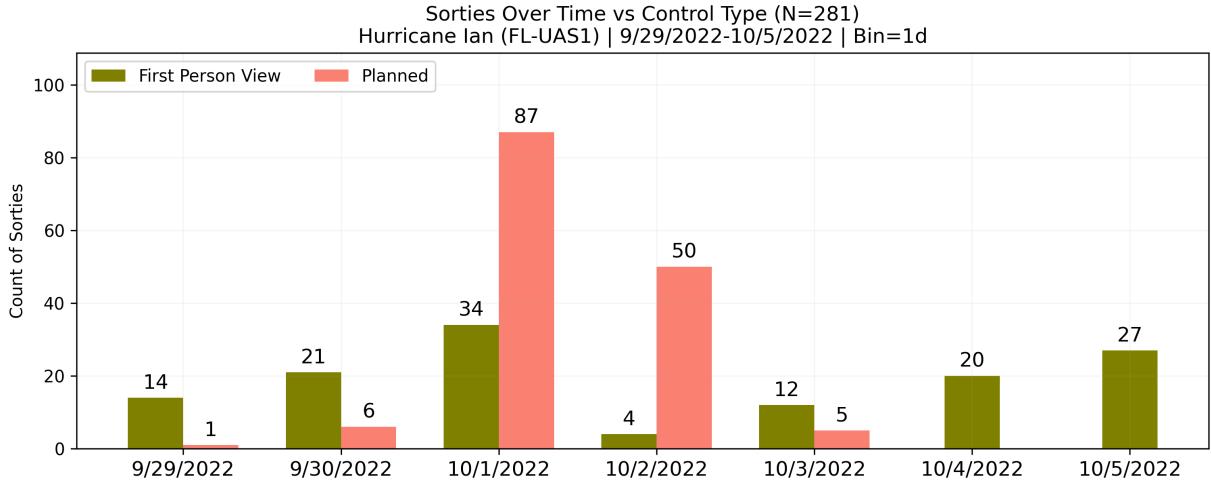
Fig. 2: The count of sorties flown per day grouped by control type.

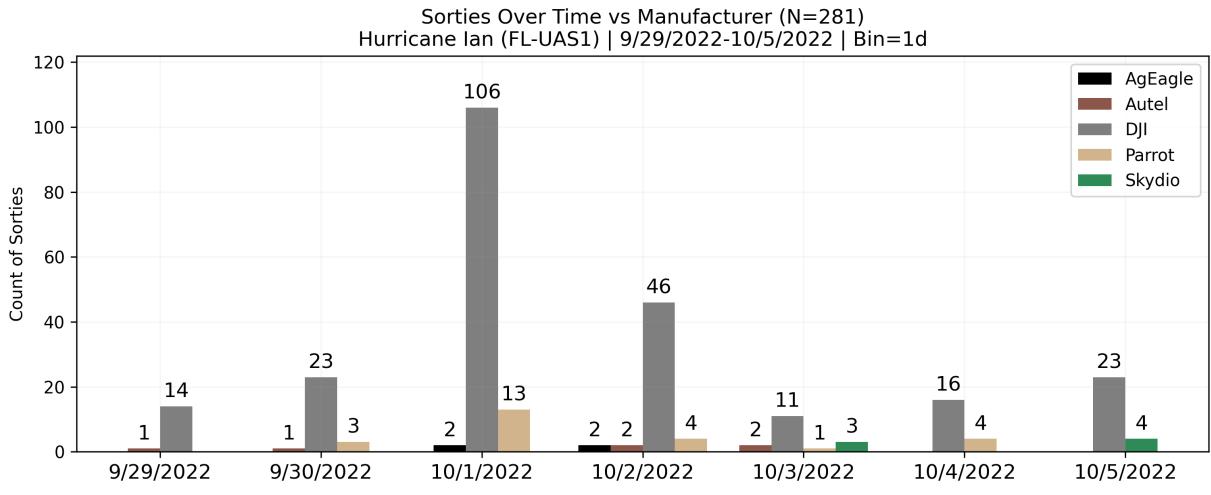
Fig. 3: The count of sorties flown per day grouped by manufacturer.

Viewing the same data in terms of sUAS manufacturers, it is observed that DJI sUAS account for the vast majority of sorties; in fact 239 of the 281 sorties flown during Hurricane Ian were flown by a DJI sUAS (85.1%). This distribution is detailed in Figure 3.

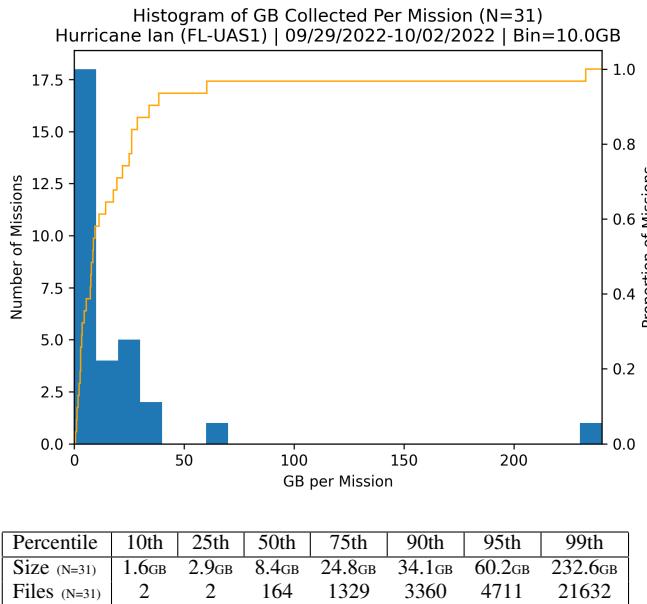
Fig. 4: Amount of data collected per mission.

Further analysis of the data collected at Hurricane Ian was performed with the intention of developing guidance on the development of edge computing and data storage for sUAS operations in the future. Collected data from the period of September 29, 2022 to October 2, 2022 was analyzed. One finding of note is that the missions resulted in 8.5GB of data on average, and 60.2GB at the 95th percentile, which is shown in Figure 4. Two conclusions can be drawn from this information.

First, in terms of memory storage, missions can be reliably dispatched with blank 64GB memory cards, and memory cards with larger capacity and higher cost can be reserved for data intensive missions.

Second, when comparing this data with the average distance an sUAS team had to travel for their mission ($p50=12\text{mi}$, $p95=35\text{mi}$) [9], in order to reliably outperform physically driving the data to its destination wireless connectivity should have an approximate capacity of 8GB/hr (17.8Mb/s), and ideally 60GB/hr (133.3Mb/s).
