## Anatomy of a Robotaxi Crash: Lessons from the Cruise Pedestrian Dragging Mishap

**Abstract.** An October 2023 crash between a GM Cruise robotaxi and a pedestrian in San Francisco resulted not only in a severe injury, but also dramatic upheaval at that company that will likely have lasting effects throughout the industry. Issues stem not just from the loss events themselves, but also from how Cruise mishandled dealing with their robotaxi dragging a pedestrian under the vehicle after the initial post-crash stop. External investigation reports provide raw material describing the incident and critique the company’s response from a regulatory point of view, but exclude safety engineering recommendations from scope. We highlight specific facts and relationships among events by tying together different pieces of the external report material. We then explore safety lessons that might be learned related to: recognizing and responding to nearby mishaps, building an accurate world model of a post-collision scenario, the inadequacy of a so-called “minimal risk condition” strategy in complex situations, poor organizational discipline in responding to a mishap, overly aggressive post-collisi

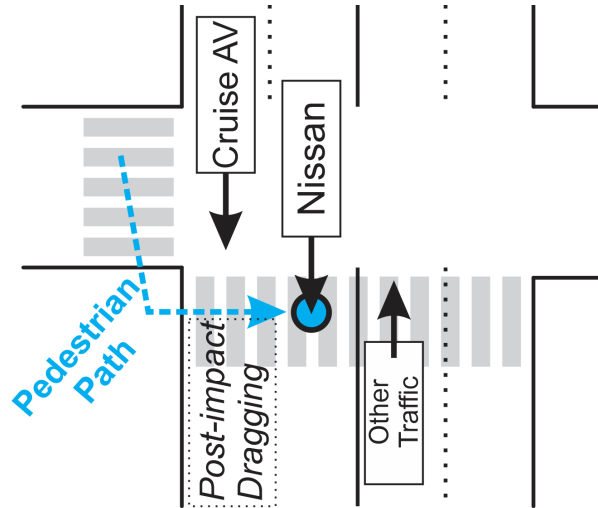
Figure 1. Simplified diagram of mishap; not to scale.

Figure 1 shows a simplified diagram of the mishap geometry. At the start of the mishap sequence, two vehicles were stopped at a red traffic light next to each other at an intersection on a 4-lane surface road: the Cruise AV on the curb lane, and a human-driven Nissan in the medial lane, adjacent to the two-way street center-line.

After the vehicles' light had changed to green, a pedestrian entered the crosswalk on the far side of the intersection. The pedestrian first crossed the AV's lane, and then the Nissan's lane. Both vehicles accelerated straight through the intersection toward the far crosswalk as the pedestrian traversed their paths. The pedestrian stopped in front of the Nissan, with her path blocked by oncoming traffic in the other direction. The pedestrian was likely distracted from the approaching Nissan ("did not look left") while attempting to signal opposing traffic to permit continuing the crossing (interpretation of description at EXPR 47). The Nissan struck the pedestrian in its lane, braking only after impact.

After an impact interaction with the Nissan, the pedestrian separated from the Nissan and entered the AV's travel lane. The AV started braking just before impact, hitting the pedestrian at close to its maximum pre-impact speed, coming to a quick stop. The AV's front wheel ran over the pedestrian, leaving the pedestrian under the AV.

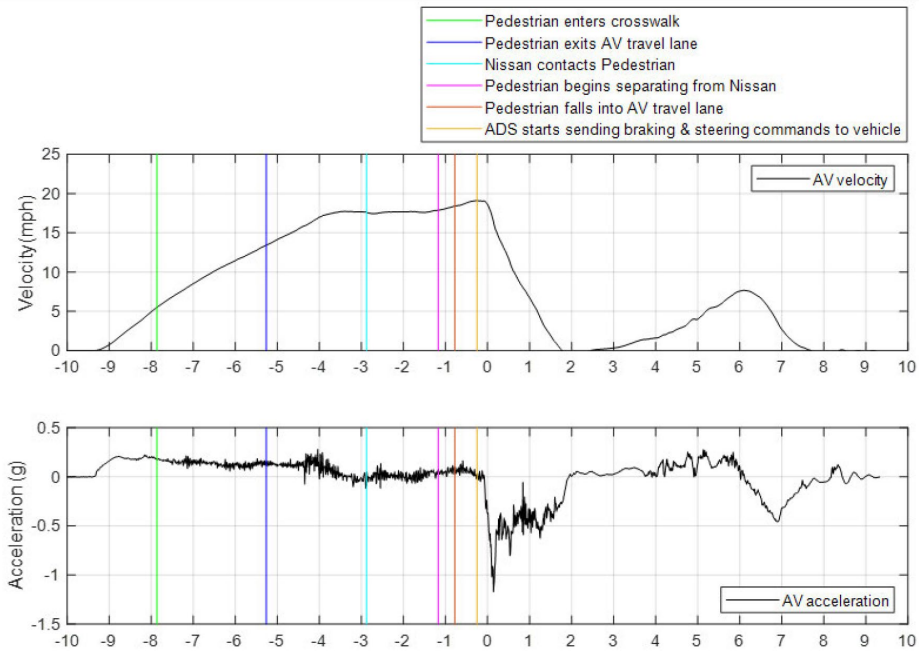
Figure 2. AV velocity and acceleration profiles from EXPR 43.

- -7.9 sec: Pedestrian enters crosswalk. AV traveling approximately 5.5 mph (fig. 2).
- -7.7 sec: AV predicts pedestrian will cross AV’s lane. AV continues accelerating.

- -5.3 sec: Pedestrian leaves AV travel lane after 2.6 seconds. AV traveling approximately 13.5 mph, and continues to accelerate (fig. 2).
- -4.8 sec: AV predicted paths for Nissan and Pedestrian “are consistent with a potential collision”, but “the ADS did not consider the potential of a collision between the Nissan and the pedestrian” (EXPR 15, 50, 53, 77).

- -2.0 sec: AV Pedestrian tracking is dropped. However, intermittent classification and tracking continues until -0.3 sec (EXPR 79).
- -1.5 sec (approx.): AV resumes gentle acceleration (Fig. 2)

- -0.78 sec: Pedestrian enters AV's travel lane approximately 21.5 feet in front of AV. AV at 18.4 mph (EXPR 66).
- -0.78 sec: Initiating braking now would have completely avoided pedestrian contact, but AV did not brake, instead increasing speed slightly (EXPR 66, fig. 2).

**Delay in braking:** The laws of physics did not preclude stopping in time to avoid AV/pedestrian impact. The AV had enough time to totally avoid impact if it had immediately responded to the pedestrian presence in its lane, even accounting for braking latency (EXPR 66). Even a delayed but earlier braking “would have potentially mitigated severity of the initial collision” (EXPR 66). Due to a slower-than-possible response, AV aggressive braking beyond 0.5g only occurred after impact time 0 (fig. 2).
