# The Role of Legacy Mobile Networks in Infrastructure Resilience: Evidence from the Southern Brazil Flood

**Abstract**—This paper investigates the resilience of mobile communication networks during the extreme flooding that affected Rio Grande do Sul, Brazil, in May 2024. Based on regulatory data and technical insights from operators, the study identifies the main causes of network disruptions, primarily related to flooding and prolonged power outages. The results reveal the significant vulnerability of modern networks (4G/5G) during the event and the essential role played by legacy technologies (2G/3G) in sustaining basic connectivity under adverse conditions. The findings highlight the need for disaster-aware infrastructure planning, considering the continued importance of legacy systems, diversified power supply strategies, and resilient network designs to improve service continuity during future crises.

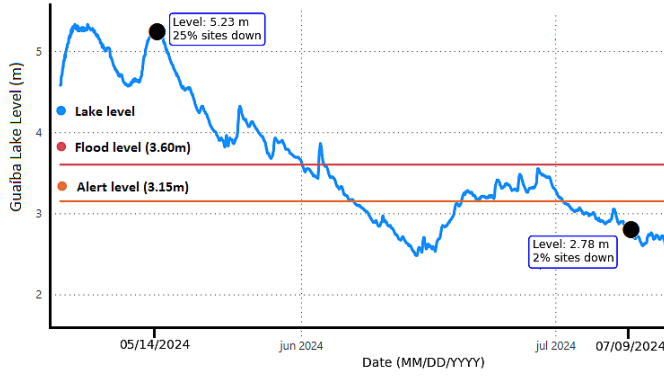
Fig. 1. Evolution of the Lake Guaíba water level in Porto Alegre during the 2024 flood. Snapshots corresponding to the critical (May 14) and recovery (July 9) phases are highlighted. A more complete timeline of events is available in the datasets presented in [9].

The evolution of Lake Guaíba’s water level is shown in Figure 1, providing a temporal reference for the two key snapshots analyzed in this study: the peak disruption phase (May 14, 2024) and the recovery phase (July 9, 2024). These moments were selected as representative of the most critical and recovery periods, respectively.

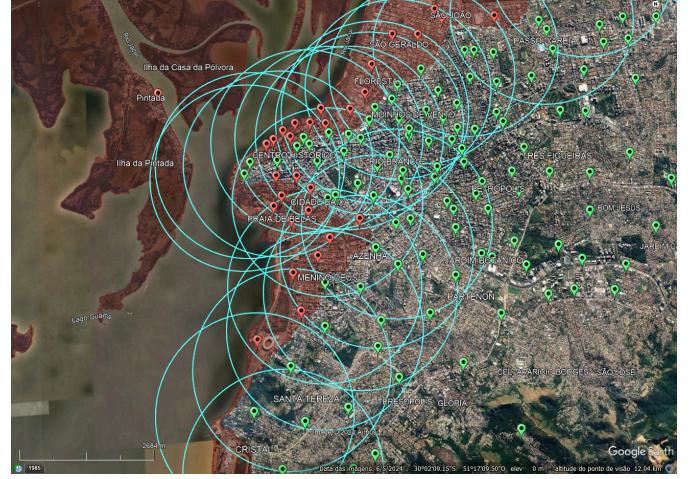
The red-shaded polygon delineates the flooded area, while the blue circles represent the estimated coverage zones of each active Base Transceiver Station located at the flood boundary, according to the technology in use (2G and 5G). Red markers identify the sites that went out of operation during the event, whereas green markers indicate the sites that remained operational.

Fig. 3. Estimated 2G coverage maps of a mobile operator's stations in the city of Porto Alegre - (2km radius).

For the map generation shown in Figures 3 and 4, we simulated a worst-case signal coverage scenario, adopting the minimum coverage radius for each technology: 2 km for 2G and 0.5 km for 5G, as specified in Table IV. These maps represent the estimated mobile coverage in Porto Alegre on May 6, 2024, combining flood extent data—corresponding to the peak water level of 5.35 meters [15]—with the technological composition and spatial distribution of each Base

The analysis reveals a significant disparity in coverage between 2G and 5G, with 2G demonstrating broader signal reach in the flood-affected areas due to its lower operational frequencies. Notably, even in the most severely affected zones, 2G cells remained operational in higher proportion compared to 5G, ensuring basic voice and SMS connectivity in the absence of modern data services.

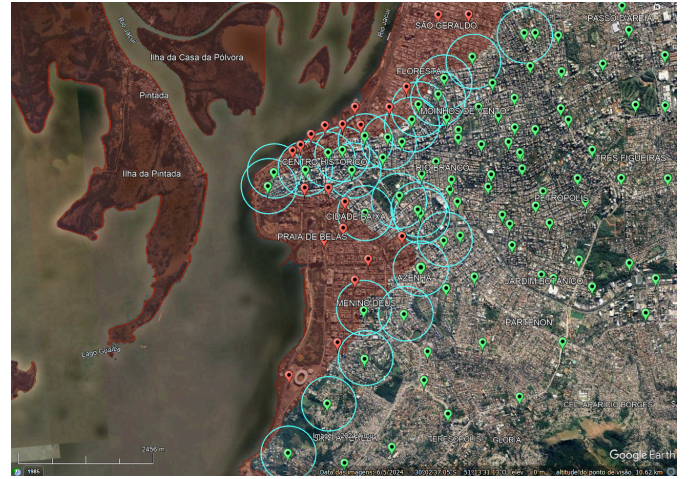
Fig. 4. Estimated 5G coverage maps of a mobile operator's stations in the city of Porto Alegre - (0.5km radius).
