Low-Magnification SEM May Suffice: Interpretable Deep Learning for Multi-Scale Fracture-Cause Classification in Zirconia-Toughened Alumina

Abstract. Reliable identification of fracture origins in alumina matrix composite hip and knee implants is critical for quality assurance and patient safety, yet current fractographic workflows are time-consuming, partly subjective, and reliant on high-magnification scanning electron microscopy (SEM). We present an interpretable vision-transformer (ViT) workflow for automated classification of fracture causes in an alumina matrix composite (BIOLOX[®] *delta*, CeramTec GmbH) widely used in total joint replacements. A dataset of 8,493 SEM images (50×–10,000×) was curated from five years of in-production burst and proof tests and annotated into three defect categories defined along the manufacturing chain: green body, hard machining, and material defects. Under severe class imbalance, the fine-tuned ViT reached an accuracy of 0.907 and a macro-F₁ of 0.888 in stratified five-fold cross-validation, with a two-stage perceptual-hash/SSIM leakage audit confirming negligible specimen overlap. Notably, performance at low magnification (50×) was comparabl

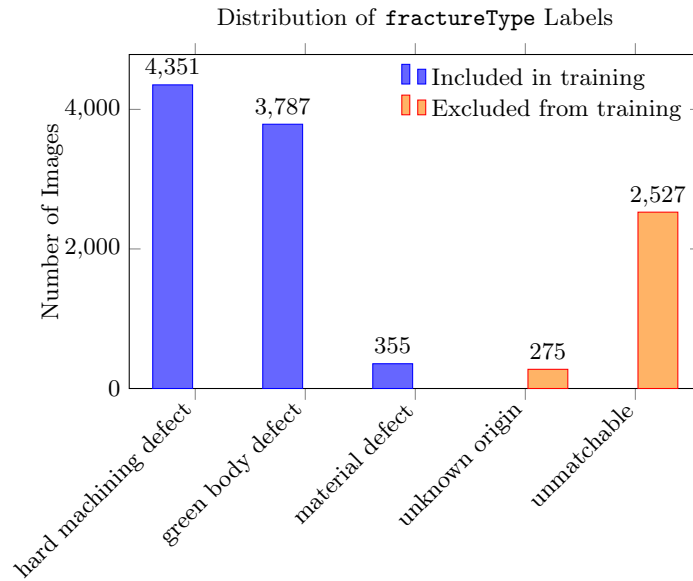
Fig. 1: Class distribution of the cleaned fracture dataset after image-FOAN matching.

Dataset statistics The resulting dataset contained 8 493 labelled SEM images. Labels were aggregated into three classes: *green body defect*, *hard machining defect* and *material defect*. A fourth class, *unknown origin*, and a set of unmatchable images were excluded from training because they lack a clear supervisory signal, however could be used in future work for semi-supervised or self-supervised approaches. Figure 1 summarises the class distribution. The dataset is highly imbalanced with the minority class assigned to only 4% of images. Magnifications were extracted via OCR of scale bars embedded in the original SEM frames. Eight distinct magnifications were present ($50\times$, $100\times$, $250\times$, $500\times$, $1k\times$, $2k\times$, $4k\times$, $10k\times$), with high magnification ($1000\times$ – $10\,000\times$) used more frequently in expert analyses than low magnification ($50\times$ – $100\times$).

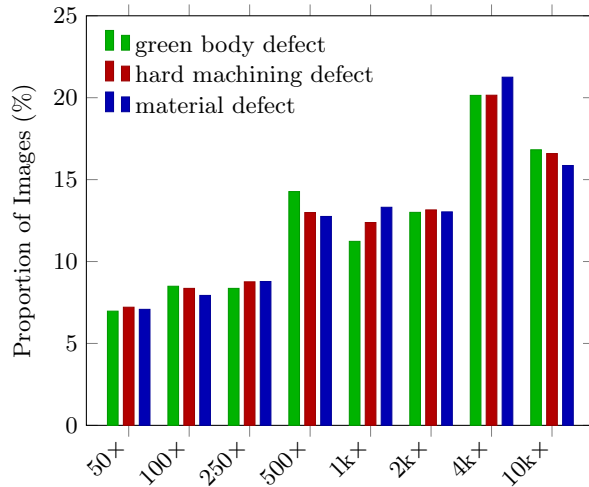
Fig. 2: Magnification distribution per fracture type (proportions within class).

In addition to class counts, the distribution of SEM magnifications within each fracture type was analysed (Fig. 2). The proportions are broadly similar across classes. The balanced distribution reduces the risk that the classifier could exploit magnification as a spurious shortcut, ensuring that morphological features rather than scale dominate the decision process.

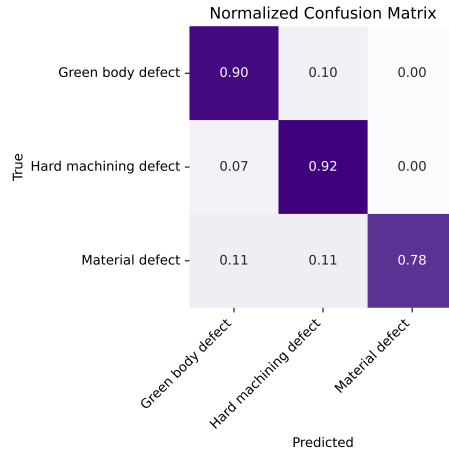
Fig. 3: Aggregated, row-normalised confusion matrix over the five cross-validation folds.

Error structure The confusion matrix in Fig. 3 reveals a largely *symmetrical* confusion between *green body* and *hard machining* defects: 10 % of green body images are mis-labelled as hard machining, while 7 % of hard machining samples are assigned the opposing class. For the *material-defect* class the pattern is asymmetric: 22 % of material-defect images leak into the other two classes (11 % each), limiting recall to 0.78, *yet* almost no samples from the other classes are mistakenly predicted as material defect, yielding a column-wise precision of 0.94. This behaviour is consistent with the visual similarity of early-process cracks (green body vs. machining) and the relative scarcity of material-defect examples, which makes the classifier conservative—i.e. high precision but lower recall—when assigning that label.

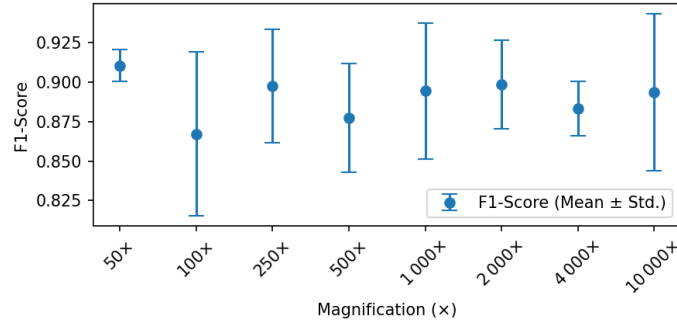
Fig. 4: F_1 score of the ViT model across magnifications. Error bars denote standard deviation across folds. Robust performance at low magnification indicates that macro-scale fracture patterns are predictive of underlying causes. *Mechanistic note:* macro-scale mirror geometry and hackle-field organisation appear sufficient to separate manufacturing-related fracture origins in many cases.

Although high magnification is typically considered essential for fracture analysis ([10]), images at $50\times$ achieve F_1 scores within one standard deviation of those at $4k\text{--}10k\times$, suggesting comparable diagnostic value (Fig. 4); a formal statistical comparison was beyond the scope of this work. This indicates that macro-scale fracture patterns—radial fans, arrest lines—already encode enough statistical regularities for the ViT to diagnose the origin, challenging the conventional analyst workflow that prioritises high-magnification inspection first. In practice, an automated pre-screening step at low magnification could therefore accelerate routine failure analysis by flagging the most probable cause before expensive high-mag imaging. Mechanistically, this observation can be rationalised by classical fractography: global features such as mirror extent, shape, and hackle-field organisation are known to reflect local crack velocity gradients and stress fields around the initiation site [9]. These cues differ systematically between manufacturing-related defect types, explaining why low-magnification views already provide sufficient diagnostic signal.

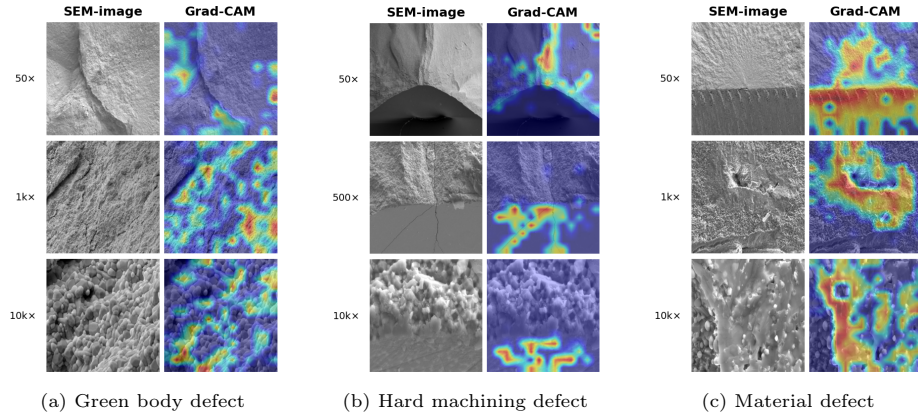
Fig. 5: Grad-CAM visualisation of the three defect classes (one fracture instance each) at increasing magnifications. For each class the original SEM image is shown on the left and the corresponding Grad-CAM heat-map on the right. All panels were correctly classified by the model with confidences above 90 %.

Figure 5 illustrates representative Grad-CAM visualisations from the hold-out batch for each defect class across increasing SEM magnifications. In all three cases the highlighted regions coincide with morphological cues that are physically meaningful in fracture analysis, such as fracture mirrors, hackle lines, grain boundary structures, and machining traces.

Green body defects At low magnification (Fig. 5a, 50 \times) the model emphasizes edges in the fracture mirror and shading variations around the origin. These structures are consistent with the geometry of hackle lines, which typically point back to the initiation site. While a definitive diagnosis is rarely possible at this scale, the model already extracts useful information and predicts the defect correctly. At intermediate magnification (1k \times), intergranular cracks and shadow-like grain boundary features become prominent, and the model highlights exactly these regions. At the highest magnification (10k \times) it focuses on rounded grain surfaces that are characteristic of pre-sintering defects. This progression across scales mirrors the logic of established fractographic reasoning, making the model’s decision highly plausible.

Hard machining defects In the case of machining-induced defects (Fig. 5b), the model relies at 50 \times on fine surface lines that are not visually striking, yet its prediction is correct. At higher magnifications, breakout regions and cracks are emphasised, which are robust indicators of machining damage. At the highest scale, machining marks converging toward the origin are strongly attended, providing circumstantial evidence of the failure mechanism. Across magnifications,

the model’s focus consistently aligns with meaningful morphological cues for machining defects.

Material defects For material defects (Fig. 5c), the low- magnification view at $50\times$ provides only weak diagnostic cues. The model predominantly attends to machining marks, metallic abrasion, and the fracture-mirror, while the actual defect remains largely undetected. Nevertheless, it predicts a material defect—likely because the metallic residues are interpreted as foreign material. While this interpretation is understandable, these residues are not the fracture origin. This constitutes a *right-for-the-wrong-reason* pattern that, despite the nominally correct label, limits the trustworthiness of low-magnification predictions for the material-defect class and motivates expert verification at higher magnifications. At higher magnifications ($1k\times$ and $10k\times$), pore-related irregularities and adjacent grain connections become visible, and the model shifts its attention accordingly. In these cases the decision is well supported by features that are genuinely diagnostic of intrinsic material flaws.

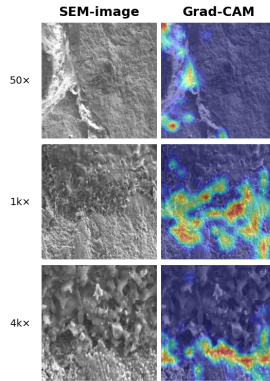
Fig. 6: Example of a misclassification. In each case, a *green body defect* (ground-truth label) is erroneously predicted as a *hard machining defect* within the same fracture instance. For each magnification-level, the left column shows the raw SEM image and the right column the corresponding Grad-CAM heat-map.

Misclassifications Figure 6 illustrates typical error cases where the model predicts a machining defect instead of the correct green-body defect. The underlying problem is that the images contain fracture mirrors but not the actual initiation site. At $50\times$, the model highlights structures resembling machining marks, which is misleading in the absence of hackle lines or origin features. At higher magnifications, carbon residues obscure the surface, further reducing interpretability. These examples underline that the model can produce plausible but ultimately incorrect attributions when the true fracture origin is missing or imaging conditions are compromised.
