Additives That Prevent Or Reverse Cathode Aging In Drift Chambers With Helium-Isobutane Gas*

A. M. Boyarski¹

Stanford Linear Accelerator Center, Stanford, CA 94309, USA

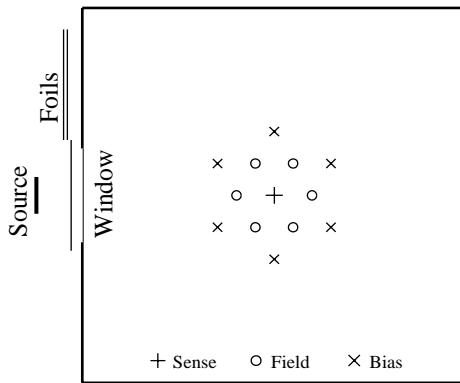
Figure 1. The test chamber. A single drift cell is enclosed in a square aluminum tube 10.2 cm per side, and 30.5 cm long.

A small test chamber was built having one hexagonal BaBar-like cell as shown in Fig. 1. The sense wire (20um gold coated tungsten-rhenium) is surrounded by six field wires (120um gold coated aluminum) at 1 cm wire spacing. The six outer bias wires at 1300 volts together with 2050 volts on the

sense wire provide a 19.2 KV/cm field on the field (cathode) wires and 239 KV/cm on the sense (anode) wire.

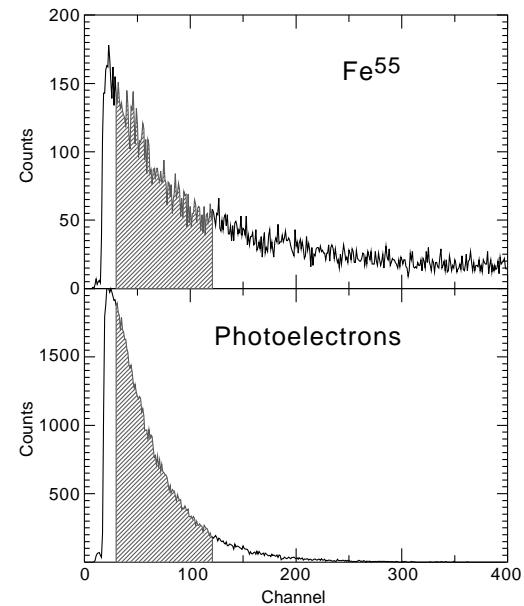
Figure 2. Pulse height spectrum for small pulses from Fe⁵⁵ and from single photoelectrons. The shaded channels are used to count single electron avalanches. The Fe⁵⁵ peak is off scale at channel 5500.

A Pico ammeter (Keithly 487) and a multi-channel analyzer (Perkin Elmer/Ortec 142PC, 570, and TRUMP PCI-8K) measured the cathode current and anode pulse spectrum respectively. The 8K-channel range in the analyzer could accommodate both the Fe⁵⁵ peak at channel 5500 and the signal from one-electron avalanches at channel ~32. The analyzer did not record pulse heights below channel 20. The top plot in Fig. 2 shows the small pulse spectrum from

Fe^{55} at a low source level, while the bottom plot shows the spectrum when incandescent light is allowed into the chamber. The latter spectrum is from photoelectrons off the cathode wires, and establishes the shaded channels (30-120) to be used for counting single electron avalanches. The small pulses from Fe^{55} are due to conversion locations grazing the boundary of the cell with only a single (few) electron(s) reaching the anode.

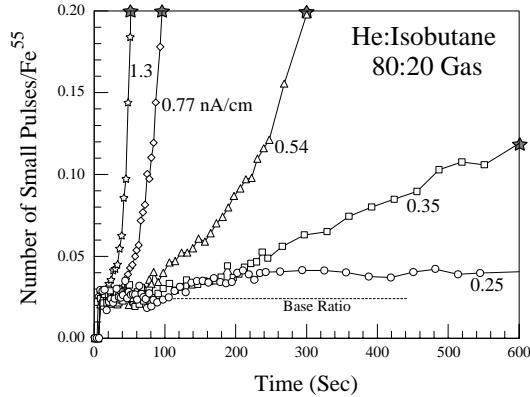
Figure 3. Transient behavior of small pulses in the (80:20) gas after opening the source shutter, for various levels of wire current. A star at a boundary indicates that breakdown occurred outside of the plot area.

the transient behavior of small pulses for wire currents from 0.25 to 1.3 nA/cm in the Helium:Isobutane (80:20) gas with no additives.

When the source is first opened, the small pulse ratio starts at the same 0.025 base value for all current levels. At the highest current (1.3 nA/cm) the ratio grows rapidly until the chamber breaks down after 60 seconds. At lower currents the breakdown takes longer to develop. At 0.25 nA/cm the chamber does not breakdown although there is an elevation in the number of small pulses.

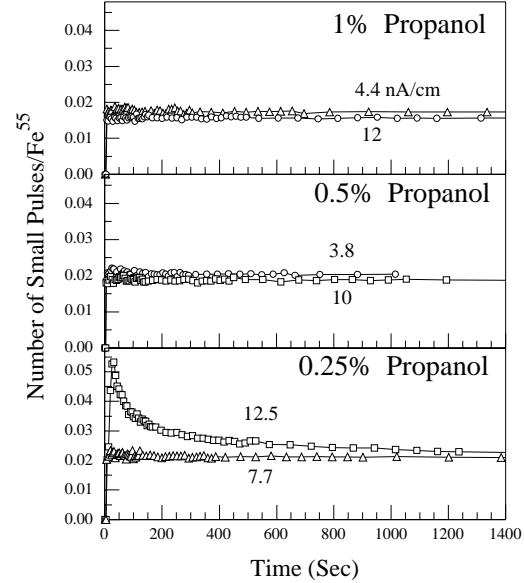
Figure 4. Transient behavior of small pulses with an alcohol additive 2-Propanol. Concentrations above 0.5% show no small pulse activity.

Some additives allowed chamber operation beyond wire currents of 10 nA/cm. The transient behavior with 2-Propanol, $\text{CH}_3\text{CHOHCH}_3$, is shown in Fig. 4. At concentrations of 1% and 0.5% there is no small pulse activity for wire currents of 10 nA/cm or more, while at 0.25% there is an initial increase at 12.5 nA/cm and then a gradual decline. The declining

A strange behavior already seen in Fig. 4 bottom is the rise and fall of the small pulse activity after the shutter is opened. This was seen for all gases with or without additives, for currents slightly below the break down threshold. Fig. 7 shows this effect for the Helium:Isobutane (80:20) gas.

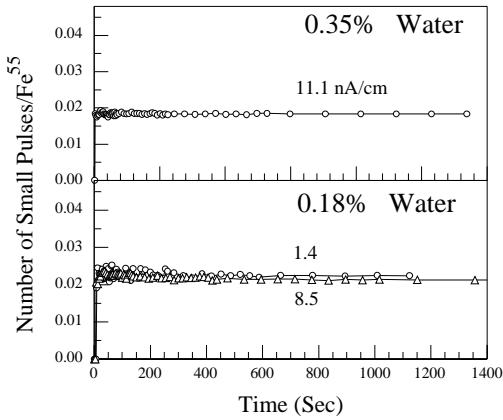
Figure 5. The small pulse transient behavior with a 0.35% or 0.18% water additive shows no increase in small pulses.

The transient behavior for a water additive is shown in Fig. 5. There is no visible small pulse activity with 0.35% or 0.18% water.

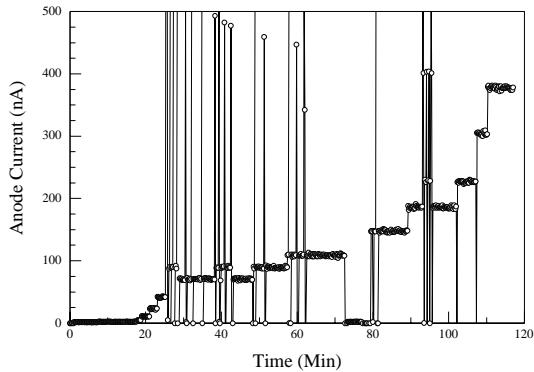
Figure 6. The anode current during a curing cycle with 0.05% O_2 is shown. The spikes are chamber trips, but after repeated attempts the chamber reaches a stable state at each current level up to the maximum Fe^{55} source level.

The final two additives tried in this study, O_2 and CO_2 , behaved differently. Whereas the previous additives allowed immediate operation at higher chamber currents, these did not. With O_2 or CO_2 it was necessary to increase the ionisation slowly. If brought on too quickly, the chamber would ignite in Malter mode, but after repeated attempts would become stable. Fig. 6 shows the anode current with 0.05% oxygen. After 2 hours of training the maximum Fe^{55} source was reached, at an anode current of 375 nA (29 nA/cm wire current).

But more importantly, when the O_2 was removed from the chamber gas, the chamber could still operate at the maximum 29 nA/cm wire current. The O_2 additive was able to cure a damaged chamber. This measurement was repeated several times (by damaging the chamber at high source levels and elevated high voltage, followed by a cure cycle) with the same result.

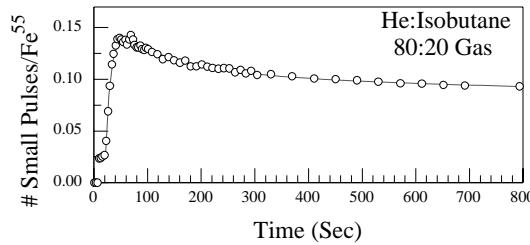
Figure 7. Small pulse activity at ionisation levels just below the break down threshold shows a rise and then a fall from a step increase in Fe^{55} ionisation.

The increase in small pulses is readily explained by the Malter theory, in which an insulating deposit on the cathode collects the incoming positive ions and charges up to a point where the resulting high electric field draws off electrons from the insulator. As the charge and the electric field build up with time, the rate of emission of electrons also increases as observed, until Malter break down occurs or the charge build up is balanced by ohmic current flow through the insulator.

But the sudden reduction in small pulses after a build up period means that some other mechanism turns on which suppresses emission of electrons from the insulator. A likely candidate is heat. The positive ions gain energy when traversing the 19 KV/cm electric field at the cathode, and this energy is dissipated as heat in the collisions with the gas near the insulator or the insulating surface itself. As the insulator heats up, its effective resistance may fall. The charge build-up would then discharge more rapidly and the emission of electrons would decrease as observed.

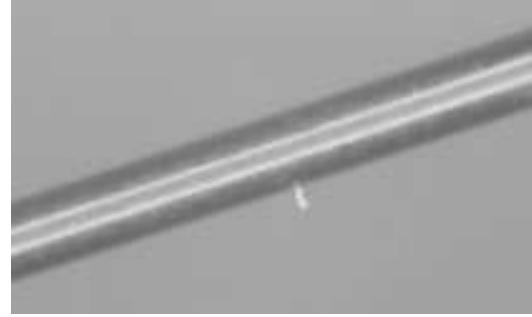
Figure 8. Picture of a whisker on a 120 μm cathode wire after the chamber was purposely damaged by running at the maximum source strength and an elevated high voltage.

After the test chamber was maximally damaged, the chamber was opened and the wires were viewed with a microscope. A few whiskers were found on both the anode and cathode wires. An example of a

long whisker on a cathode wire is shown in Fig. 8. The whisker is white in color. Another cathode whisker (not shown) was of approximately equal size but was black in color.

The chamber was then operated with 0.05% oxygen and run until cured to the maximum source strength. Pictures were again taken of the same regions on the cathode wires. The white whisker was gone while the black one was still there as before.

This suggests that the white whisker was a damaging element. It contributed to chamber break down and was removed by the oxygen cure. On the other hand, the black whisker did not cause break down at the highest ionisation level. However, this was a recent observation and there was no time to repeat it before the aging workshop. The white whisker could have fallen off the wire while transporting the chamber to the microscope room. This work will be repeated.
