Field Emission Dark Current of Technical Metallic Electrodes

F. Le Pimpec*, R. Ganter

Paul Scherrer Institut
5232 Villigen
Switzerland

Abstract

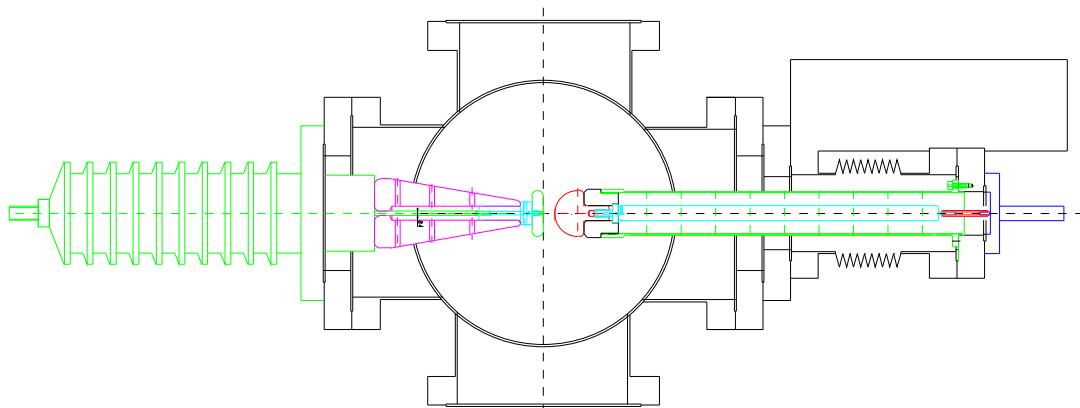
Figure 1: Dark Current -100 kV DC test stand. The flat cathode is mounted on the left side of the system.

The ultra-high vacuum (UHV) system shown on Fig.1, outside its metal confinement bunker for radiological protection, is pumped by a 150 l/s diode ion pump. The average pressure reached is in the low 10^{-9} Torr scale after a quick bake of the ion pump. A more thorough bake brings the pressure in the mid 10^{-10} Torr. An injection line, a leak valve and a Torr capacitance gauge allow the controlled injection of different gas in the system to prepare the glow discharge in between the electrodes.

A negative and continuous 0 to 100 kV bias is applied to the cathode through an insulating ceramic, left side of the picture (Fig.1). The anode is grounded. The capacitance of the system is closed to 300 pF, hence an energy potentially stored of 1.5 J at 100 kV. The current flowing from the cathode to the anode is measured across a 1 M Ω resistor with a digital FlukeTM voltmeter. The gap separation between the electrodes are adjustable via a translation feedthrough and controlled with a mechanical comparator. The sagging due to the weight at the end of the rods makes that the two electrodes are not centered on each other. We do not expect this off centering to be of any consequences on the high voltage processing. However, it explains the off center damages seen on cathodes. Accurate measurement of the current to the 50 pA level is achieved.

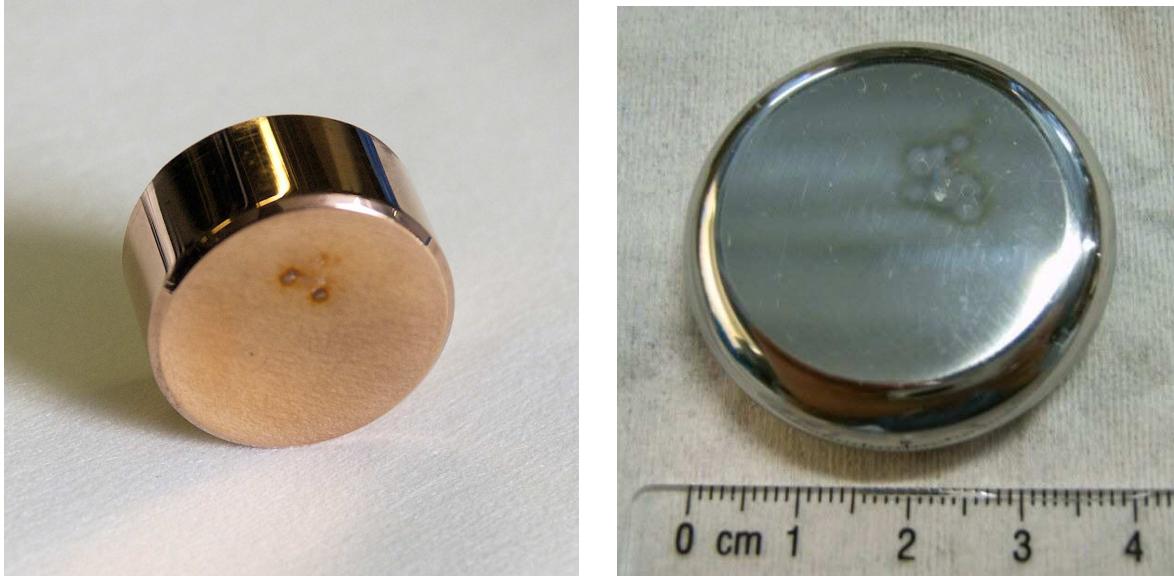
Figure 2: Cleaned Cu cathode after high voltage testing, left. Damaged Mo cathode, right picture Damages can be clearly seen.

All our electrodes tested have the same shape, see Fig.2 & 3 for the cathode and anode, respectively. The mean roughness was, by design, defined to be less than $R_a \leq 0.2\mu\text{m}$. On the anodes picture, Fig.3), the copper anode, has a hole in the middle. This hole was made to mimic the behaviour of the extracting anode of the 500 kV pulser. None of the other electrodes have this hole. The R_a of the electrodes was checked after high gradient testing.

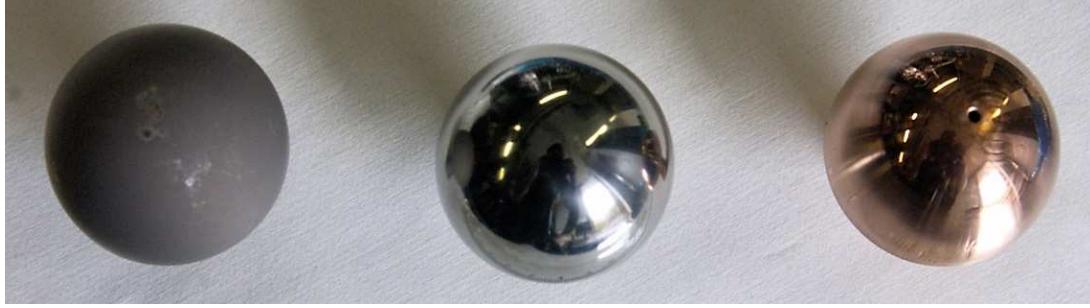
Figure 3: Three anodes used for HV testing, Ti on the left(grey black colour, after vacuum firing), Mo in the center and Cu on the right. Pictures taken after HV testing. Damages can be seen on the Ti electrodes

Upon inspection of the electrodes after their extraction from the chamber; damage spots can be seen on either one of the electrodes. Damages are located on the anode around the top of the mushroom, and 4 separated spots can be seen on the cathode spread over a trail of 1 cm long. Damages on Ti anode are similar to the one seen on the SS and Cu anodes, in extension and morphology (melted area).

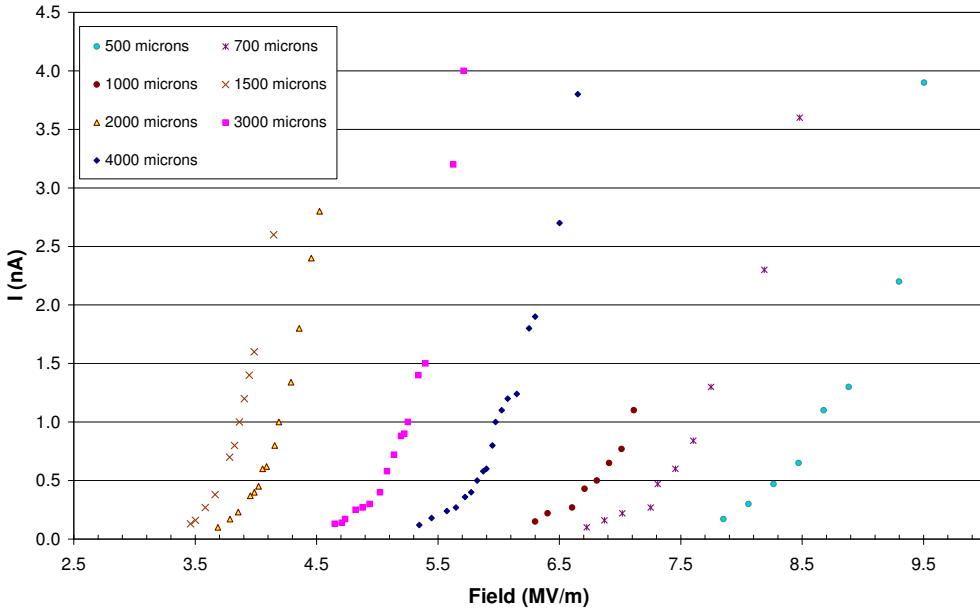
Figure 4: Dark current of Al electrodes after a system bake at 190°C for 100h and after electrical conditioning of 29 kV at a 4 mm gap drawing 7 nA of current from the cathode to the anode.

Pristine as received Al electrodes were tested. The first test after a thorough bake of the chamber led to a dark current of 1nA at a gap of 1 mm for a field of 7.1 MV/m. The gap between the electrodes was set at 4 mm and the electrodes were conditioned overnight by applying 29 kV and drawing 7 nA of current. The next day the dark current measured increased to 13 nA. Several dark current curves were then produced and compared to the as received test, Fig.4. The obvious conclusion is that at this level this DC electrical conditioning did not lead to any improvement.

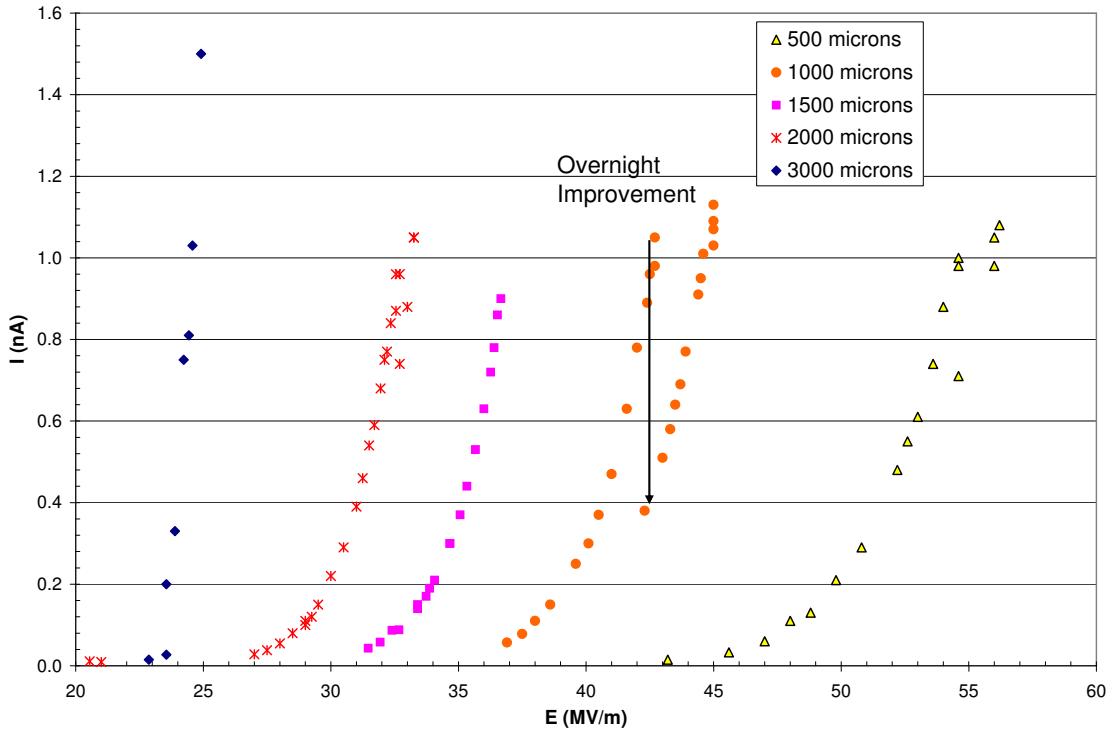
Figure 5: Dark current of Al electrodes after an Ar Glow Discharge, following the previous He processing and high field conditioning.

not sufficiently severe that still a current of 1 nA at 1 mm was measured for a field of 41.5 MV/m. Finally, the best result obtained playing this game of He-Ar GD, was to hold a field of 52 MV/m at 1 mm without dark current. However, at some point an arc more violent than the previous one, will sufficiently damage the cathode that no more GD will be able to restore the holding of the high electric field. A summary of the performance obtained with Al electrodes is shown in Table 4.

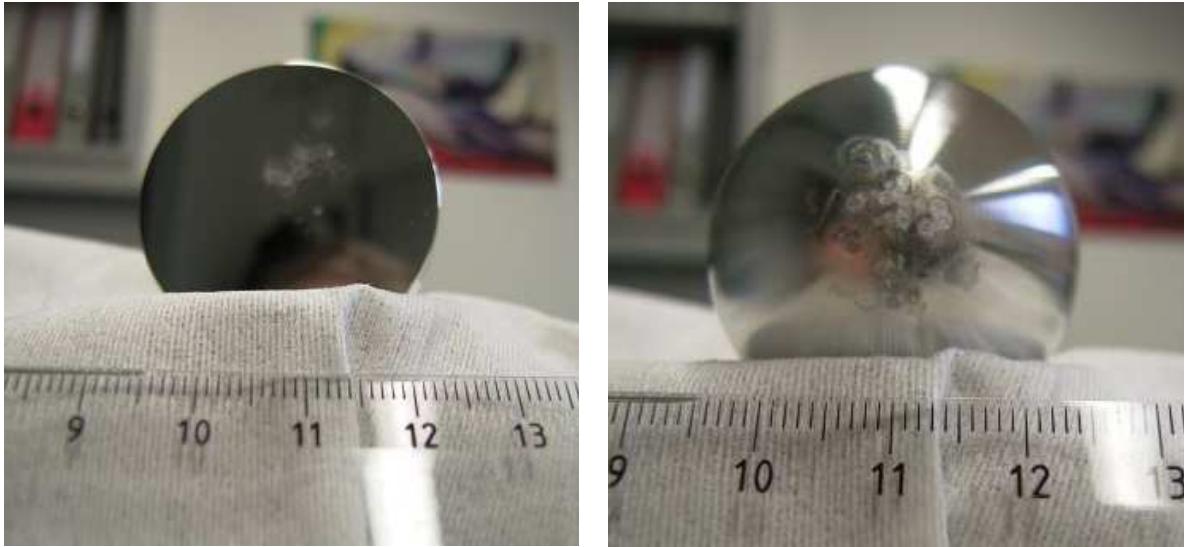
Figure 6: Breakdown damages withstood by the Al cathode (mirror finished-left) and anode (right) during the conditioning period. Scale in cm.

We then replaced the damaged Al cathode by a pristine mirror like finish Al (6082) cathode, machined to an R_a of 3 nm. The previously damaged mushroom anode was reused, after having been solely wiped with alcohol before reinstallation in the UHV system. The damages on the anode were localized around the summit of the anode, and similar to the one shown in Fig.6 right picture.

With this configuration, the as received system held stably without dark current, an electric field of less than 36 MV/m. At this value, an arc occurred. Inspection of the cathode through the viewport of the UHV system showed pitting, hence damages. An He-Ar GD was then applied to cure and clean the electrodes. Results are summarized in Table.4. The column labelled <0.05 nA shows the field strength held without measuring any FE. The System held the 90 MV/m electric field at 750 μ m, and broke down at 92 MV/m. The vacuum arcing was so severe that no further PGD was able to restore such fields. Final damages of the Al electrodes upon removal are shown in Fig.6. The results show that the breakdown is cathode initiated as the cathode was pristine and the anode was already severely damaged.

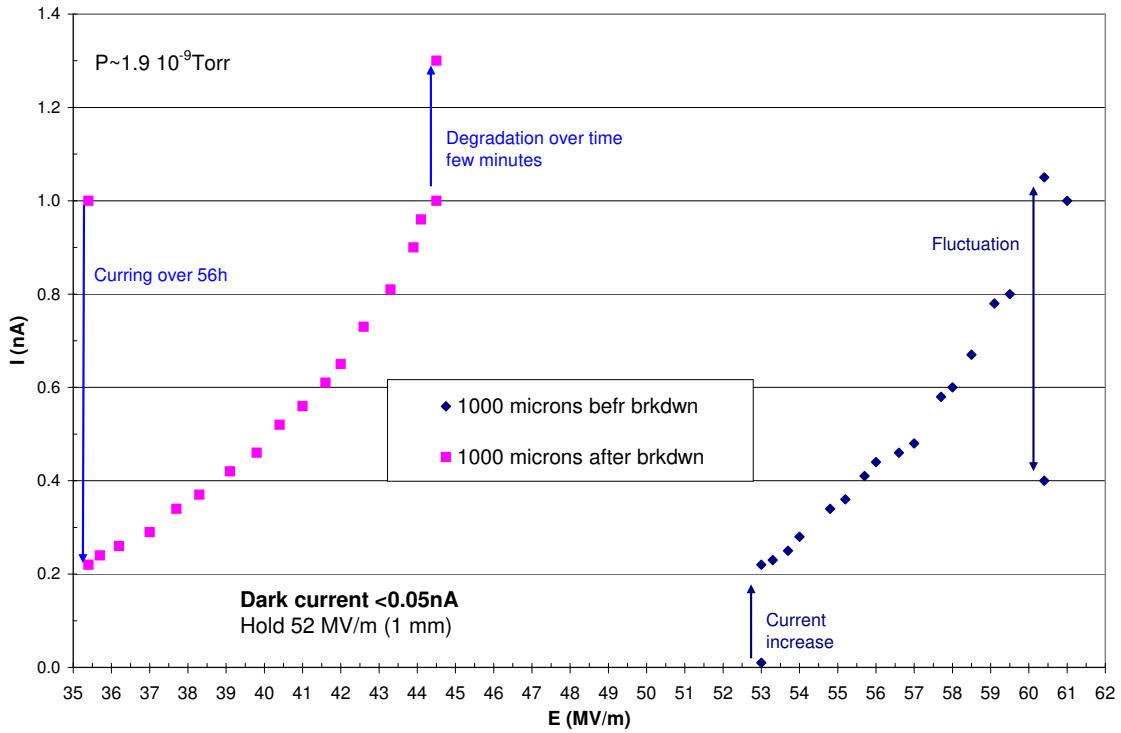
Figure 7: Dark current evolution of Ti electrodes after a 2nd Ar Glow Discharge. The square curve is obtained after a surface breakdown at 62 MV/m

In the case of Ti, we have observed after plasma treatment, a stable field holding at 52 MV/m without FE. From 53 MV/m on, dark current appeared and reached 1 nA at 62 MV/m, cf Fig.7 (diamonds). The field held there for a few minute until arcing, bringing the current above 1 μ A. The field was then reduce to 35 MV/m in order to get a 1 nA current value, cf Fig.7 (squares.) This current value did decrease over 56 hours of 35 MV/m field processing. A few MV/m were then gained to bring back the current to 1 nA. It is possible that after a soft breakdown leading to dark current emission around 1 μ A, no rise in pressure can be detected. At a pressure of 2.10^{-9} Torr, gas released by ESD process can in principle be detected. A simple calculation will show that such a current will produce a gas flux of $\sim 3.10^{-9}$ Torr.l.s $^{-1}$, hence an increase of pressure of $\sim 2.10^{-11}$ Torr; assuming an ESD coefficient of 10^{-2} molecule/electron. This is below the resolution of our instrumentation.

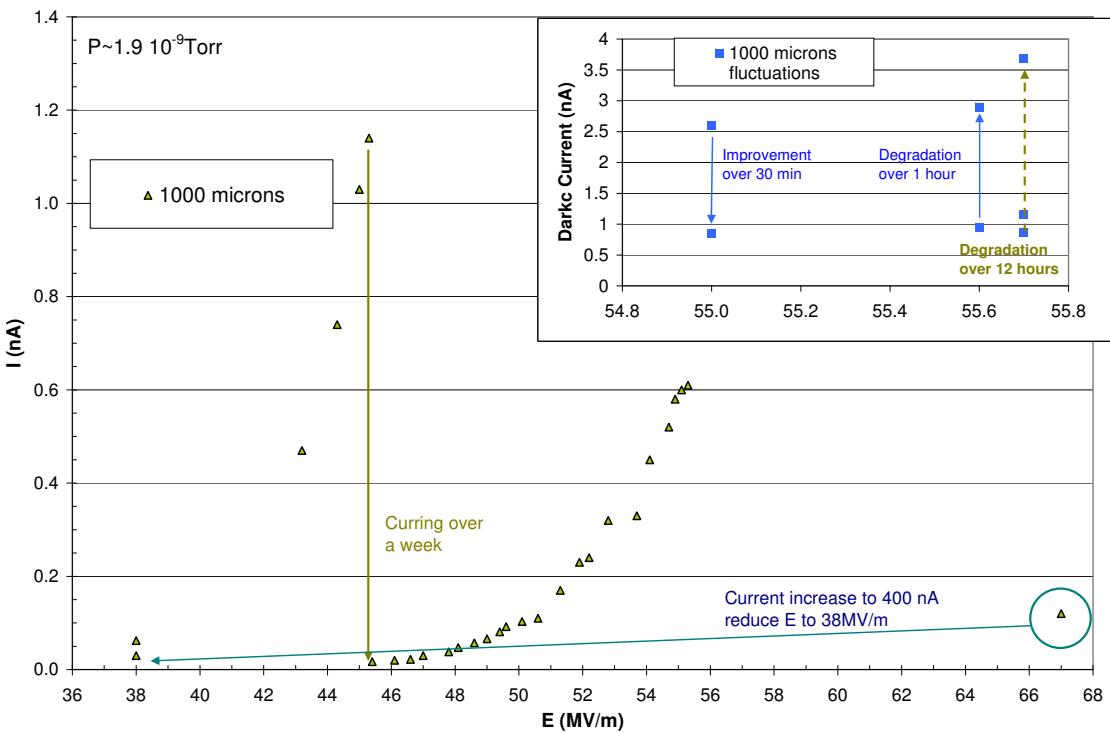
Figure 8: Dark current evolution of Ti electrodes after a 3rd Ar Glow Discharge.

A subsequent ArGD for 90 minutes at 580 eV under pressure varying from 0.156 Torr to 0.174 Torr was done. During this PGD, the Ar gas was evacuated several time and then replaced by new Ar coming from the cylinder. The field held after this plasma was 61 MV/m. The voltage was then increased and fluctuation in the emitted current below 50 pA were observed, above 63 MV/m the dark current was fluctuating around 0.1 nA and thus until 67 MV/m, see Fig.8. Field conditioning over a week showed, like in the case of Al or SS, an improvement in the dark current emission. The final stable electric field obtained for 1 nA at 1 mm gap is 55 MV/m, see insert in Fig.8. Above this level of field, the dark current does not diminish but it increases with time, Fig.8.

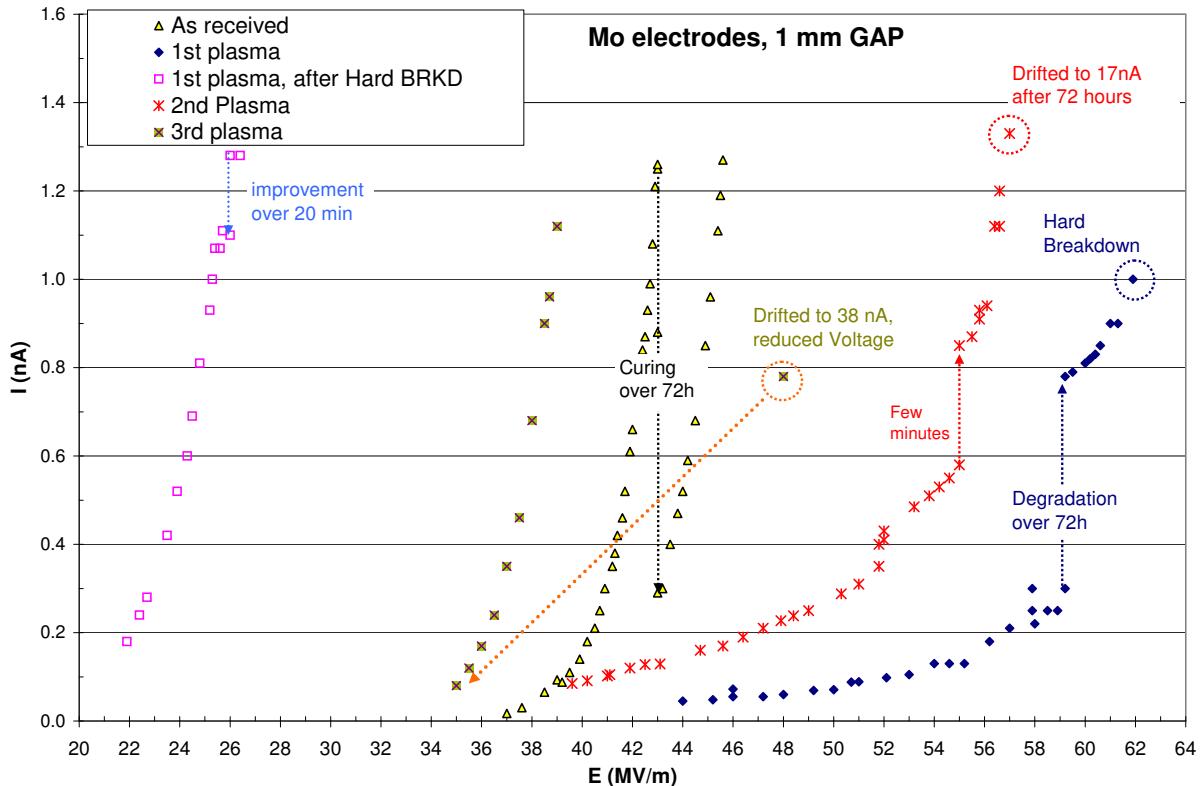
Figure 9: Dark current evolution of Mo electrodes after processing.

As for the Ti electrodes, dark current appears at some voltage. Raising the field increased the dark current until breakdown occurs. Dark current plots from as received electrodes(triangles), and after three plasma treatments are presented in Fig.9. The first ArGD push the limits of the dark current onset (diamonds) until a hard breakdown occurs, bringing the current over the μ A. The onset and the 1 nA limit is then greatly reduced (squares). The second ArGD allows to partially recuperate from this breakdown (asterisks). A third plasma He-Ar, does not bring any extra improvement (crosses in squares). Mo conditioning from broad electrodes at large gap ($> 500\mu\text{m}$) is similar as conditioning with short gaps. Mo reach higher gradient than Cu but it sparks more to get there [24], hence showing more damage than Cu, Fig.2. From this, it is obvious that a special electrodes conditioning procedure must be used to process them, and thus to protect the electron source.
